GROUP	MODEL
ELE	2020MY Telluride (ON) LX/S/EX w/Halogen Headlamp
NUMBER	DATE
296 (Rev 1, 06/01/2023)	May 2023

TECHNICAL SERVICE BULLETIN

HALOGEN HEADLAMP REPLACEMENT

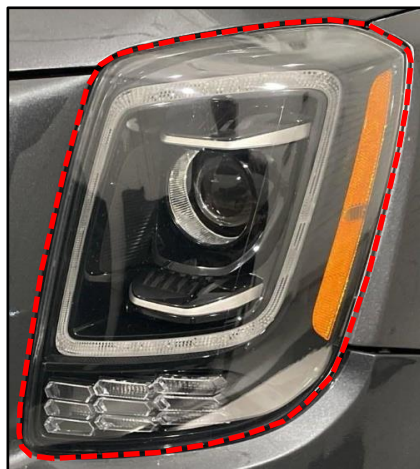
Halogen Headlamp Assembly

This bulletin provides information associated with the 'Halogen Headlamp High Beam Warranty Extension Program' (WTY030) to replace the affected (left and/or right side) headlamp assembly on certain 2020MY Telluride (ON) LX/S/EX vehicles, produced at Kia Georgia from January 09, 2019 through November 18, 2019, which may exhibit a loss of high-beam functionality. Due to an internal failure in the headlamp, the high-beam lights may not illuminate when turning the light switch from the low to high beams. The low-beam lights may not illuminate when turning the light switch from the low to high beams. The low-beam function is not affected. The vehicle's warranty for this issue will be extended from 5 years/60,000 miles to 15 years/150,000 miles, whichever comes first, starting from the date the vehicle was first put into service. Follow the procedure outlined in this publication to replace the (left and/or right side) halogen headlamp assembly with a new part.

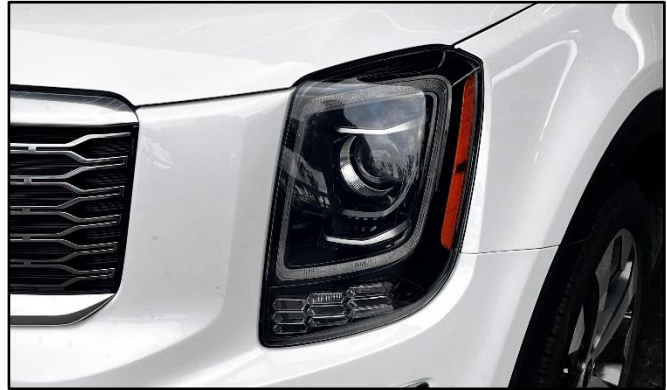
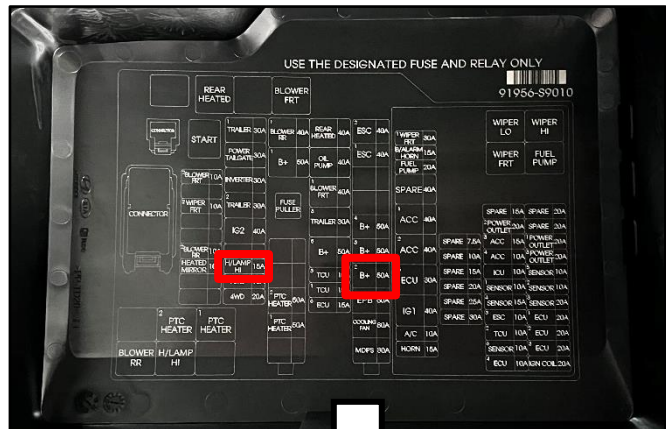
- Perform a visual inspection of the bulb.
 - If the bulb is **(OK)**, continue to step 2.
 - If the bulb is **(NG)**, this TSB does not apply. Claim Diagnosis Op Code **232A0710**.
- Ensure the 50A B+2 and 15A H/LAMP HI headlamp fuses are not blown.
 - If the fuses are not blown **(OK)**, proceed to step 3.
 - If the fuses are blown **(NG)**, this TSB does not apply. Claim Diagnosis Op Code **232A0710**.

Note: The multi-fuse does not need to be removed to inspect the 50A B+2 fuse.

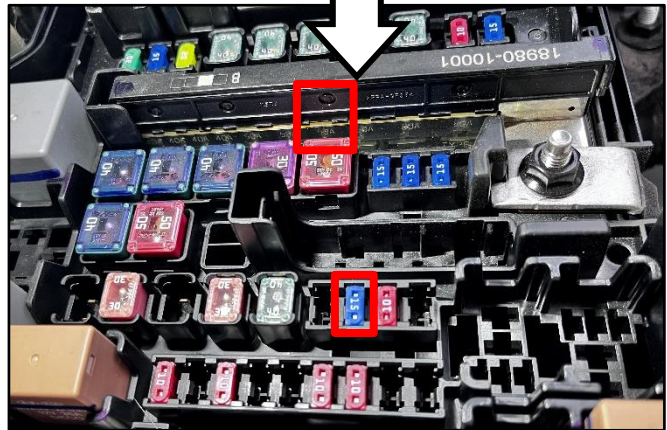
- Verify headlamp connector is properly seated.
 - If the connector is properly seated **(OK)**, proceed to 'Replacement Procedure'.
 - If the connector is **not** properly seated **(NG)**, remove connector and properly install. No further action required. Claim Diagnosis Op Code **232A0710**.

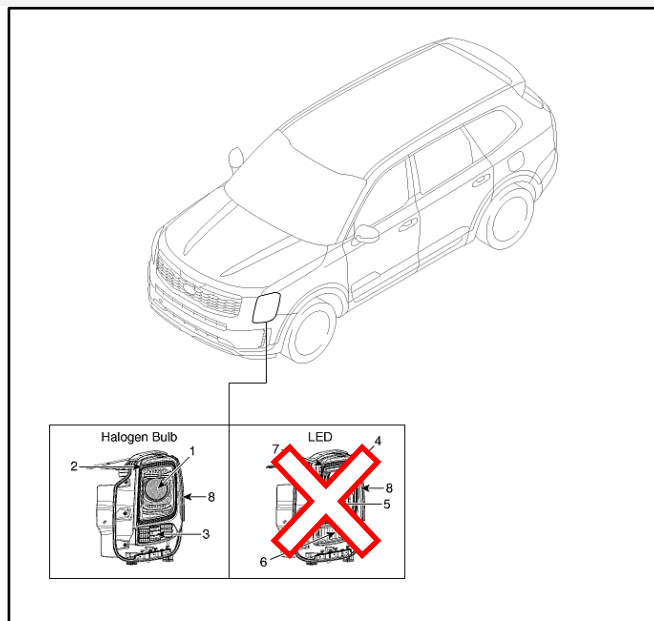
1. Low/High Beam
2. Daytime Running Light
3. Turn Signal Lamp
8. Side Marker

1. Replace the affected (left and/or right side) 'halogen' headlamp assembly by referring to "Body Electrical System → Lighting System → Headlamp → Repair procedures" in the applicable Shop Manual on KGIS.

Note: Install the halogen bulb on the replacement headlamp assembly prior to installing the new headlamp.
