Preliminary Information

PIP5853D TCCM Drivability DTCs and Possible Low Battery Charge Models

Brand:	Model:	Model Years:	VIN:		Engine:	Transmissions:
			from	to		
Chevrolet	Silverado 4500HD, 5500HD, 6500HD	2019 - 2023	All	All	All	All

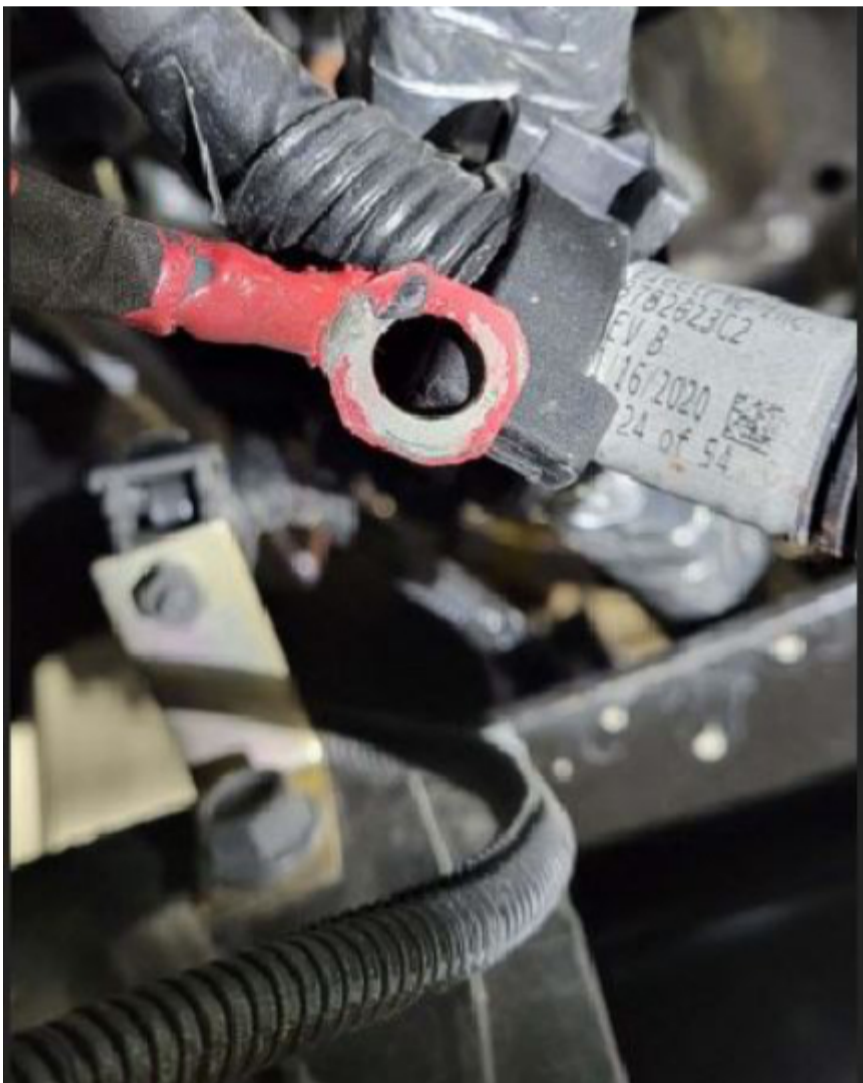
Also, there may be an issue at G110

This ground may be loose; however, it will feel tight due to the anti-corrosion paint that has been applied. This paint will not only make the ground feel tight but will also seep behind the ground and cause a poor connection

If no concern is seen with the ignition 1 voltage G110 should be removed and inspected for a poor connection, for the presence of anti-corrosion paint behind the eyelet, or for a too long bolt installed.
