# Spartan Fire, LLC

Campaign Service Bulletin  
CSB22-250-001A

**CONDITION:** Front Suspension could experience a loss of dampening due to lower shock eye position.

**CORRECTION:** Replace lower shock mount and bolt.

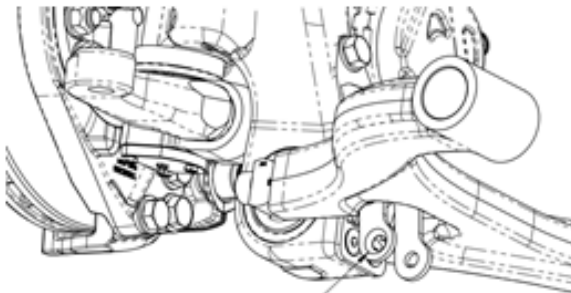
COUNTERSINK ORIENTED  
TO REAR OF UNIT

- Transfer shackles to the new lower shock bracket and tighten to specification with the shackles placed into the original orientation, including bolt direction.
- Install the new lower shock bracket (with shackles) with new hardware and blue Loctite 242 (or equivalent), torque to specification.

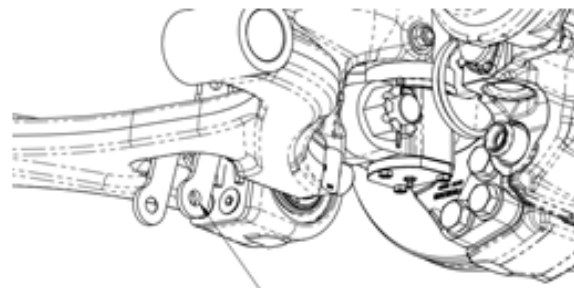
NON-COUNTERSINK ORIENTED  
TO FRONT OF UNIT

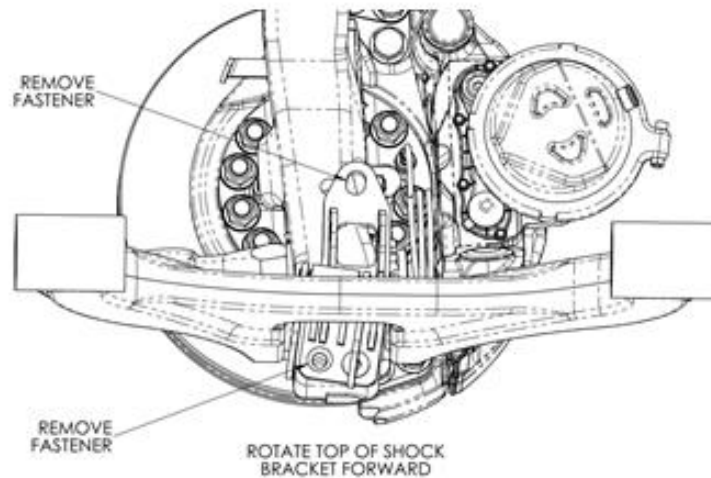
- **Lower Shock Bracket Removal**
- Lower shock bolt brackets can be difficult to remove and reinstall on trucks equipped with a 24k suspension. This is due to the fact that one of the lower flathead screws is directly behind the spring shackle links. To further compound the difficulty, the upper shackle bolt is covered up by the lower control arm and is inaccessible. The following tips will help make the job easier.

At full suspension droop, the lower shock bracket can be rotated about the one difficult to access bottom flathead screw if the other two fasteners are removed. This rotation often allows enough displacement of the bracket to allow access to the upper shackle bolt. Loosening the upper shackle bolt allows the shackle links to be swung out of the way and

full access to the lower flathead screw can be gained.

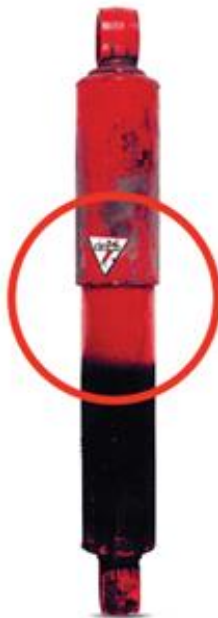
#### Shock is Misting

An even coating of oil is present on shock body.

**SHOCK IS OKAY**

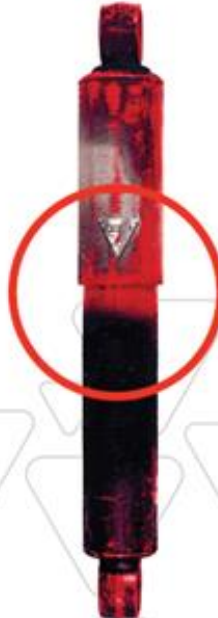
#### Road Grime

Mud mixed with oil caked on exterior of shock. Evidence of misting present.

**SHOCK IS OKAY**

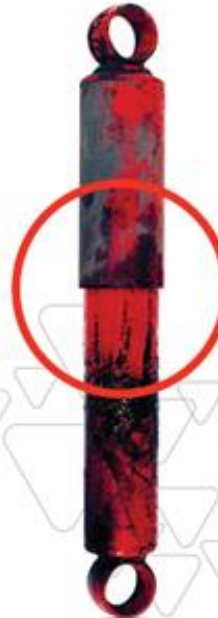
#### Shock is Leaking

Oil is leaking in streams above road grime area. Drops of oil present on shock.

**REPLACE**
