June 9, 2023

Moisture in the Headlights

AFFECTED VEHICLES

| Year | Model | Trim | VIN Range |
|---|---|---|---|
| 2019–22 | ILX | ALL | ALL |

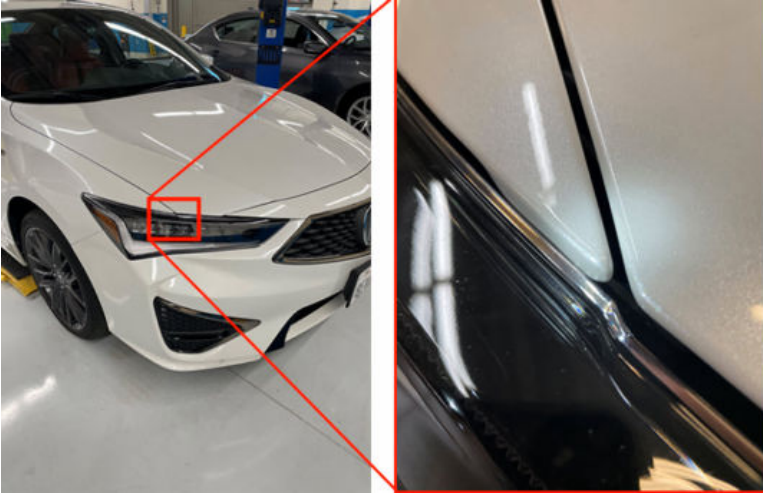
1. Visually inspect the vehicle for any areas of potential body interference. Body stresses may include the area where the fender, hood, and headlight meet.
2. Inspect to see if the tip of the fender is touching the headlight as shown below.

4. If the headlight is contacting the fender, refer to the REPAIR PROCEDURE.

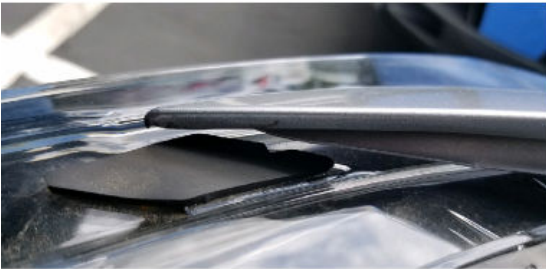
OK

3. There should be clearance between the headlight and the fender as shown below.

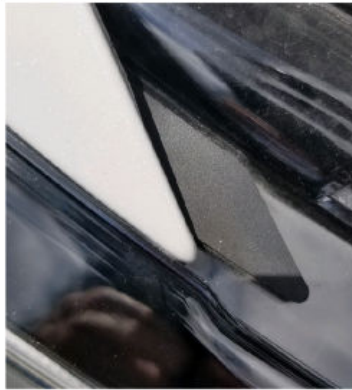
NO GOOD

The headlight making contact with a body panel can create a separation in the adhesive between the headlight lens and the housing, allowing moisture to enter the headlight.

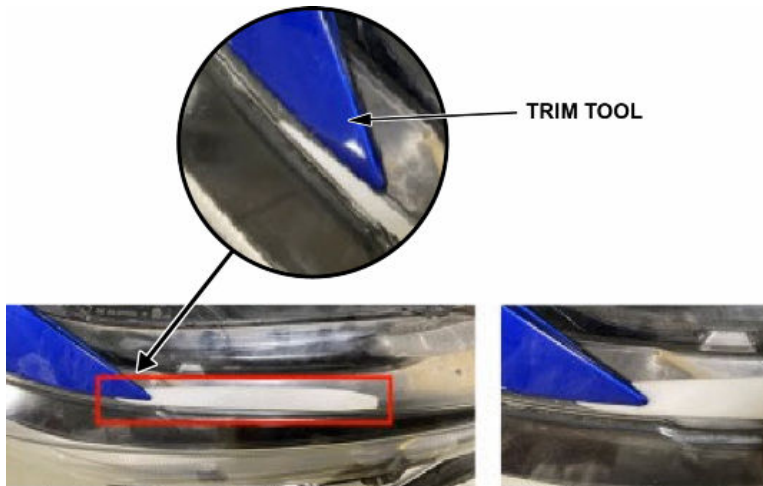
12. If the headlight is still making contact with the fender, use the tapered end of a plastic white trim stick between the headlight and the fender to maintain clearance while tightening the top two headlight mounting bolts.

NOTE: Be careful not to apply too much force as this could bend the fender or damage the headlight.

13. Remove the white stick and confirm there is no longer contact between the two surfaces.
14. If contact is still occurring, loosen the top two headlight bolts and slide two white sticks in the same location, then tighten the top two bolts.
15. Remove the white sticks and confirm there is no longer contact between the two surfaces.
16. Close hood and evaluate hood-to-fender fit and finish. Readjust as needed.
17. Do the headlight adjustment - refer to Service Information.
