TECHNICAL SERVICE BULLETIN

| Classification: EC19-004B | Reference: NTB19-036B | Date: June 13, 2023 |

MIL ON WITH DTC P26DE STORED IN THE ECM

APPLIED VEHICLES: 2017-2020 GT-R (R35)

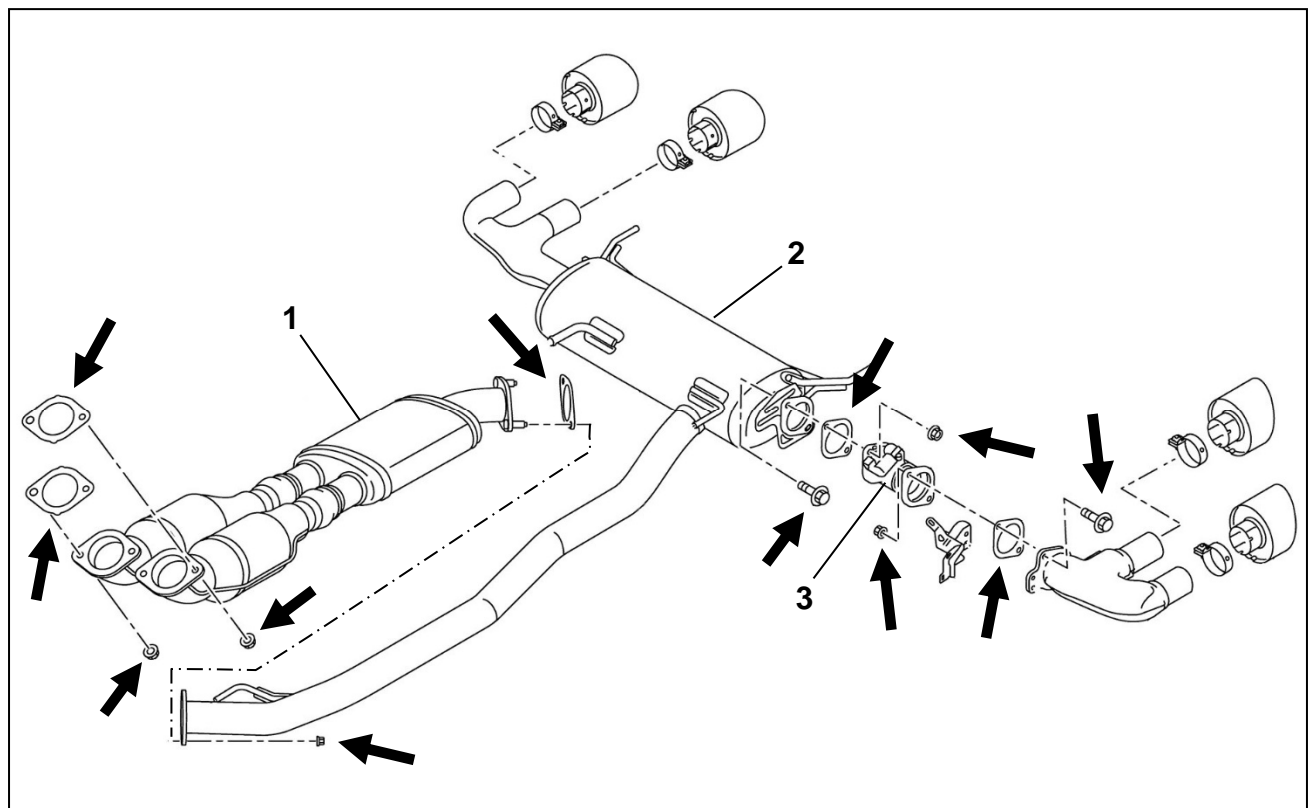
Figure 4

1. Sub muffler 2. Main muffler assembly 3. Electric control muffler
