INFINITI®

CAMPAIGN BULLETIN Fan Coupling Nut Torque Inspection

Reference: P3A06

P3A06 – 2023 QX80 COOLING FAN COUPLING NUTS

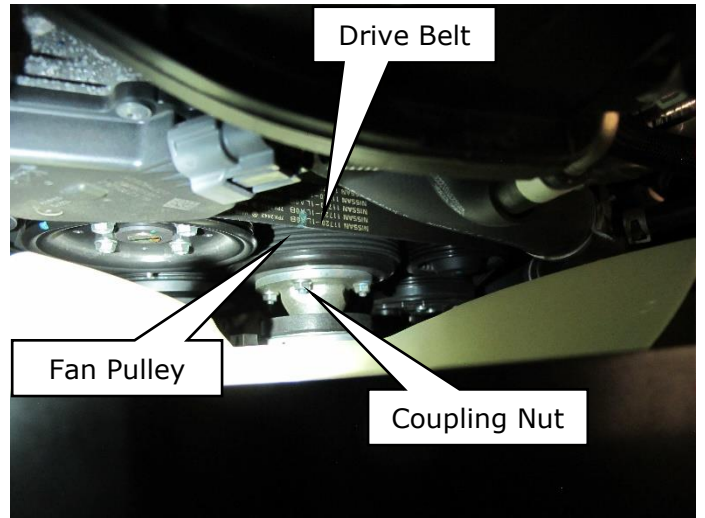
Figure 7

- a. Drive belt and fan pulley (Figure 7): **Must not have any damage.**
- b. Missing fan coupling nuts (Figure 7): **Must have (4) present.**
- c. Cooling fan and shroud (Figure 8): **Must not have any damage.**
- d. Radiator hoses in area of cooling fan (Figure 8): **Must not have any leaks.**
- e. Transmission fluid warmer pipes in area of cooling fan (Figure 8): **Must not have any leaks.**

- **YES =>** Provide clear photos of the damaged components found in Step to FQA using the information below. **HOLD** the vehicle until further notice.
 - a. Take clear pictures of the VIN certification label and all the damaged components found in the engine fan coupling area.
 - b. Photo file type must be JPEG, PNG, or PDF.
 - c. Email photos to fqa_inspection_support@nissan-usa.com
 - d. Provide a brief explanation of extent of damage and parts involved.
 - e. **The E-Mailed file size cannot exceed 10 MB.**
 - f. Make sure to include the below information:
 - E-Mail Subject Line: P3A06 QX80 Fan Coupling
 - Dealer Name:
 - Dealer Code:
 - Dealer Address:
 - VIN:
 - Contact Person Name:
 - Contact Person E-mail Address:
 - Contact Person Phone Number:
- **NO =>** Proceed to Step 7 to torque the engine fan coupling nuts.
