Service Bulletin

Bulletin No.: 23-NA-062

Subject: Rear View Camera Issues – DTCs B395A, B395B, B395C, B101E, B101D

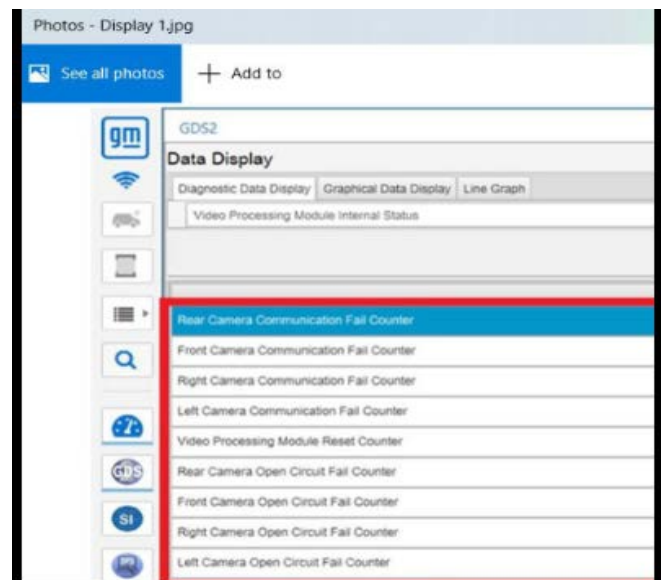
6083540

The VPM counters are listed in priority order from most usefulness to least. The ones outlined in red are considered the most critical and usually most helpful in root causing surround viewing issues.

3. The three most critical parameters to look at are:
 - 3.A. Camera Communication Fail Counter
 - 3.B. Video Processing Module Reset Counter
 - 3.C. Camera Open Circuit Counter

4. Write down the counters found in the VPM using the scan tool.
5. Cross-reference the DTCs and counters with the troubleshooting table below to determine most probable cause.

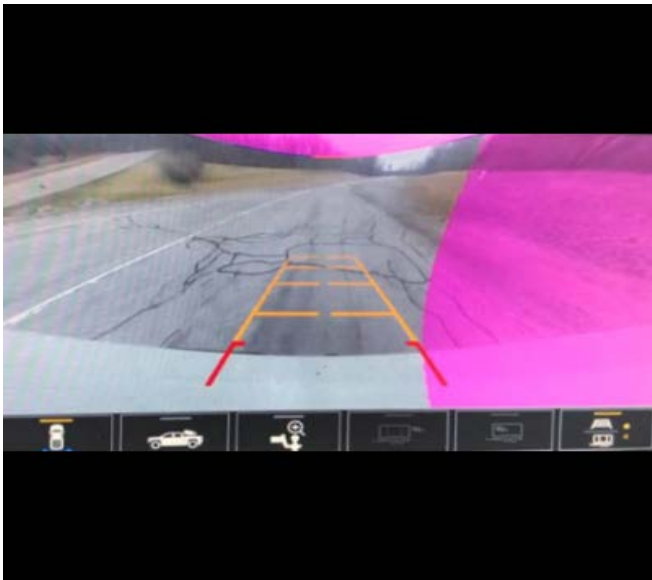
6083542

Pink on the screen will be most likely an intermittent Coax issues caused by damaged or frayed coax cables.

Some intermittent conditions can be caused by wire terminal fretting corrosion, which is a build-up of insulating, oxidized wear debris that can form when there is a small motion between electrical terminals.

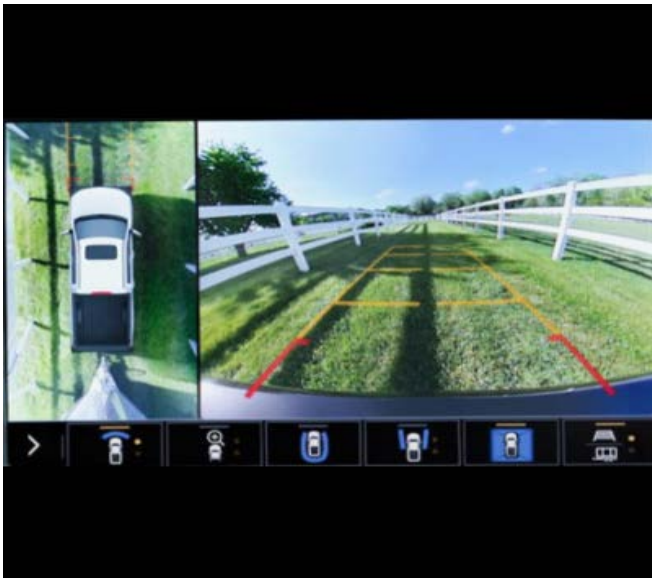
6083543

Verify P17 Info Display Module displays infotainment system information properly. The Video Processing module controls the buttons on the touch screen. Confirm the buttons on the touchscreen are functioning properly.

- If the “Cameras” Icon is greyed out and not working. The connection issue may be between the VPM and Radio.
- If the touch buttons are working properly, it could be an issue with the coax cable connection from the VPM to the Rear Vision Camera.

Note: Before testing the coax cable, check the cable's exterior for being pinched, cut, damaged, or having loose connections at the components, all of which can cause reception issues.

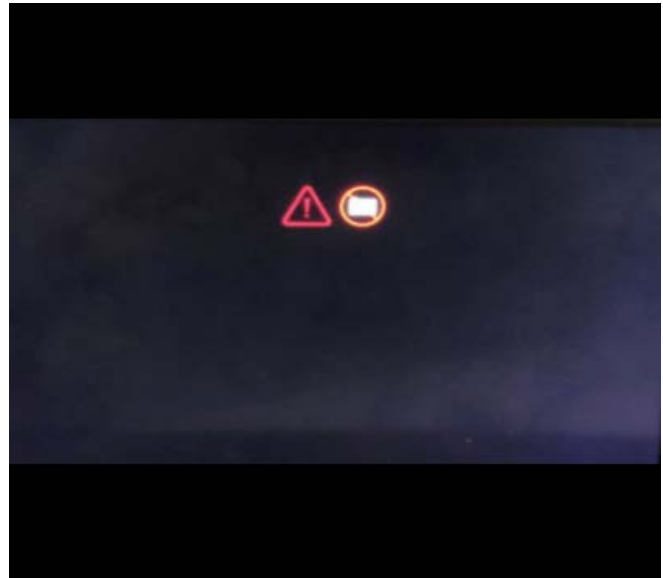
6083546

If the rear camera or the VPM do not provide the rolling counter, you will see the following black screen with an icon:

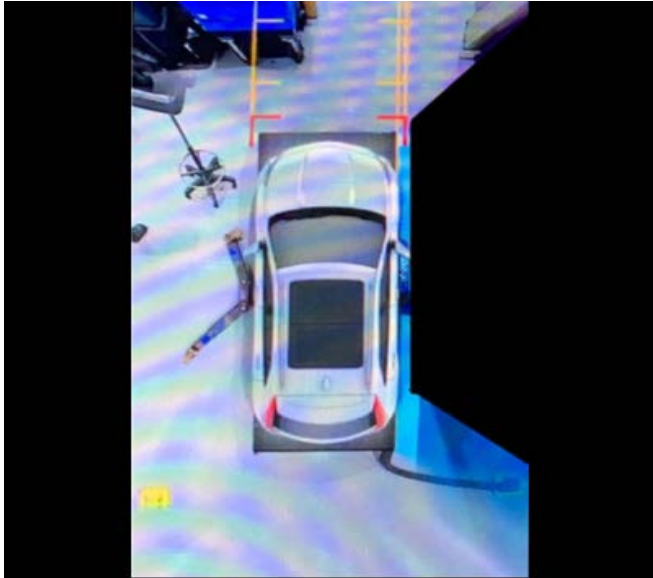
6083547

The VPM does not monitor the left, right or front cameras with a rolling counter. These camera's will display in black on their perspective side if there is an issue.

Figure below is of a right camera issue:
