GLOBAL SAFETY FIELD INVESTIGATIONS  
DCS6606  
URGENT - DISTRIBUTE IMMEDIATELY

Subject: N222375791-05 - Customer Satisfaction Program  
Park Assist Retrofit  
Population Update

# Customer Satisfaction Program

## N222375791 Park Assist Retrofit

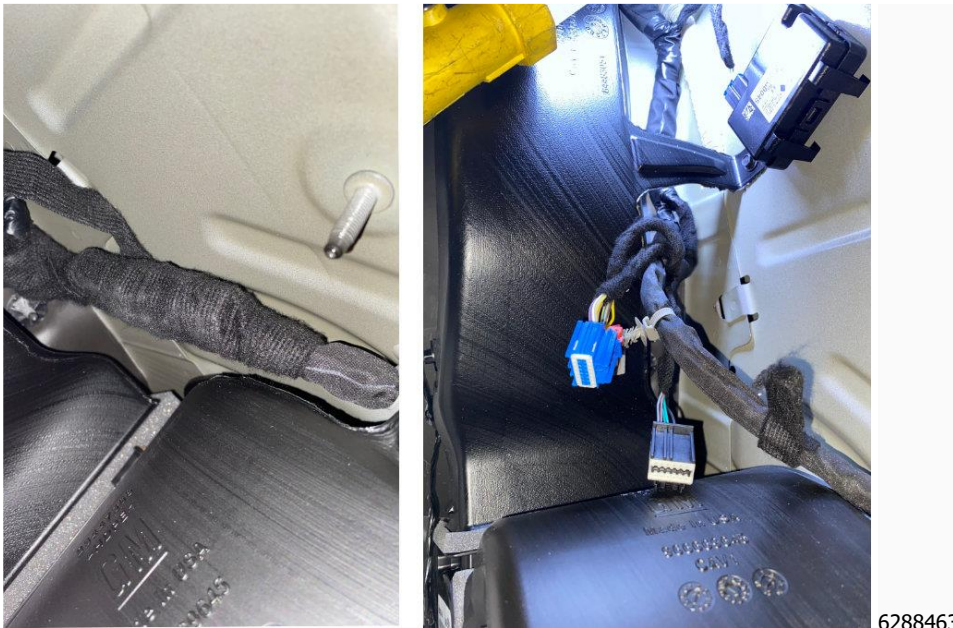
6288463

**Note:** The wiring harness for the Parking Assist Control Module may be wrapped around an adjacent wiring harness as shown above. Remove the attaching tape by unwrapping. Do **NOT** cut the tape as it could damage the wiring harness.

1. Install the new Parking Assist Control Module. Refer to *Parking Assist Control Module Replacement* in SI.

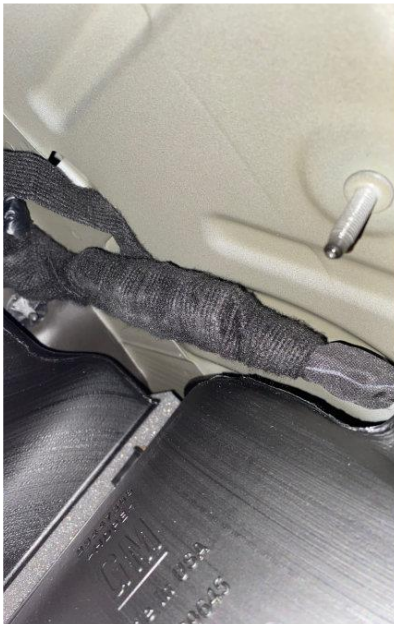
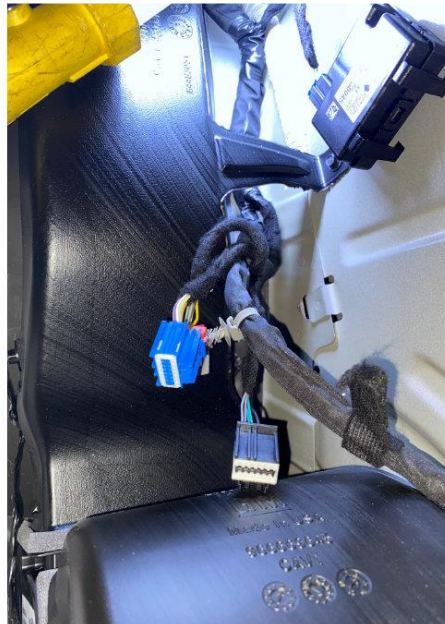
6288463

**Note:** The wiring harness for the Parking Assist Control Module may be wrapped around an adjacent wiring harness as shown above. Remove the attaching tape by unwrapping. Do NOT cut the tape as it could damage the wiring harness.

1. Install the new Parking Assist Control Module. Refer to *Parking Assist Control Module Replacement* in SI.

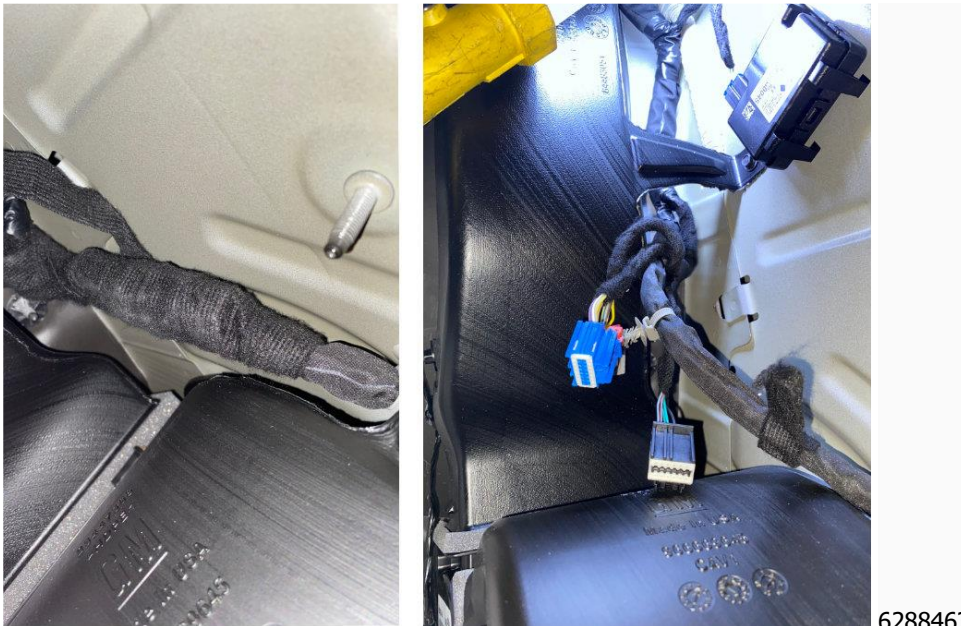
6288463

**Note:** The wiring harness for the Parking Assist Control Module may be wrapped around an adjacent wiring harness as shown above. Remove the attaching tape by unwrapping. Do NOT cut the tape as it could damage the wiring harness.

1. Install the new Parking Assist Control Module. Refer to *Parking Assist Control Module Replacement* in SI.

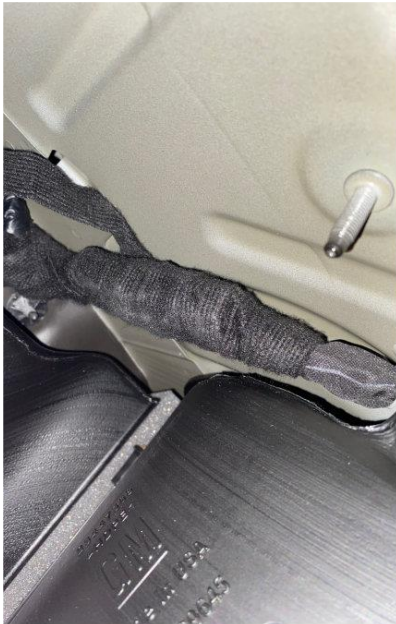
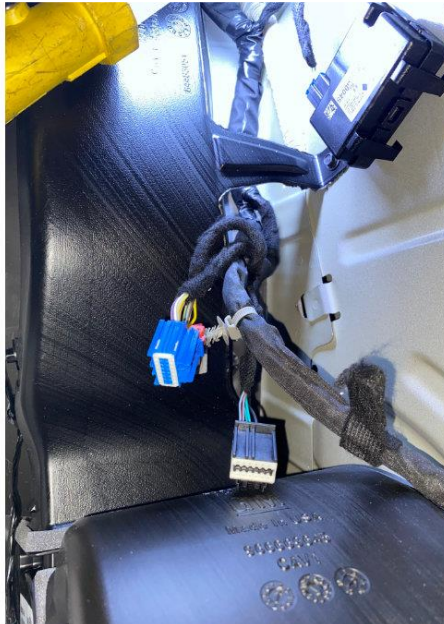
6288463

**Note:** The wiring harness for the Parking Assist Control Module may be wrapped around an adjacent wiring harness as shown above. Remove the attaching tape by unwrapping. Do NOT cut the tape as it could damage the wiring harness.

1. Install the new Parking Assist Control Module. Refer to *Parking Assist Control Module Replacement* in SI.

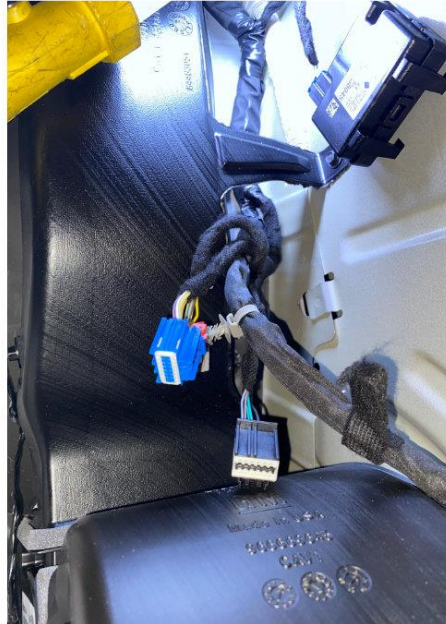
6288463

**Note:** The wiring harness for the Parking Assist Control Module may be wrapped around an adjacent wiring harness as shown above. Remove the attaching tape by unwrapping. Do NOT cut the tape as it could damage the wiring harness.

1. Install the new Parking Assist Control Module. Refer to *Parking Assist Control Module Replacement* in SI.

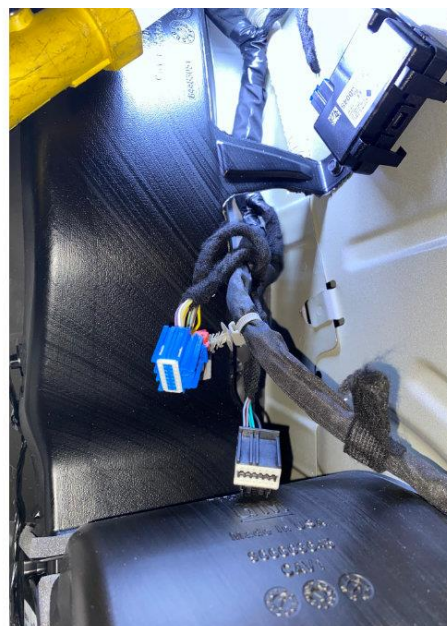
6288463

**Note:** The wiring harness for the Parking Assist Control Module may be wrapped around an adjacent wiring harness as shown above. Remove the attaching tape by unwrapping. Do NOT cut the tape as it could damage the wiring harness.

1. Install the new Parking Assist Control Module. Refer to *Parking Assist Control Module Replacement* in SI.

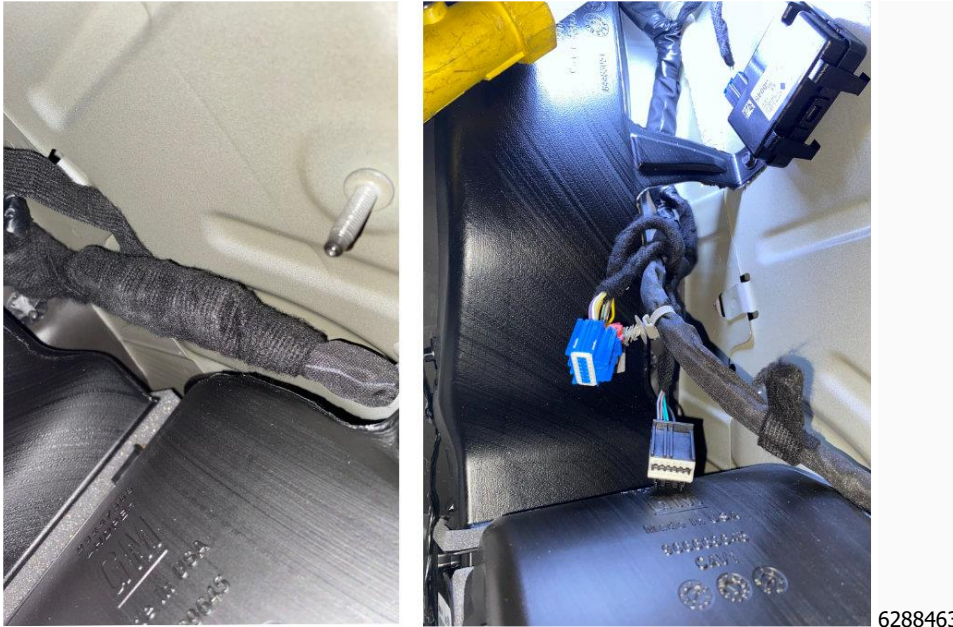
**Note:** The wiring harness for the Parking Assist Control Module may be wrapped around an adjacent wiring harness as shown above. Remove the attaching tape by unwrapping. Do NOT cut the tape as it could damage the wiring harness.

1. Install the new Parking Assist Control Module. Refer to *Parking Assist Control Module Replacement* in SI.
