# Service Bulletin

Bulletin No.: 22-NA-173

**Subject:** Information on Transmission Fluid Leak

Brand:	Model:	Model Year:		VIN:		Engine:	Transmission:
		from	to	from	to		
Chevrolet	Corvette	2020	2023	—	—	All	All

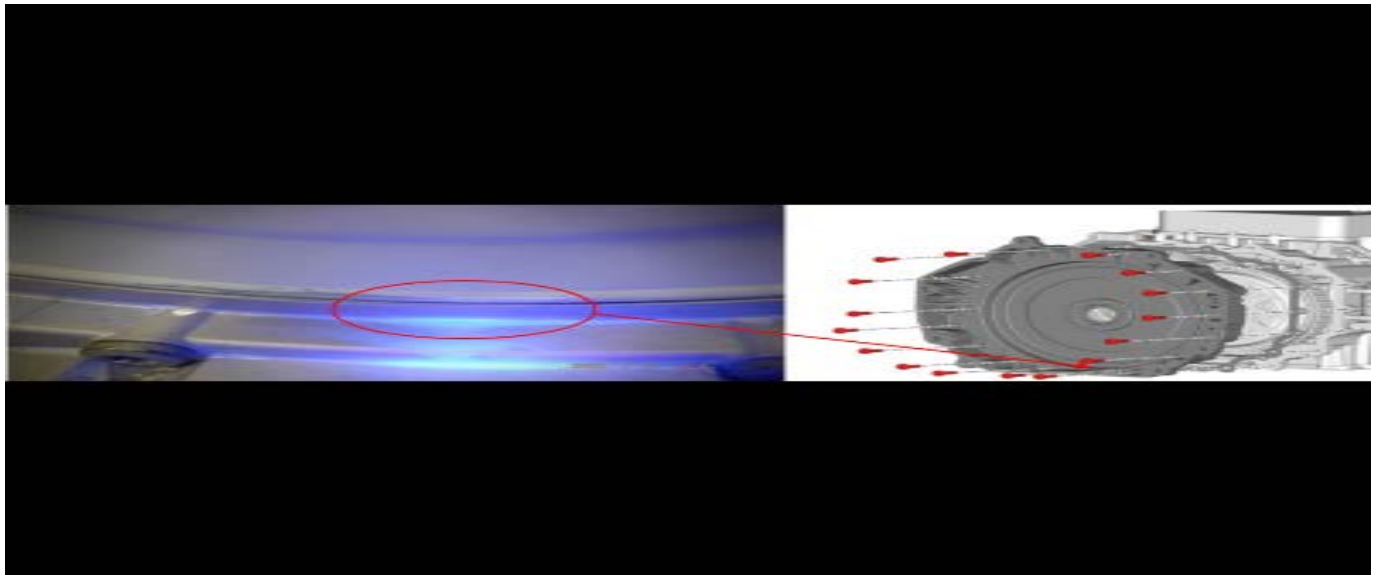
6142752

A leak between sealing plate and Bell Housing.

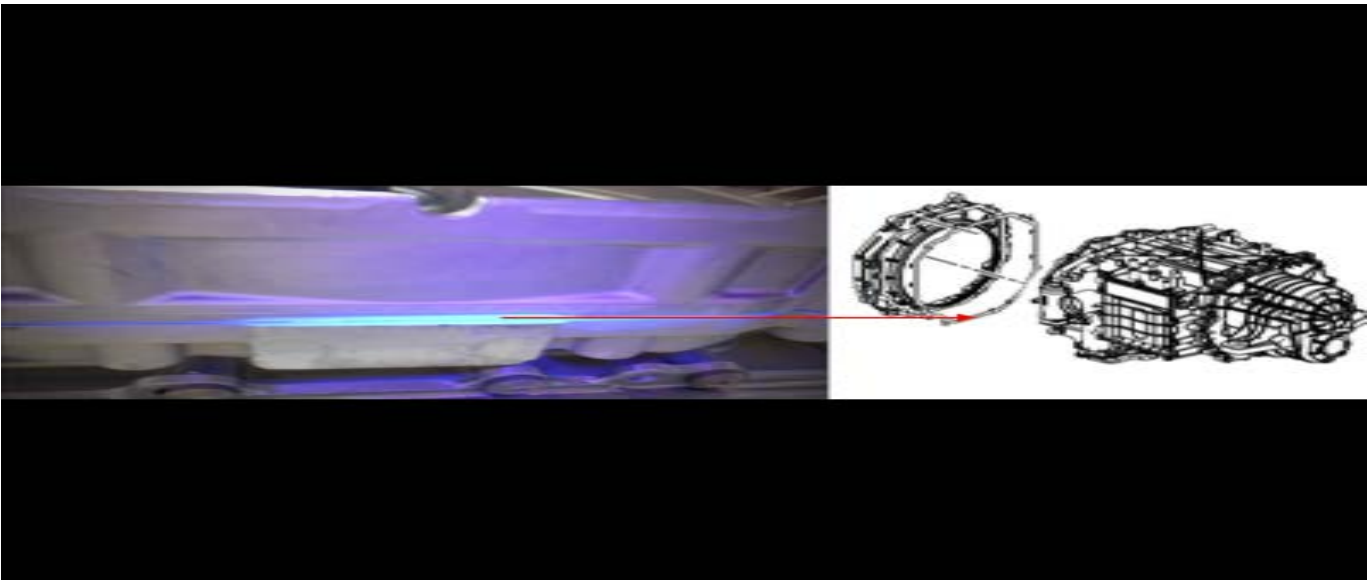
6142966

Leaks at the gasket area between the clutch and differential cover and the main case. There is a gasket in this area.

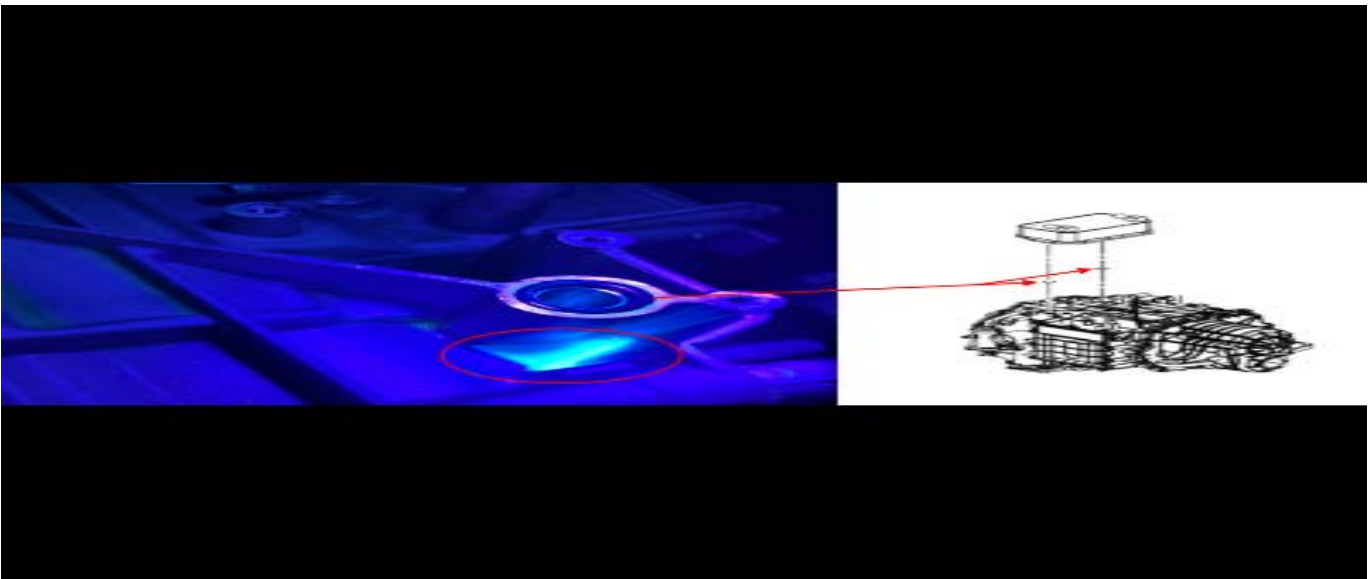
6142841

This is an area that is often mis-diagnosed as a transmission cooler issue. It was found that in most cases, leaks in this area are caused by transmission case porosity under the transmission cooler. Proper diagnosis in this area would be to inspect the cooler for any signs of physical damage. If no damage is found, carefully remove the cooler and inspect the two (14) O-rings for damage and proper sealing. The dye photo shows a puddle of oil just under the cooler sealing area in the pocket, the fluid is being pushed through the case due to material porosity. This concern will require transmission assembly replacement.

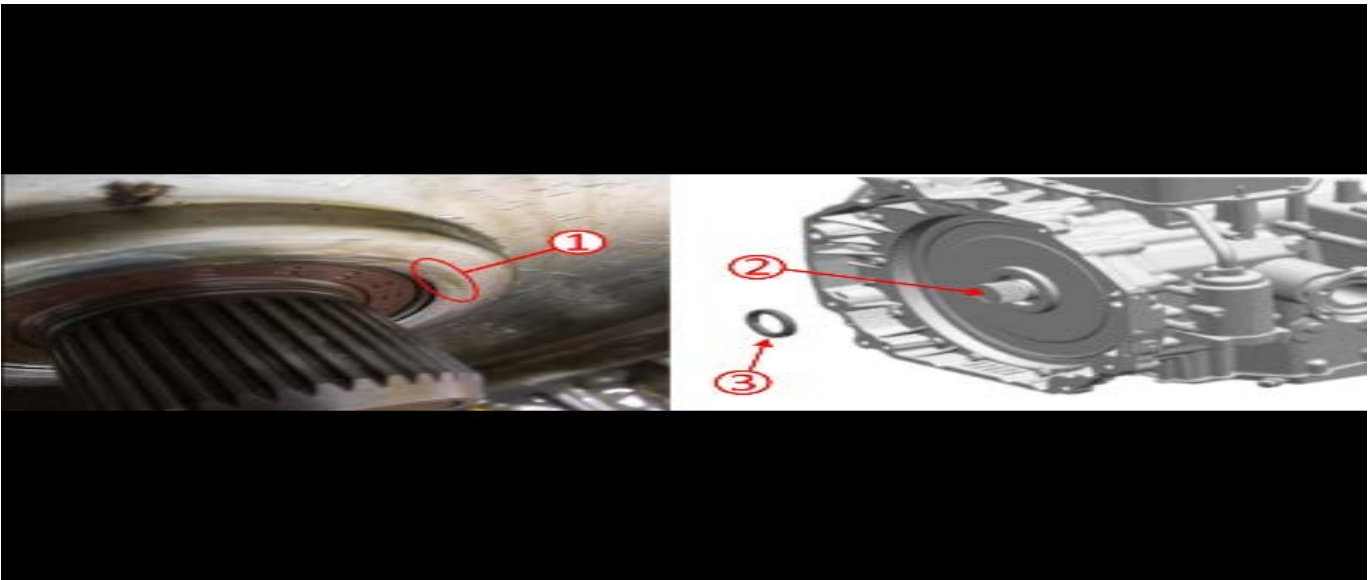
6142814

A small crack in the clutch cover area (1) of the input shaft seal can be mis-diagnosed as an input shaft seal leak (3). Additional cases have been verified at the input shaft end plug/seal (2), was damaged during transmission to engine mating.

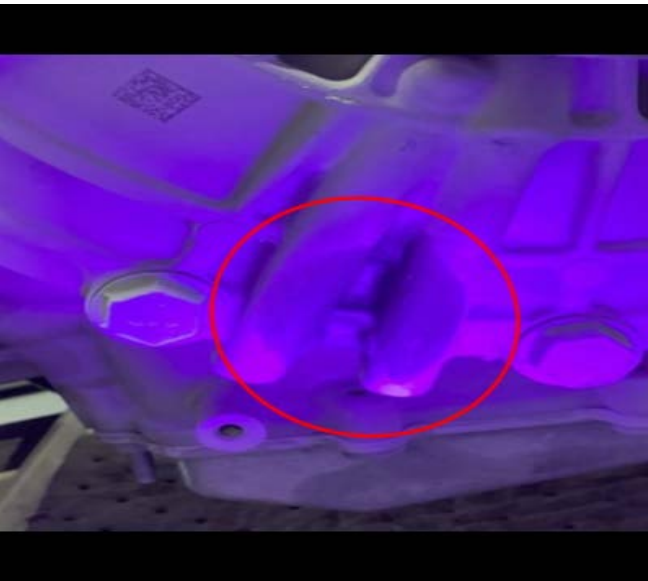
6142818

Porosity concerns with the differential cover. This area needs to be carefully powder tested to verify the leak is not associated with the cover seal (16) or the dog-bones and seals. Technicians have stated that they have found the cover double-gasketed when they confused the metal differential shims with what they thought were gaskets. All shims need to be re-installed to retain proper bearing load on differential. If porosity is found in the cover, the transmission will require replacement.

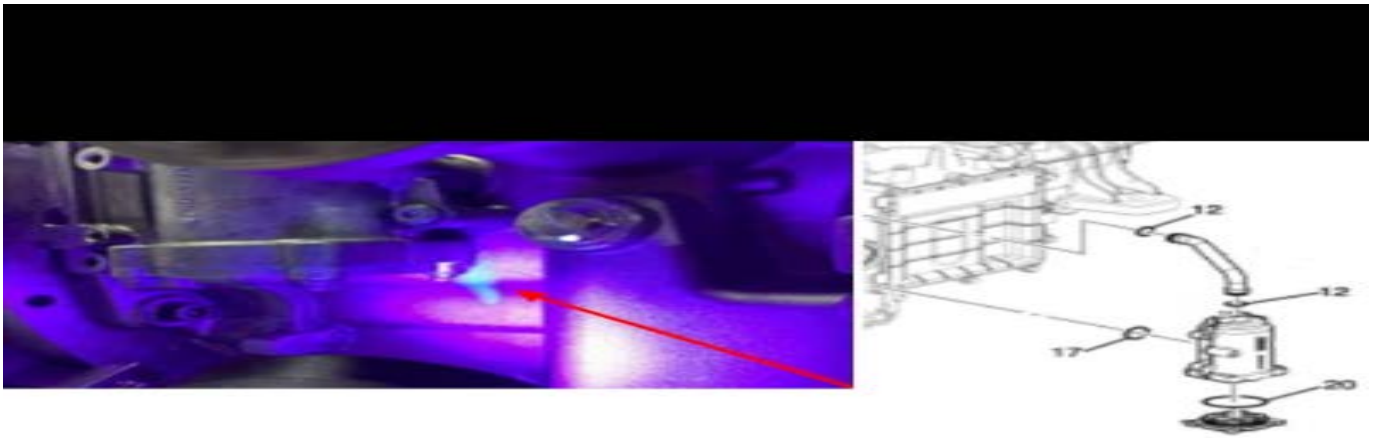
6142744

The auxiliary canister filter can create leaks in several areas. The most common area is cover seal (20), O-ring installation issues after filter replacement. Other areas of concern can be found at the are O-rings (12) and (17).

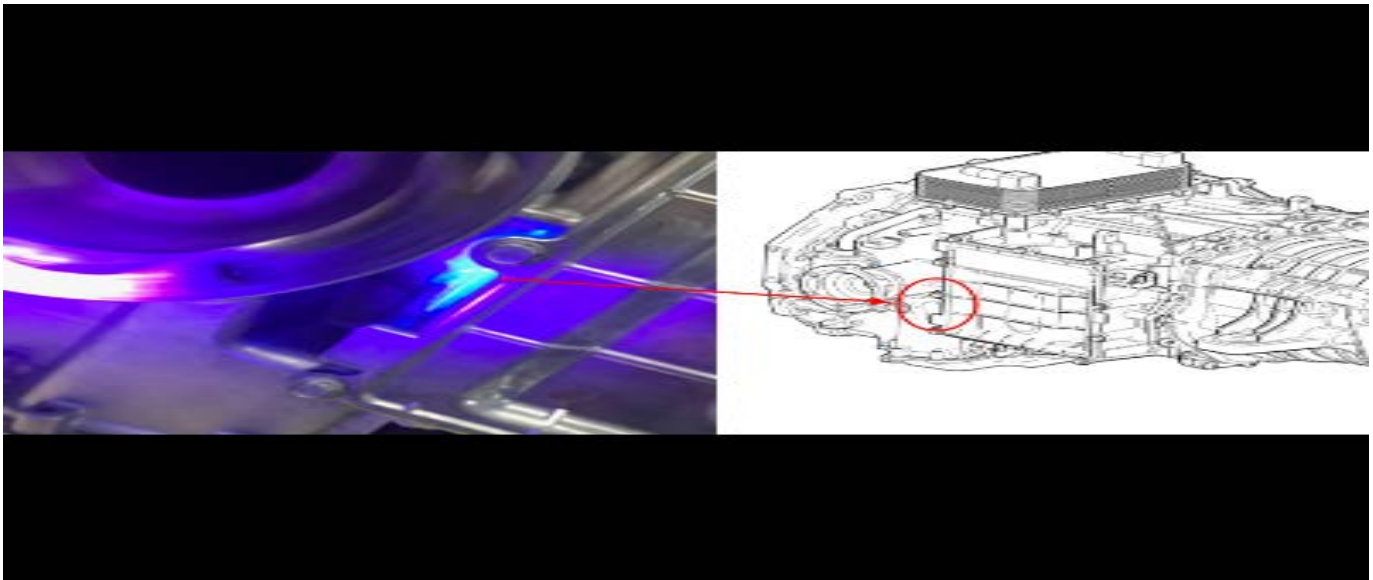
6142979

Transmission case porosity concerns have been found in the SAV cover area of the transmission. This is often the most misdiagnosed leak on this transmission. The fluid seeps through the case and runs down between the SAV cover and case to the pan rail, and often the transmission pan and gasket get replaced, then the SAV cover, and finally the transmission. Often these

leaks will not develop by just allowing the engine to run. Usually, the vehicle will need to be lifted safely on a hoist with the wheels raised to allow the vehicle to run in gear. This action applies to most porosity leaks.
