**RAPID UPDATE**

# Rapid Update 623 Grecale – ITM Software Update

DATE: MAY 4 2023

Certain Maserati Grecale (M182) MY23 listed in MODISCS+ are involved in a Rapid Update to perform a software update to the Intrusion Transceiver Module (ITM).

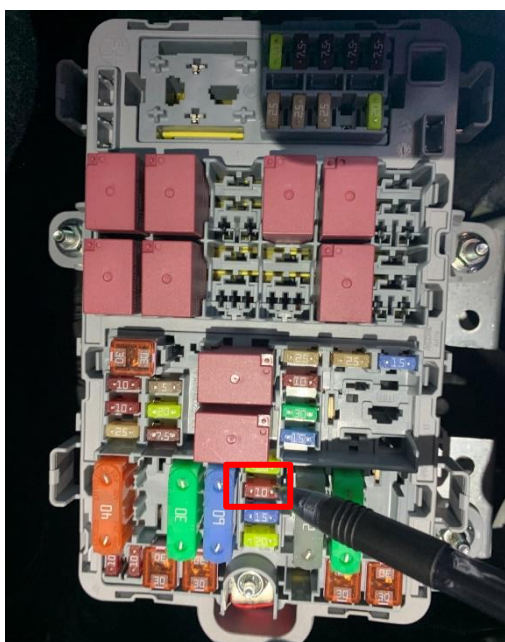
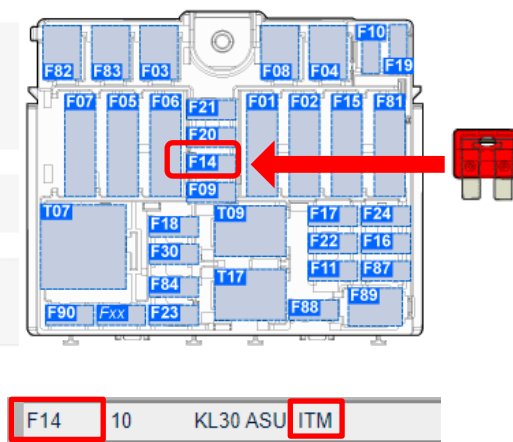
For all the vehicles already involved with **Rapid Update #599**, for which the action has already been performed, the Premium Alarm System (LSA) must be reactivated **before** proceeding with the SW update.

1. Access the Rear Distribution Unit (RDU) and re-install the **F14 10A** fuse that was removed previously per Rapid Update 599, indicated in the pictures below:

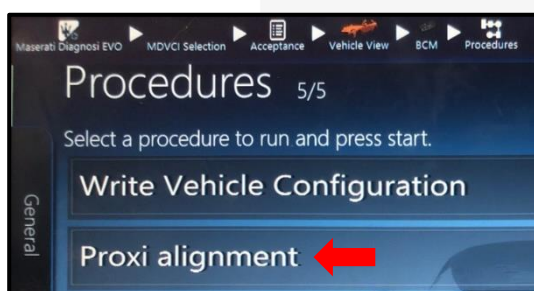
This new software release fixes a potential spontaneous activation of the Volumetric Alarm and an abnormal power absorption that could potentially drain the 12V battery.

5. Perform the **BCM – Procedures - PROXI Alignment**.
