SIB 34 02 23

2023-05-03

BRAKE SQUEAK OCCURS WITH COLD BRAKES AND DRIVING SLOWLY

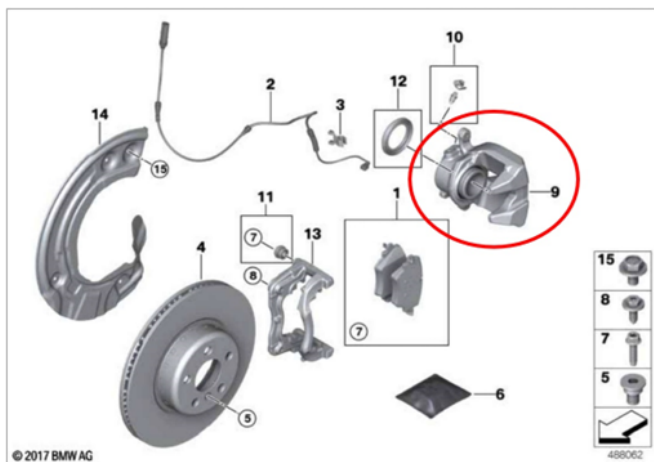
The information of the Service Bulletin only applies to front axle brake disc size of 330 x 24 (4) and calipers with "floating design" (9) as shown.

04 Brake disc, lightweight, ventilated (330X24)	2	2
The following additional parts are also essential: - brake pads - brake pad sensor - brake pad paste refer to Repair Manual!

Unfavorable tolerances of the front axle brake discs.

Replace the front axle brake discs.

Replace the front axle brake discs with pads as per REP34 11 220 "Removing and installing/replacing both front brake discs".
