SIB 41 02 23

2023-05-09

SERVICE ACTION: RIGHT REAR WHEELWELL HUMP

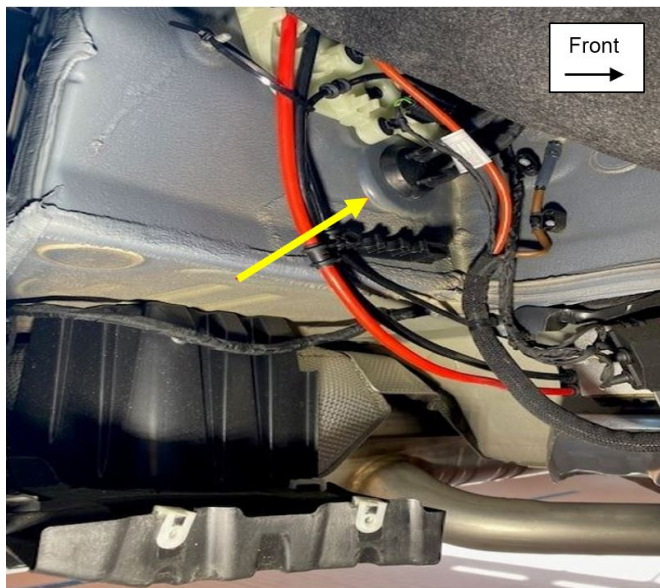
Due to prolonged, normal body flex acting on the vehicle during its service life, a small indentation and/or a crack can form in the body sheetmetal in the right rear wheelwell (aka wheel house). Potential water ingress and a risk of corrosion is possible.

2. Inspect the circular pressed hump on right rear wheelwell for any cracks and/or indentations (arrow in photo).

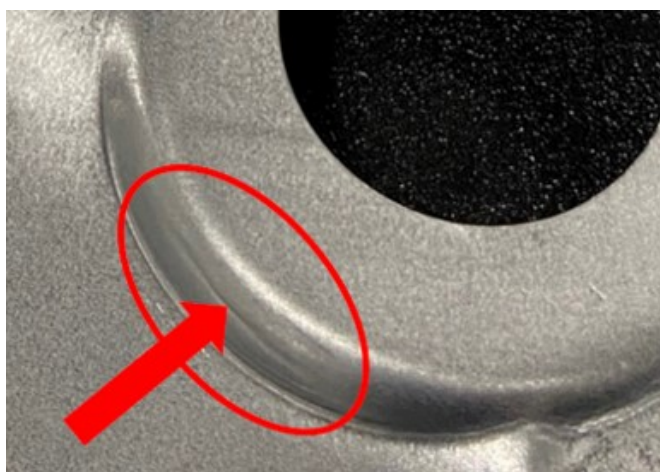
Note: This photo indicates a hump that requires rework (no good). Continue to Step 3.
