SIB 51 10 23

CRACKING SOUND IN RIGHT REAR SAFETY BELT FEED TRIM PANEL

E-Series	Model Description
I20	iX Sports Activity Vehicle

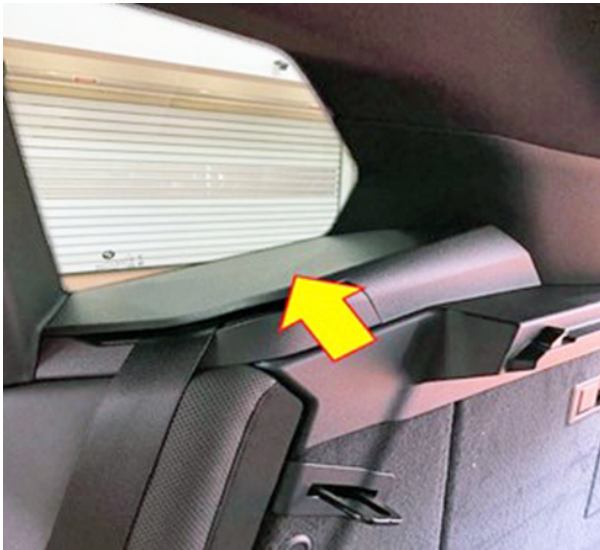
While driving on smooth roads, a cracking sound can be heard from the rear safety belt feed trim panel. This sound will ONLY occur on the right-side panel.

Excessive play in the alignment holes of the panel.

Apply adhesive tape to the sides of the alignment holes on the panel.

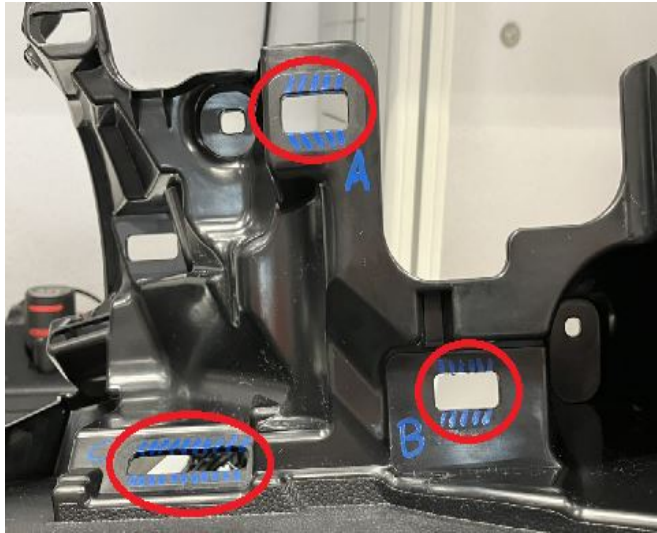
Note: The blue stripes indicate where the adhesive tape should be applied on the panel.

2. Apply adhesive tape to the sides of the alignment holes on the panel.
