SIB 52 06 23

2023-05-03

DELIVERY STOP: FRONT REAR SEAT CROSSMEMBER

E-Series	Model Description	Production Date
G06	X6 Sports Activity Coupe	March 1, 2023 – March 7, 2023

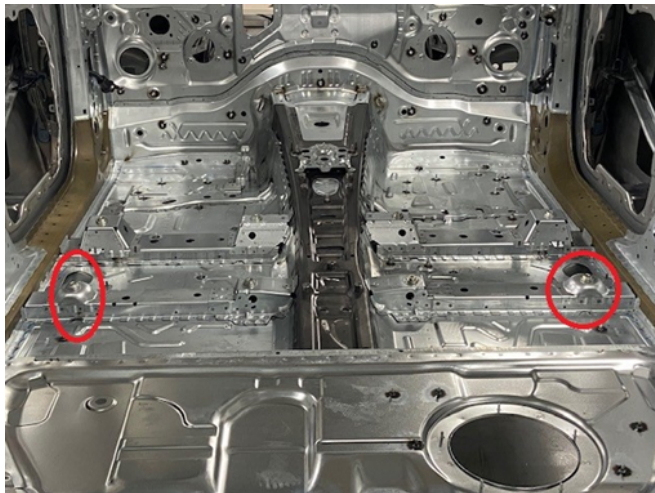
It was discovered that an indentation or crack on the driver and/or passenger seat crossmember rear outer dome (circled; viewed looking frontwards) can form.

Note: The rear inner dome on both the driver and passenger seat crossmembers are not affected.

A metal stamping error during production, on a small amount of the affected vehicles.

Inspect the driver's seat left rear (L/R) mounting dome as well as the front passenger's seat right rear (R/R) mounting dome for evidence of a metal crack or indentation as shown in the photos.

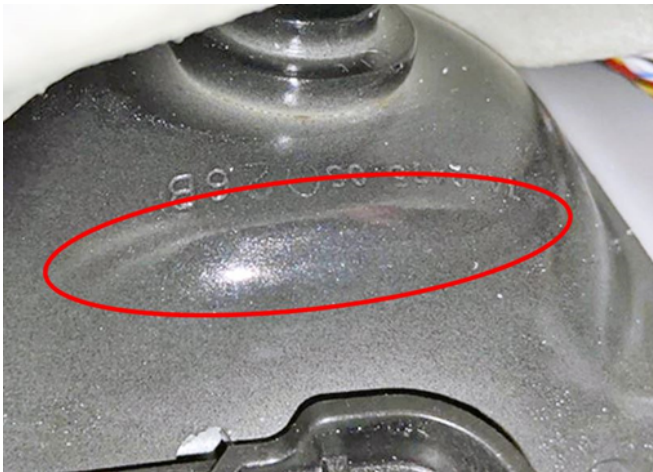
Not OK: Indent.

Go to Step 2.

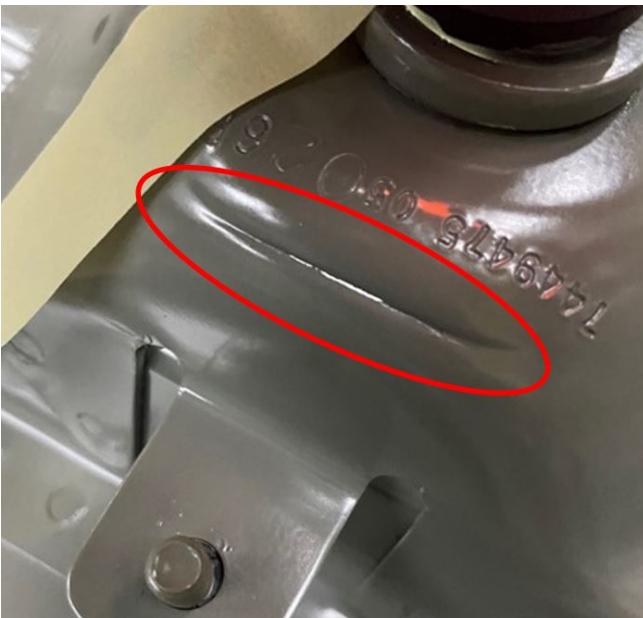
Not OK: Cracked/torn

Go to Step 2.

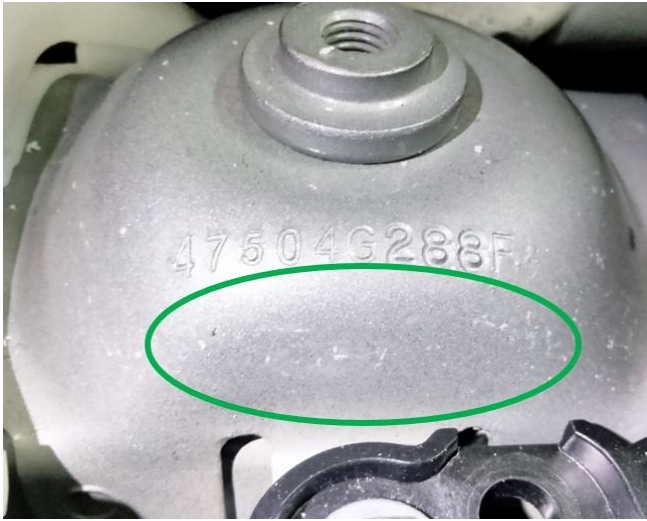
A “good” dome does not show any indications of an indent, nor of a crack/tear.

If both rear outer domes resemble this photo, go to Step 9.
