SIB 63 06 23

2023-05-16

SERVICE ACTION: HEADLAMP (HL) GAP

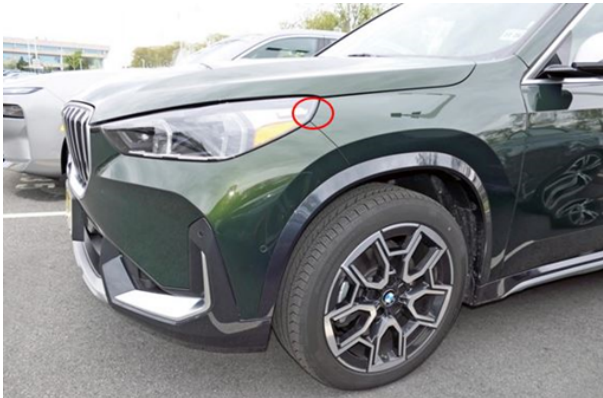
Contact between the headlamp housing and the front fender can occur, causing paint abrasion.

**Note: This can occur on either one or both sides of the vehicle.**

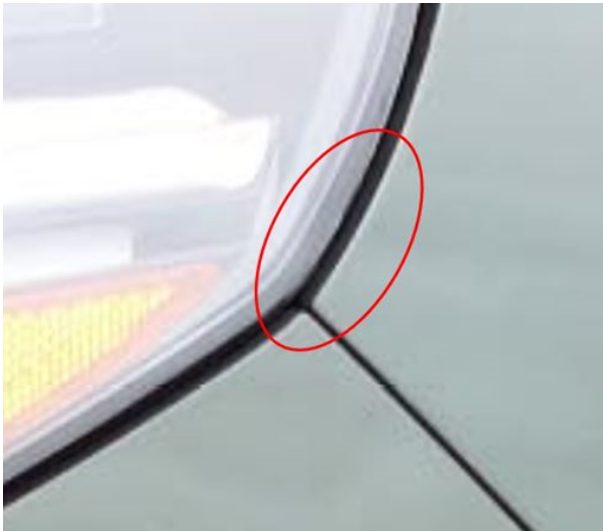
Close-up of general affected area; driver's side shown.

During vehicle assembly, the headlamp(s) may have not been correctly installed.

Inspect both headlamps (HL) for sufficient gap between the housing and fender. Rework if necessary.
