**SIB 84 03 23**

**SERVICE ACTION: PROGRAMMING CONTROL UNITS AND PROVIDING DIGITAL KEY CARD**This Service Information Bulletin (Revision 1) replaces SI B84 03 23 **dated May 2023**.**What's New** (Specific text highlighted):

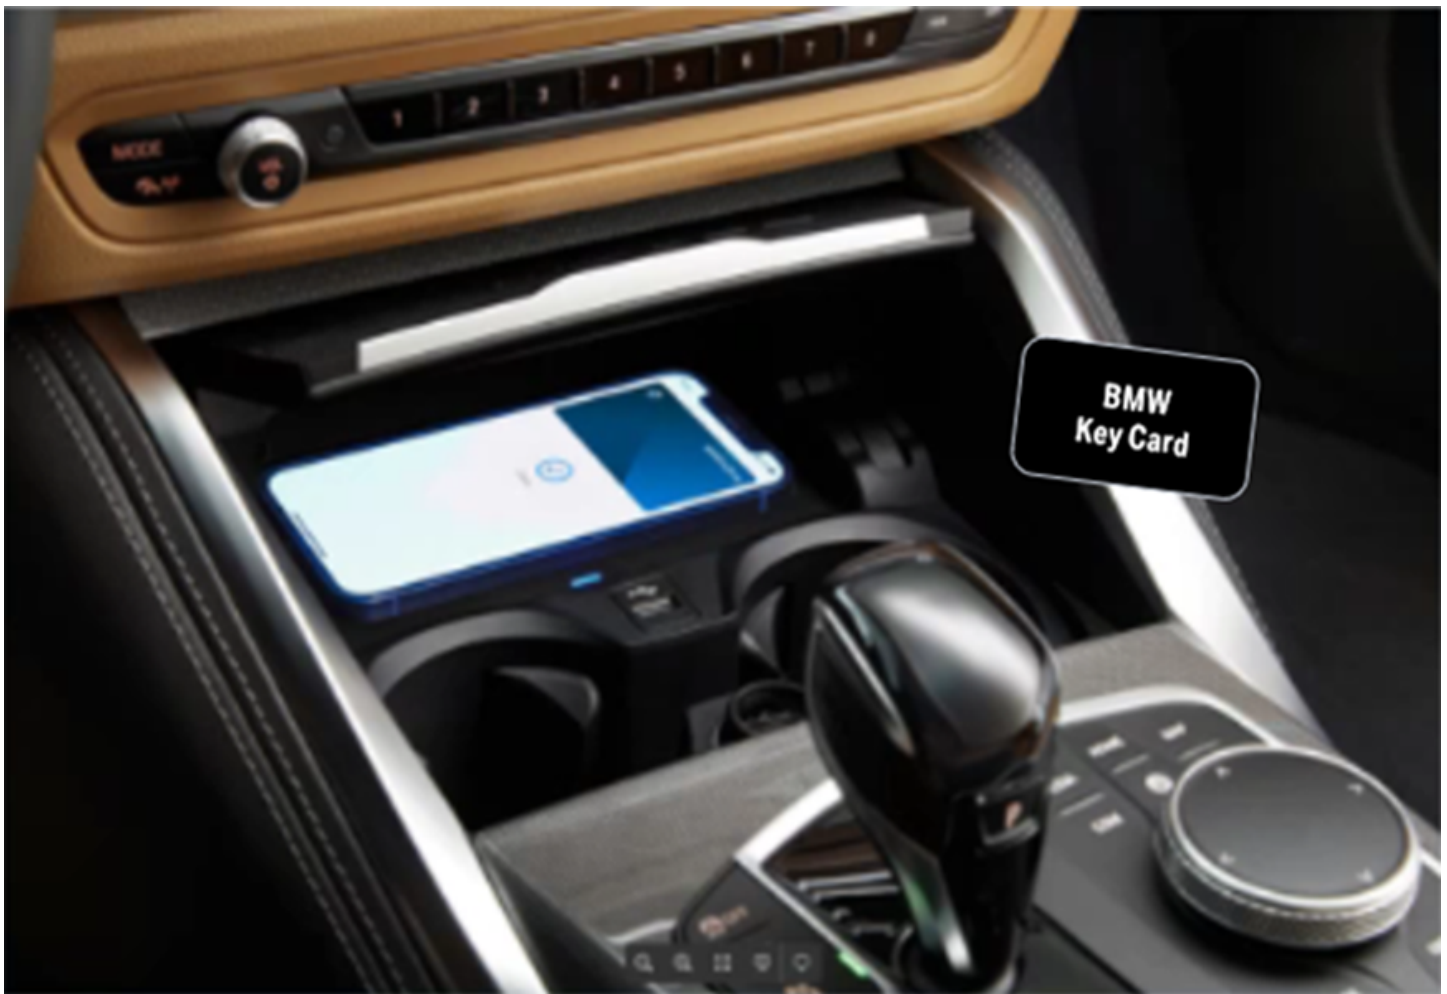
Unfavorable software causes the vehicle to not detect when the digital key (mobile phone/BMW Key Card) is removed from the wireless charging station (WCA). It is still possible to operate the window regulators, sunroof and convertible top for a certain period of time until the vehicle is locked, despite the digital key being removed from the WCA.

Example below: Wireless Charging Tray with either the BMW Key Card or a telephone with the Digital Key activated.

Order a replacement Digital Key Card for the vehicle and program the complete vehicle with ISTA 4.41.1x (release date of May 2, 2023).
