TECHNICAL INSTRUCTIONS
FOR
CUSTOMER SUPPORT PROGRAM 22TE09
HV FLOOR UNDER WIRE HARNESS AND REAR TRACTION MOTOR CABLE
CORROSION
CERTAIN 2020 –2022 MODEL YEAR HIGHLANDER HYBRID AWD

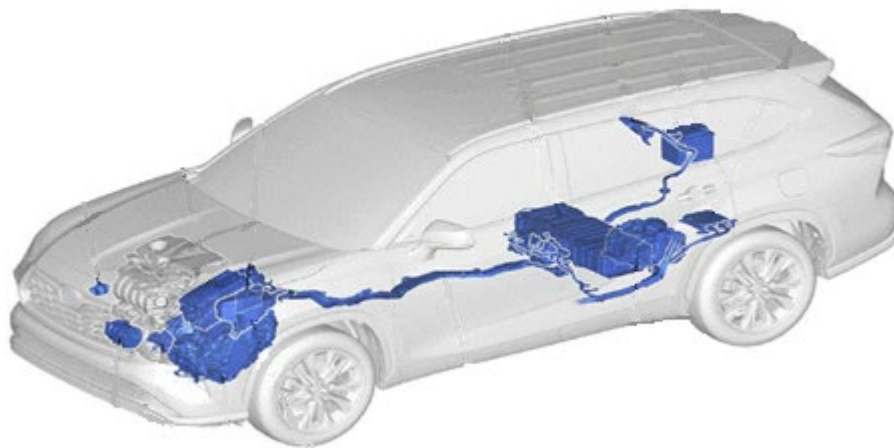
Although the HV Floor Under Wire Harness and Rear Traction Motor Cable is covered by Toyota's New Vehicle Limited Warranty for 3 years or 36,000 miles (whichever comes first), we at Toyota care about the customers' ownership experience. Toyota is providing coverage for repairs related to excessive corrosion to the wire harness connections at the Rear Motor Generator. Excessive corrosion can cause AM Radio Static during certain drive cycles, or the vehicle may not start.

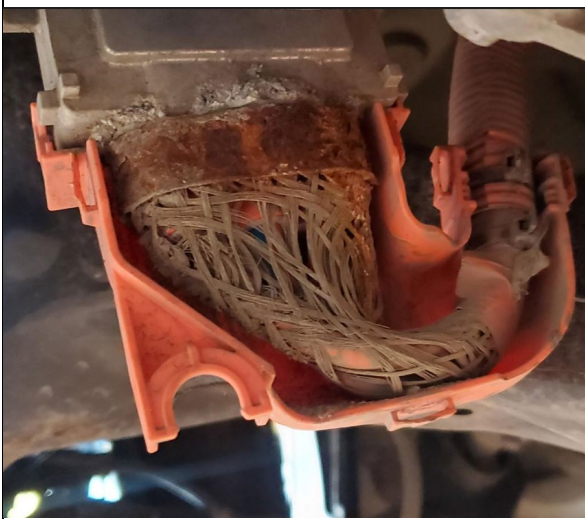
Y6 connector under vehicle at MGR

4) Inspect the Y6 connection for corrosion.

- Disconnect the Y6 connector at the MGR and inspect for corrosion, dirt, or debris.

YES –Continue to Section VI

NO - This CSP does not apply. Please consult the repair manual and continue diagnosis.

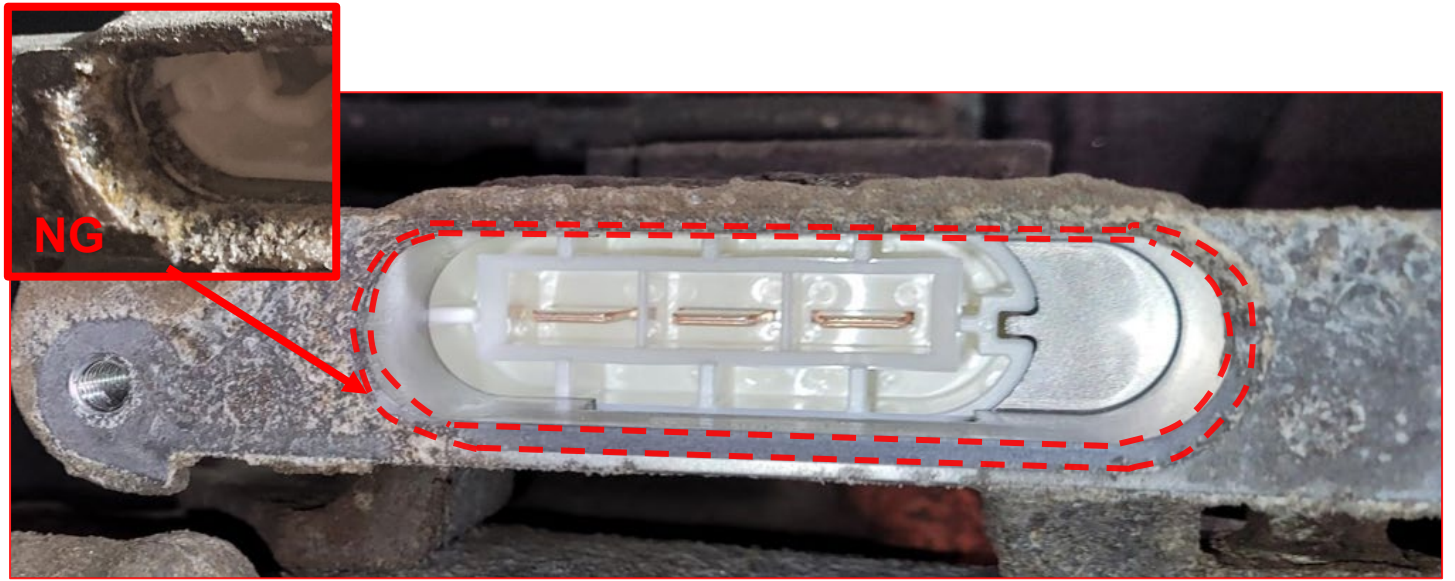
5) Inspect the connector housing of the MGR.

- Inspect the chamfer of the MGR connector housing for pitting and corrosion on the sealing surface. Corrosion in this area will cause the seal to leak. Is pitting and corrosion present?

YES – Rear Traction Motor Cable requires replacement, continue to Section VI

NO – Rear Traction Motor Cable does NOT require replacement, continue to Section VI
