DTC U010087 & No Start/ Replaced Engine ECU After Jump Starting

2019-2022	Avalon HV	2021-2024	Venza HV
2020-2023	Highlander HV	2023-2024	RAV4 Prime
2023-2024	RAV4 HV	2020-2024	Camry HV
2021-2024	Sienna HV

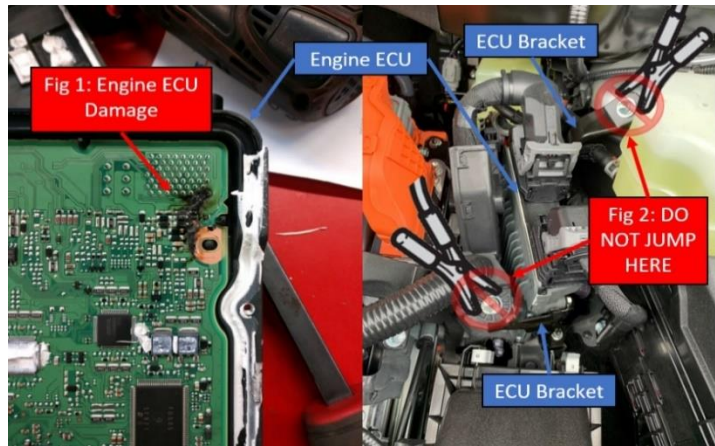
After jump-starting, the vehicle may experience a no-start condition and multiple DTCs including U010087. Upon investigation, it is found that the engine ECU has been damaged and needs to be replaced (Fig 1). In several cases, it was found that the cause of the ECU damage was improper jump starting. Further investigation found that ECU damage may occur if the jumper cables are hooked up on or around the engine ECU or ECU mounting bracket (Fig 2).

To prevent this condition from occurring, it is recommended that the jumper cables be attached as described in the owner’s manual. Below is an example of the correct jump start locations for 22 MY Highlander HV (Fig 3). Please consult the appropriate owners or repair manual to confirm the correct jump start location on other models.
