Technical Service Bulletin

50 Creaking noises heard when body twists during braking or steering maneuvers

50 23 13 2061672/4 June 9, 2023. Supersedes Technical Service Bulletin Group 50 number 23-11 dated February 21, 2023, for reasons listed below.

Model(s)	Year	VIN Range	Vehicle-Specific Equipment
A6, and A7	2019 – 2021	All	Not Applicable
A6 allroad, S6, and S7	2020 – 2021		
RS 6 Avant, A7 e quattro, and RS 7	2021

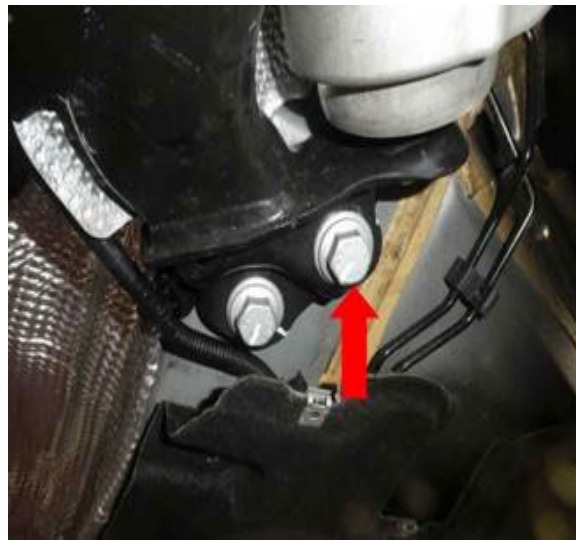
Figure 1. Front most bolt on subframe to be loosened.

1. Duplicate the noise on a test drive preferably with the customer so that the conditions under which this symptom presents are clearly identified. If this noise is duplicated on the test drive confirmation that the source of the noise is from the longitudinal member and that the repair described in this TSB will be effective can be achieved as follows.
2. Begin your diagnosis by loosening the front most bolt on the subframe mounting as indicated in Figure 1. The bolt only needs to be loosened several turns, but not removed.

As specified in the repair manual, it is necessary to replace all loosened subframe bolts at the conclusion of the entire repair.

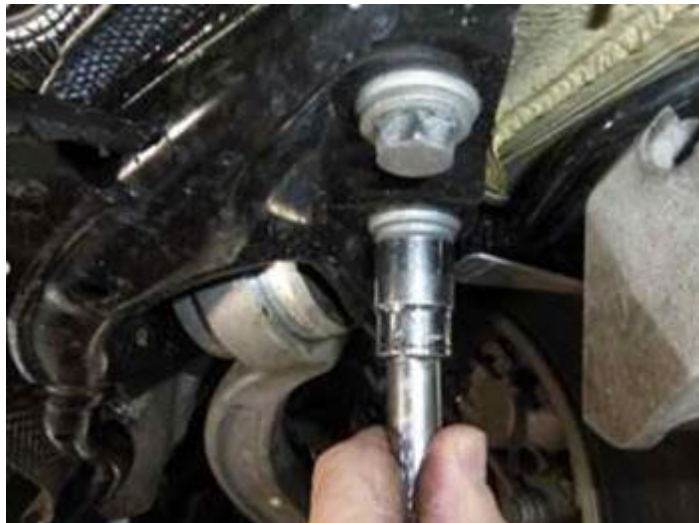
3. In many cases an audible 'cracking' noise can be heard in the course of loosening and tightening the subframe bolt (Figure 2).

Figure 2. Loosening the front most subframe bolt.

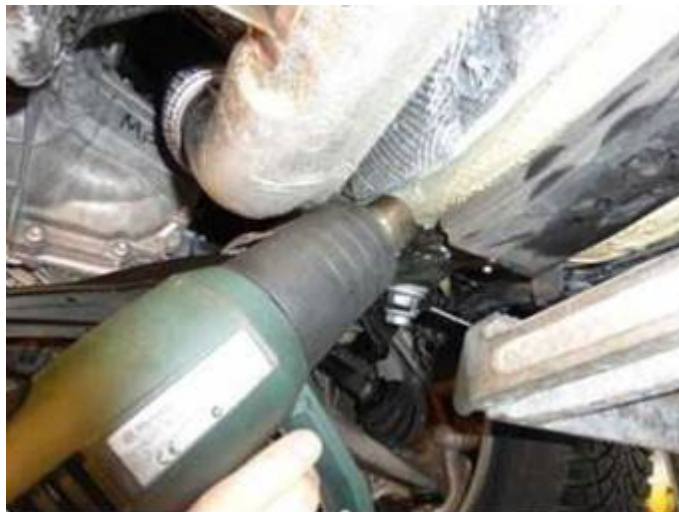
Figure 3. Warming the area of the body near the rear transverse link.

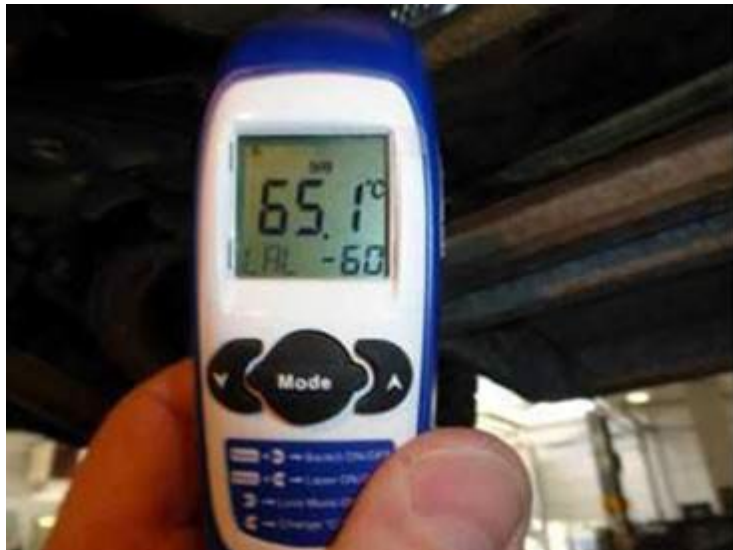
Figure 4. Surface temperature warmed to 65° C (149°F).

6. Warm the surface to approximately 65 °C (149°F) (Figure 4).

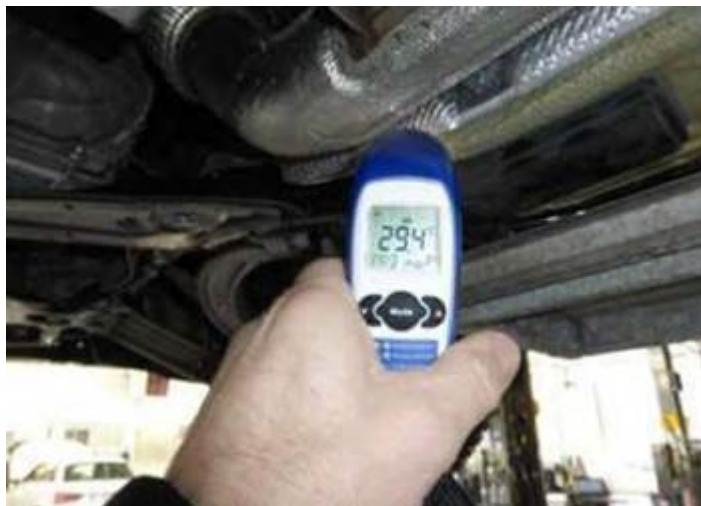
Figure 5. Surface temperature cooled to approximately 30° C (86°F).

7. Allow the surface temperature to cool to approximately 30 °C (86°F) then test drive the vehicle again.

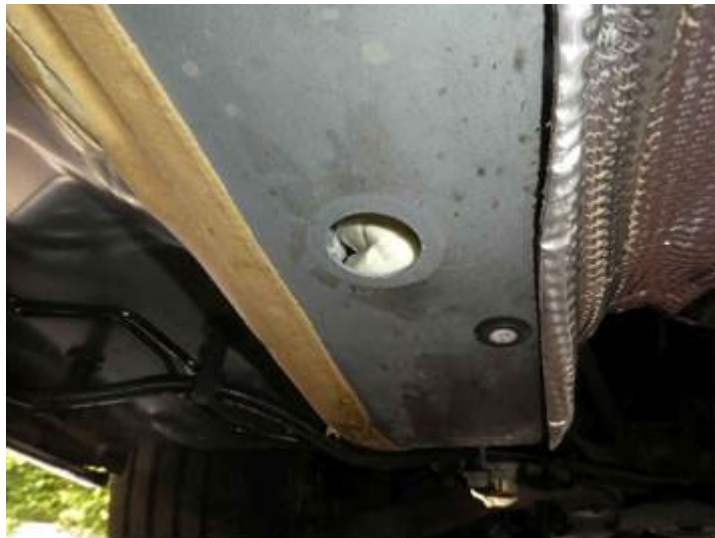
Figure 6. Body plug removed.

9. With the symptom confirmed, lower the center cover plate on the affected side. Remove the first body plug aft of the bolted connection for the transverse link (Figure 6).

Replace the body plug removed in this step with 8K0 805 267.

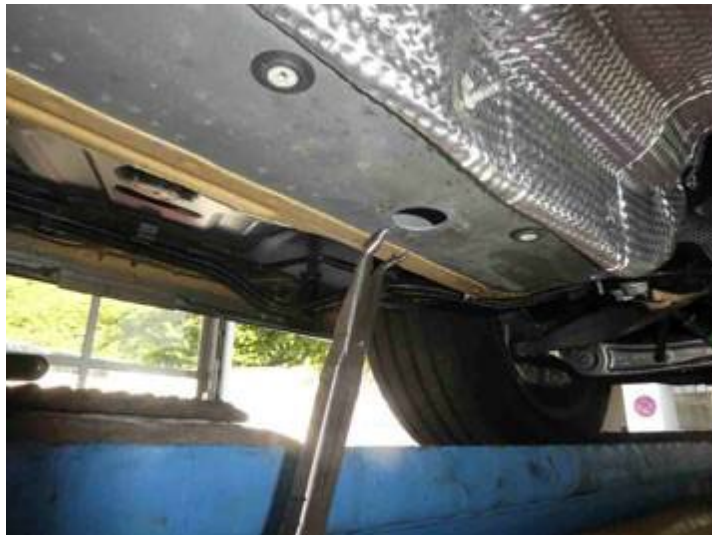
Figure 7. Remove a portion of the acoustic foam.

10. In order to provide appropriate access to the affected area inside the longitudinal member remove sections of the acoustic foam in the longitudinal member area with long needle nosed pliers. It is not necessary to remove all of the acoustic foam and the small amount removed for this procedure will not need to be replaced (Figure 7).

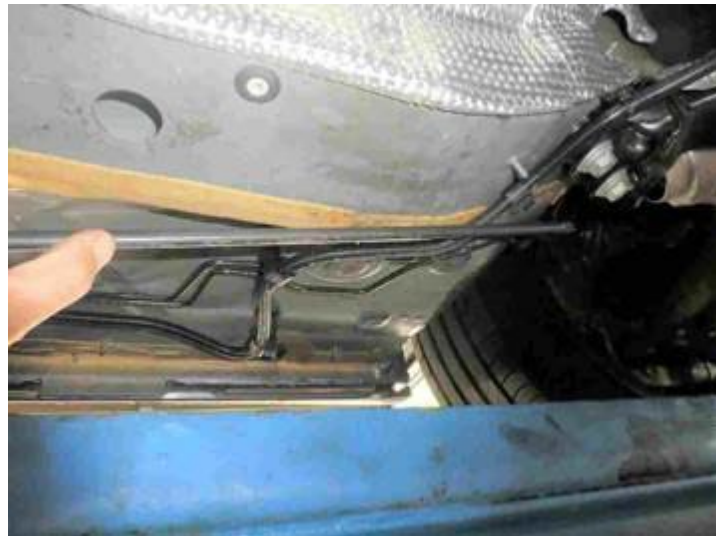
Figure 8. Tool to be fabricated.

11. An improvised tool for this modification will be fabricated. Obtain a steel rod 8mm in diameter and 60 cm long (Figure 8).

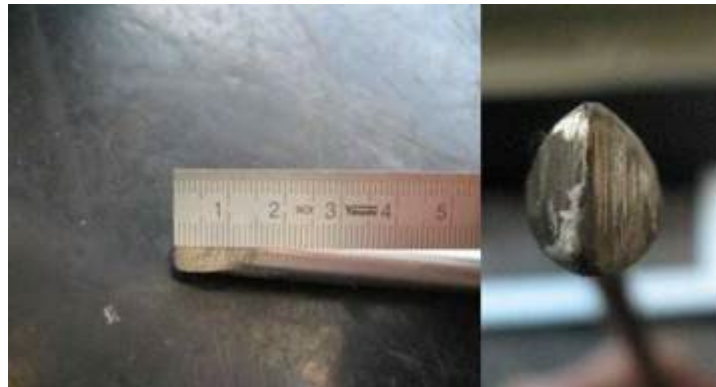
Figure 9. Ground the tip of the steel rod.

12. Grind the tip of one end of the rod into a chisel shape. The length of the grind should be 15mm +/-3mm on each side as shown in Figure 9.

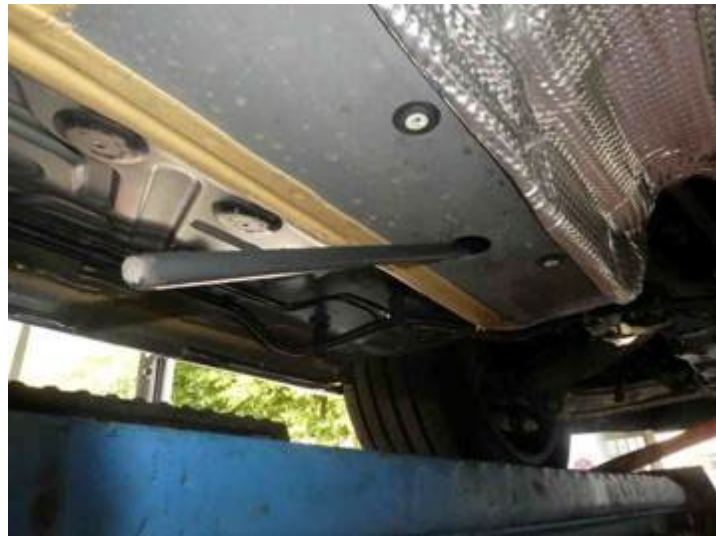
Figure 10. Insert the steel rod.

13. Insert the chisel end of the steel rod into the body opening, through the remaining acoustic foam and far enough to engage the longitudinal member support (Figure 10).

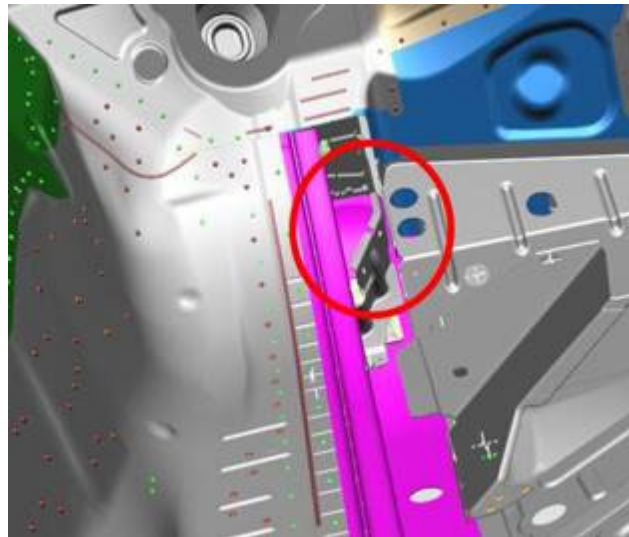
During a cornering or hard braking maneuver the longitudinal members can make contact with their internal support plates.

14. The drawing in Figure 11 shows a cut-away of the area where the longitudinal member support and the longitudinal member housing make contact.

Figure 11. Cut-away drawing of the inside of the longitudinal member.

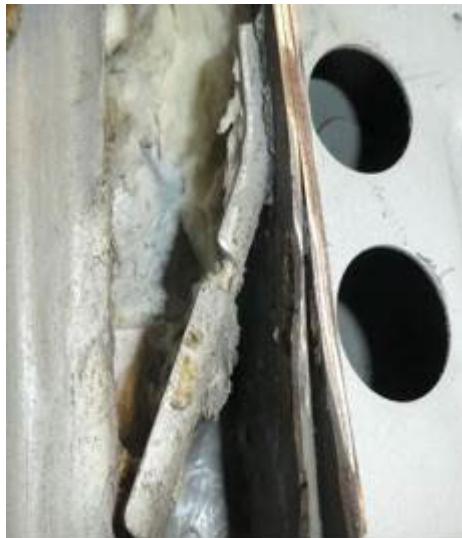
Figure 12. *Opened longitudinal member and support.*

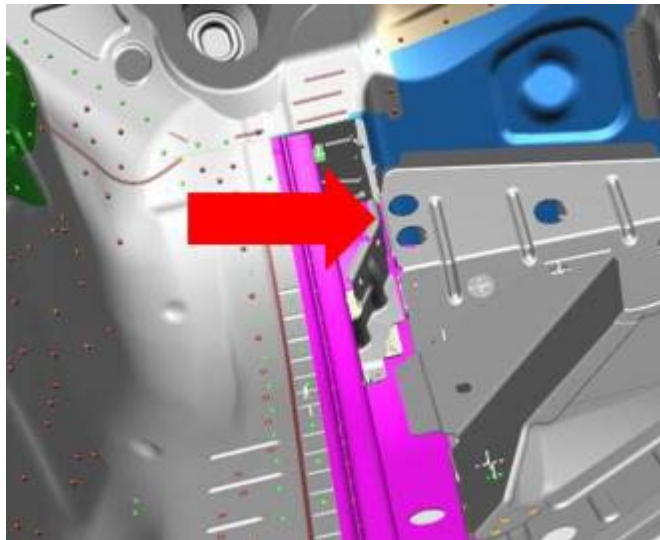
Figure 13. *Point of contact for the steel rod.*

16. Insert the steel rod to the point of contact indicated by the red arrow shown in Figure 13.

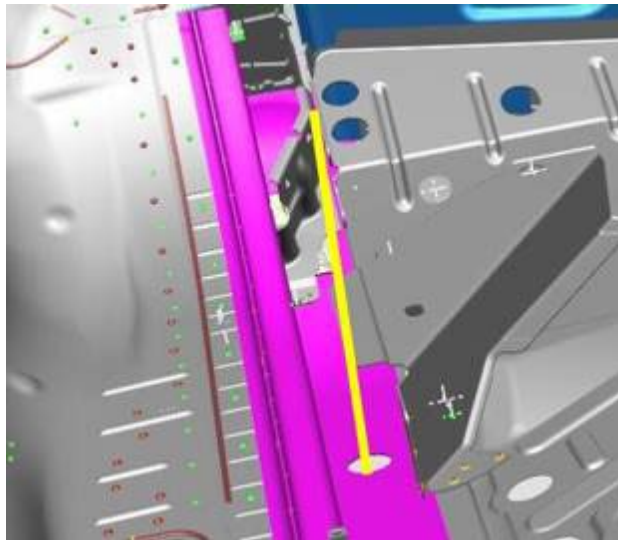
Figure 14. Direction of insertion of the steel rod.

17. The yellow line in Figure 14 shows the position the steel rod will realize after insertion and engagement with the longitudinal member support.

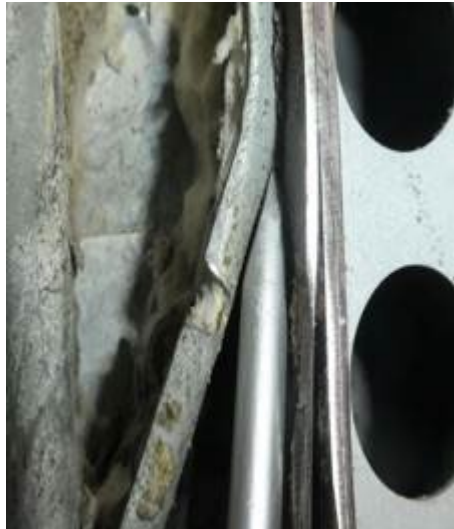
Figure 15. Correct engagement of the chisel end of the steel rod.

18. The chisel end of the steel rod must be inserted as shown in Figure 15 with the wedge engaged consistent with the space formed by the longitudinal member support to the longitudinal member housing.

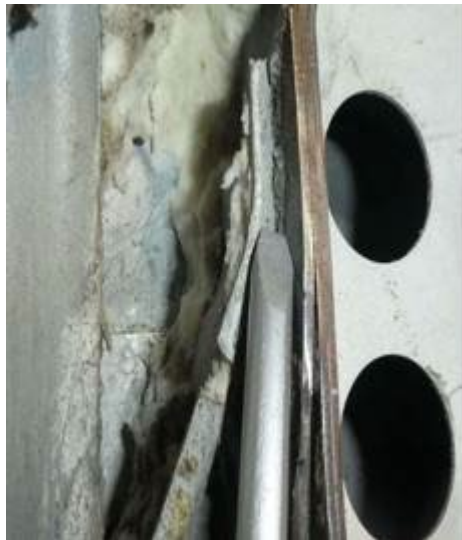
19. Figure 16 shows an incorrect engagement of the chisel end.

Figure 16. *Incorrect engagement of the chisel end.*

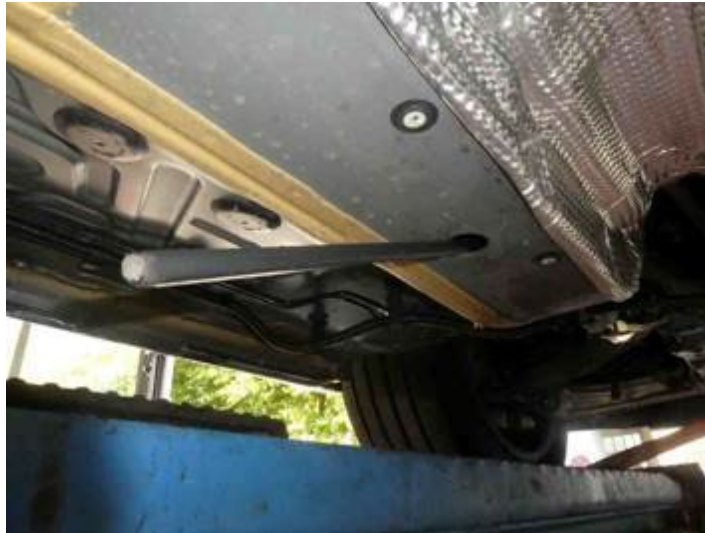
Figure 17. *Driving the steel rod into the longitudinal member support.*

20. Using a hammer drive the steel rod a distance of 4 – 5 cm. Ensure the correct distance measure and mark this distance on the steel rod with tape (Figure 17). Remove the tool when finished.
