Subject: N222365910 - Customer Satisfaction Program
Air Suspension Dump Valve

Models: 2022 Chevrolet Silverado 4500 HD/5500 HD/6500 HD
Equipped with VALVE-AIR SUSPENSION AIR RELEASE (RPO JPZ)

Customer Satisfaction Program

N222365910 Air Suspension Dump Valve

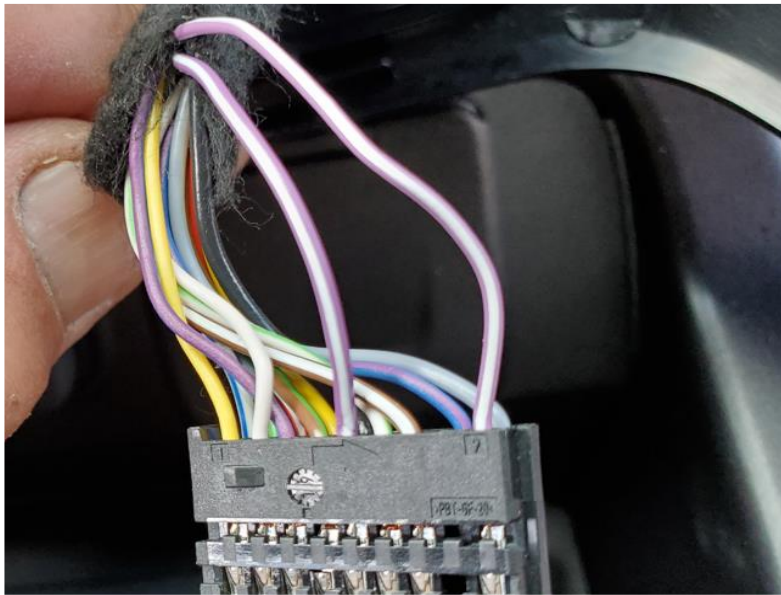
6318345

Condition	Certain 2022 model year Chevrolet Silverado 4500 HD/5500 HD/6500 HD vehicles, equipped with Valve-Air Suspension Air Release (RPO JPZ), were incorrectly invoiced with an Air Suspension Dump Valve and may have been built with the incorrect switch assembly.
Correction	Dealers will issue a reimbursement check in the amount of \$60 USD, replace the switch assembly, and disable the Air Suspension Dump Valve switch and Low Pressure indicator.

- Original Owner Letter provided by General Motors.
 - Vehicle registration.
 - Driver's license or state ID - verify that it matches the registration and owner letter.
1. Issue the customer a reimbursement check in the amount of \$60.00 USD. Record the check number in the Invoice Number field and record the VIN on the check.
 2. Remove the instrument panel center accessory function switch and discard. Refer to *Instrument Panel Center Accessory Function Switch Replacement* in SI.
 3. Disconnect the air suspension dump valve switch connector (18 pin connector).
