Technical Service Bulletin

57 Power closing door latch is intermittently inoperative, door adjustment is required

57 23 10 2058159/5 June 13, 2023. Supersedes Technical Service Bulletin Group 57 number 22-89 dated January 19, 2022, for reasons listed below.

Model(s)	Year	VIN Range	Vehicle-Specific Equipment
Q7	2017 – 2024	All	Power closing door latch
SQ7	2020 – 2024

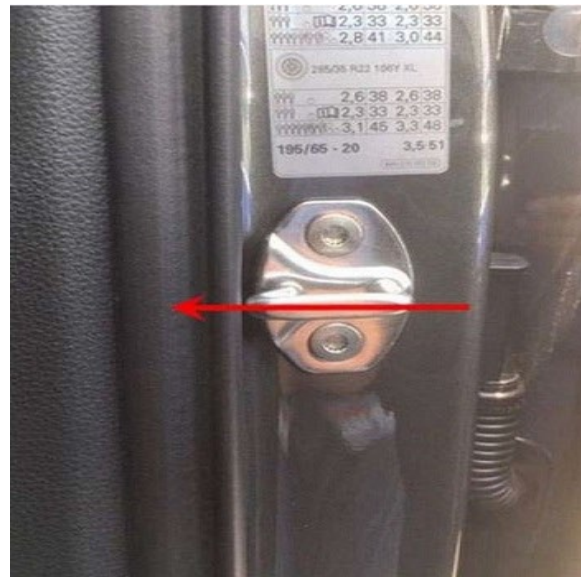
The door latch requires counter-pressure from the door/door seal, in order to generate a reliable signal for the door control module that the customer wants to close the door. If the door striker is adjusted in such a way that does not provide enough counter-pressure for the latch, the door control module does not recognize the door latch signal long enough or at all. Hence the door will not be closed.

Figure 1. Adjust door striker inward by at least 0.5 mm.

1. Check the door striker to latch alignment and perform any adjustments necessary to center the striker to the latch.
2. At the same time, adjust the door striker inward as far as possible (at least 0.5 mm) (Figure 1). The front door can be flush or slightly under flush to the rear door without causing a wind noise concern (Figure 2).

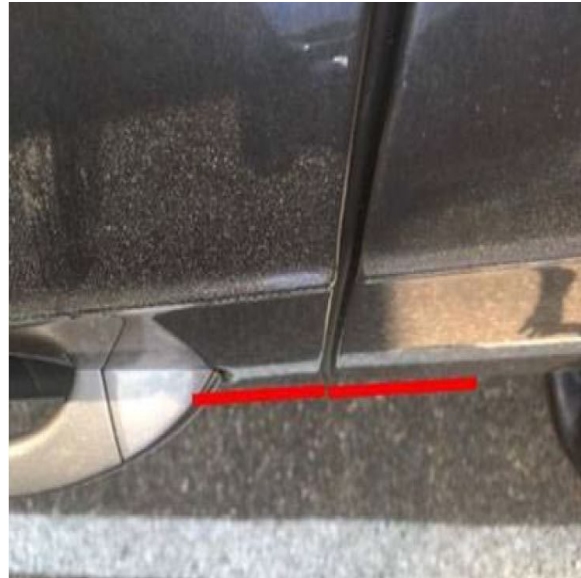
Figure 2. The front door can be flush or slightly under flush to the rear door.

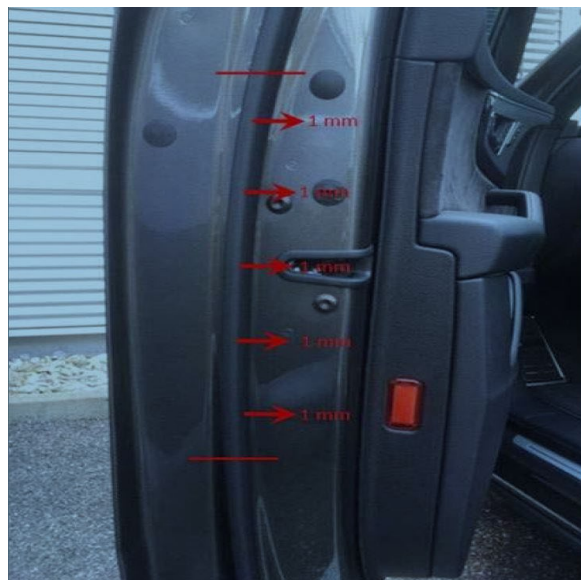
Figure 3. Install the new outer door seal with an inward offset of 1.0 mm.

3. Recheck the functionality of the power closing door latch system. If after the striker adjustment the door closes properly, do not proceed with any additional repairs.
4. If the customer concern persists, install a new outer door seal with an inward offset of 1.0 mm when compared to the original door seal location (Figure 3).

Tip: Mark the position of the original outer door seal before replacing it.
