91 No diagnostics communication to the telematics control module

91 23 04 2056076/17 June 12, 2023. Supersedes Technical Service Bulletin Group 91 number 22-30 dated September 23, 2022, for reasons listed below.

Model(s)	Year	VIN Range	Vehicle-Specific Equipment
All Audi Vehicles	2019 – 2020	All	ConBox Low

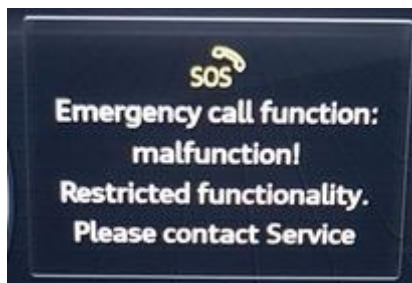
- An SOS Warning might be displayed in the instrument cluster (Figure 1).

Figure 1. Emergency call malfunction warning.

A software bug can cause the control module to freeze during a cold start.

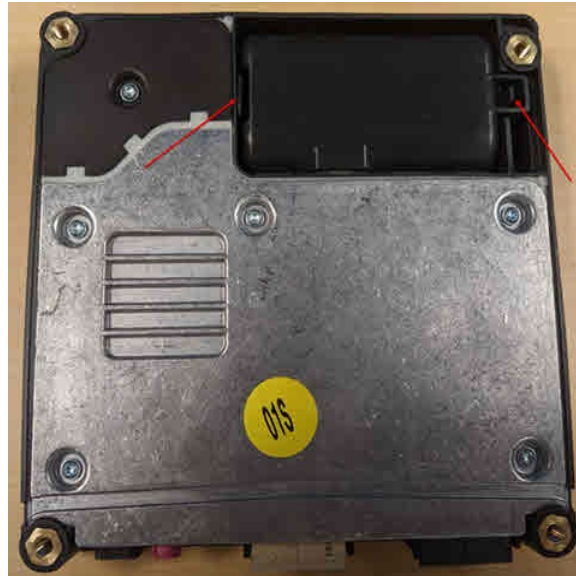
Figure 2. Backup battery compartment location.

2. Open the battery compartment of the telematics control module, J949 (address word 0075), and disconnect the backup battery (Figures 2 - 3).

4. Leave the battery and Gateway fuse disconnected for approximately 20 minutes, then reinstall the fuse.
5. Reinstall the backup battery back into the telematics control module, J949 (address word 0075).
6. Reinstall the telematics control module, J949 (address word 0075) back into the vehicle.
7. If ODIS **still cannot** connect to the telematics control module, J949 (address word 0075), then follow the ODIS test plan and replace the telematics control module with part number **992 035 286 C**.

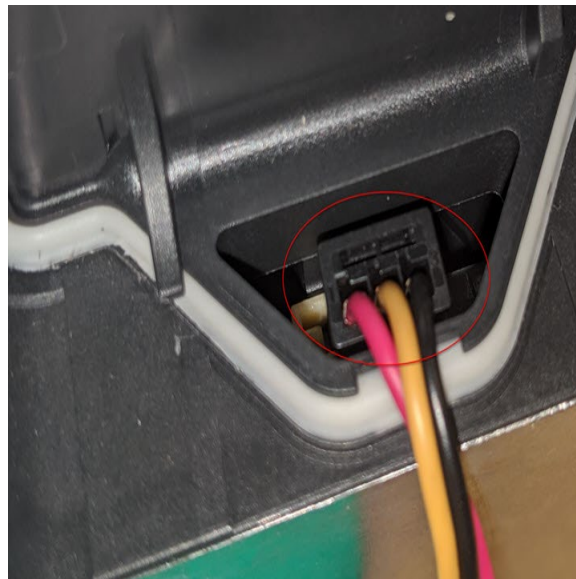
Figure 3. Backup battery connector (no release mechanism).
