Technical Service Bulletin

91 Parking aid sensor bracket(s) separates from rear bumper

91 23 05 2068573/2 June 12, 2023. Supersedes Technical Service Bulletin Group 91 number 22-52 dated December 1, 2022, for reasons listed below.

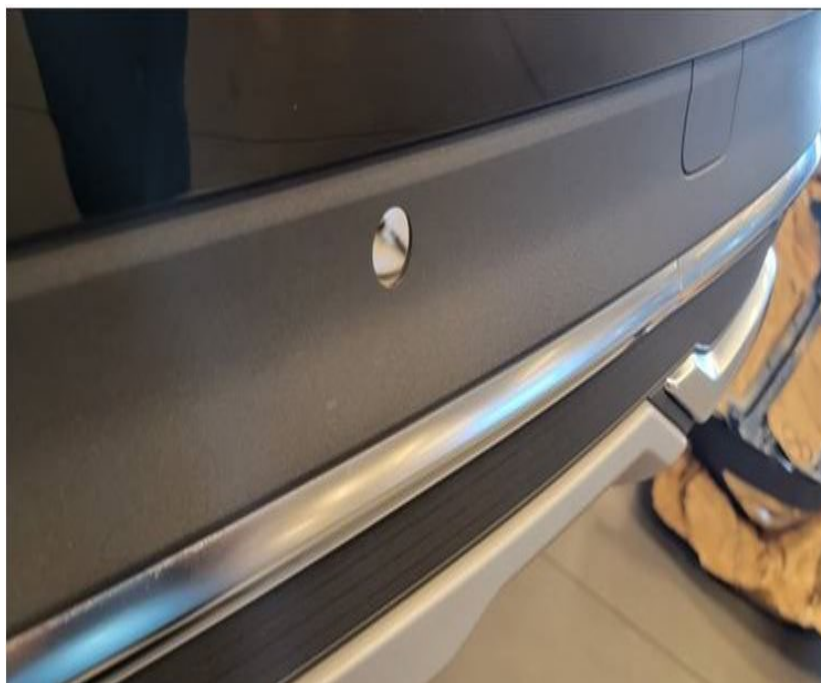
The adhesive strength of the parking aid bracket is not sufficient.

Over time, one or more of the sensor mounts may separate from the rear apron.

Figure 1: The parking aid mount has come loose.

If one or more of the sensor brackets has come loose from the rear bumper, use the steps below to re-attach the mounts.

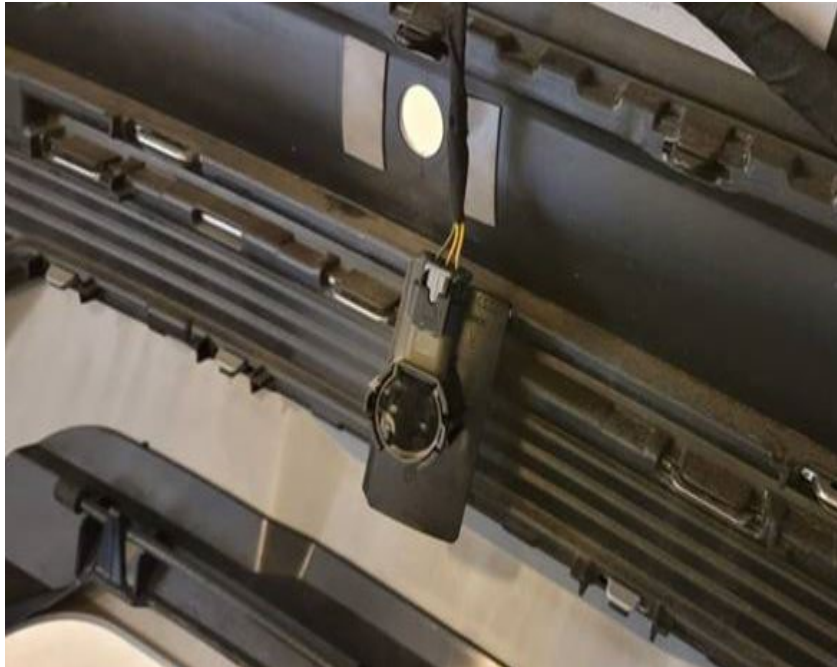
It is possible for the parking aid sensor(s) to issue false warnings when the mounts start to separate.

Figure 2: The parking aid mount has come loose.

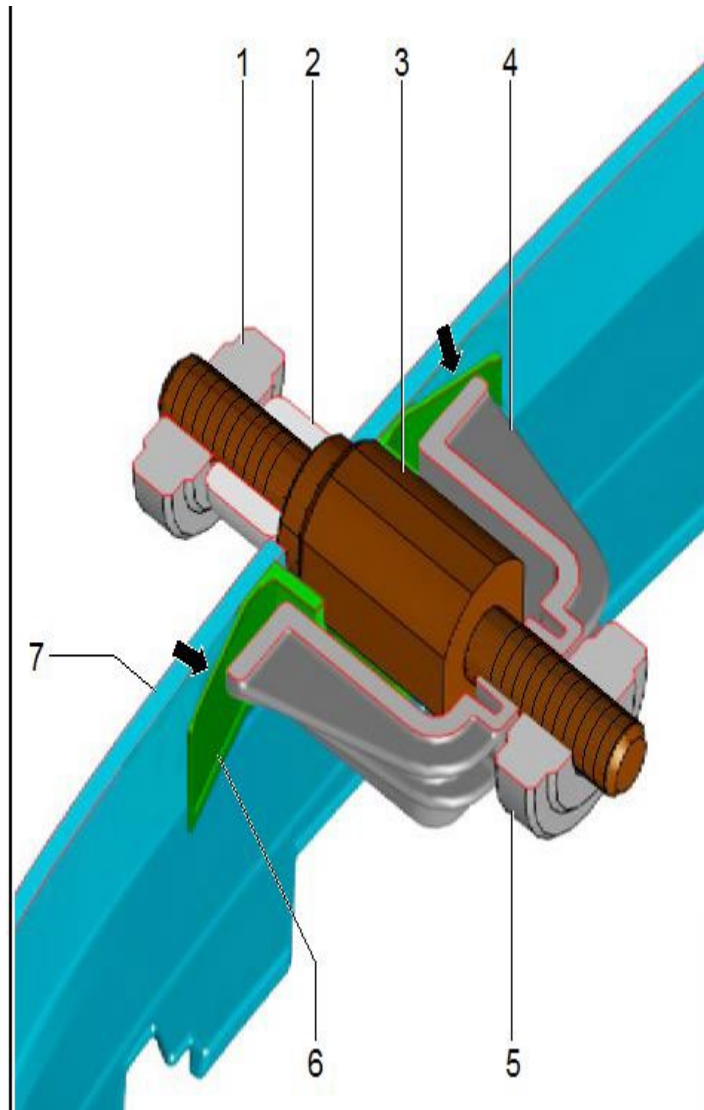
Figure 4: VAS 6614 assembled with PDC mount on rear apron.

- Slide parking aid bracket -6- onto centering pin -3- (VAS 6614) and push through rear apron -7- as seen in Figure 4.
- Slide on counter hold tool -2- from outside and tighten knurled nut slightly.
- Align bracket -6- in correct position and according to markings on rear apron.
- Slide on clamp -4- and screw in knurled nut -5- but do not tighten yet.

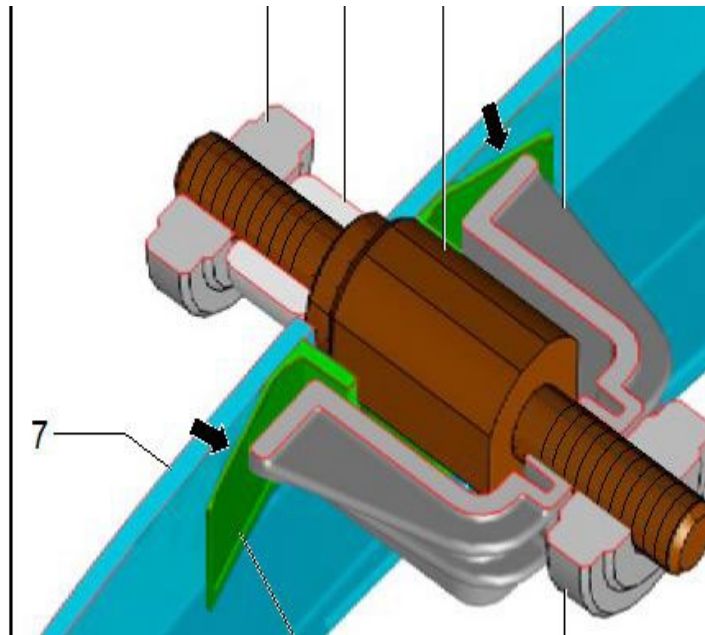
Figure 5: Arrows mark location for adhesive.

Apply plastic adhesive **D 180 KU2 A1** to areas marked by arrows between the parking aid bracket and rear apron (Figure 5).

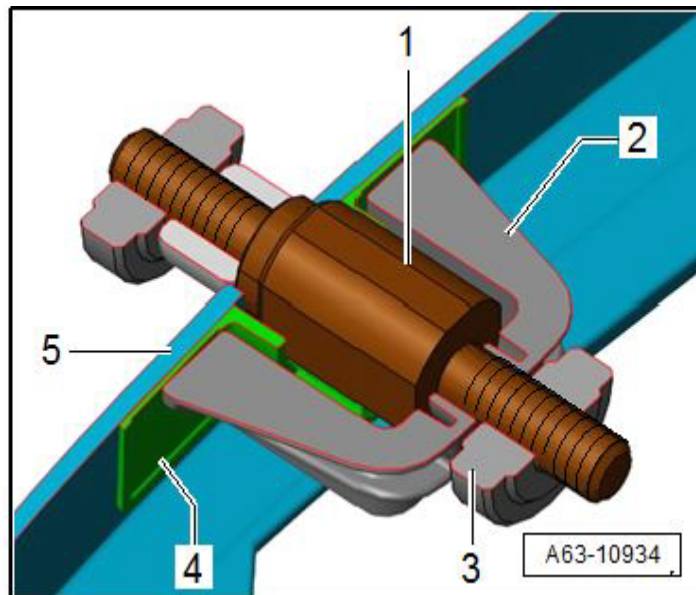
Figure 6: Mounts compressed to spoiler.

- Tighten knurled nut -3-.
- This results in clamp -2- pushing tabs of bracket -4- flat onto rear apron/spoiler -5-.
- Perform this step for all affected brackets.
