Technical Service Bulletin

94 How to properly document optical concerns for headlights and taillights

94 23 65 2061922/3 June 8, 2023. Supersedes Technical Service Bulletin Group 94 number 23-63 dated May 8, 2023, for reasons listed below.

Model(s)	Year	VIN Range	Vehicle-Specific Equipment
All Audi Vehicles	2010 – 2024	All	Not Applicable

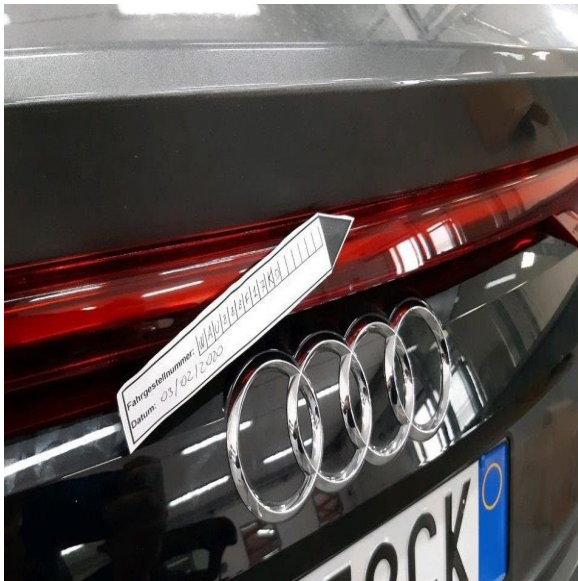
Figure 1. Example of a perspective view photo. **Figure 2.** Example of a headlight perspective view photo.

- Entire area is visible in the photo which clearly identifies the lamp affected (figures 1 – 2).
- Photo is taken with the fault component still installed on the vehicle before components are removed.
- Photo is in focus and properly lit.
- Defect flag should be completely visible and legible.

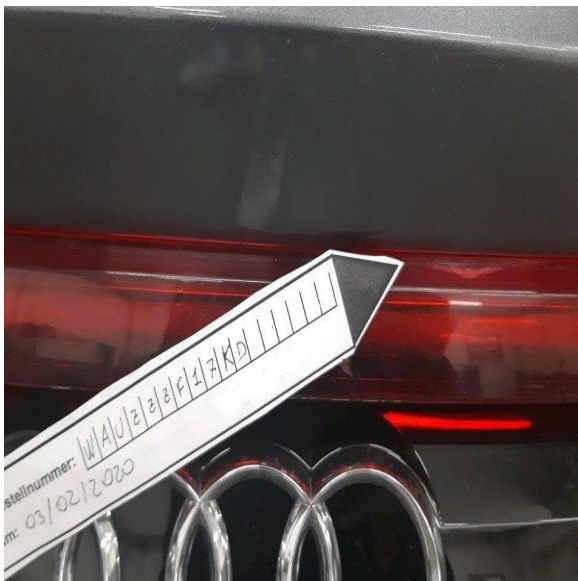
Figure 3. Example of tail light close-up.

- Defect flag points at the area of concerns (figures 3-4).
- Concern is clearly visible in the photo.
- Defect flag VIN and date are completely visible in the photo.
- Photo is in focus and properly lit.

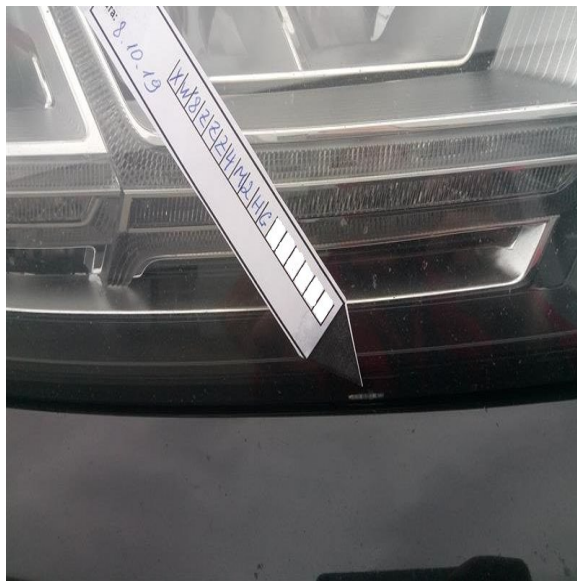
Figure 4. Example of headlight close-up.

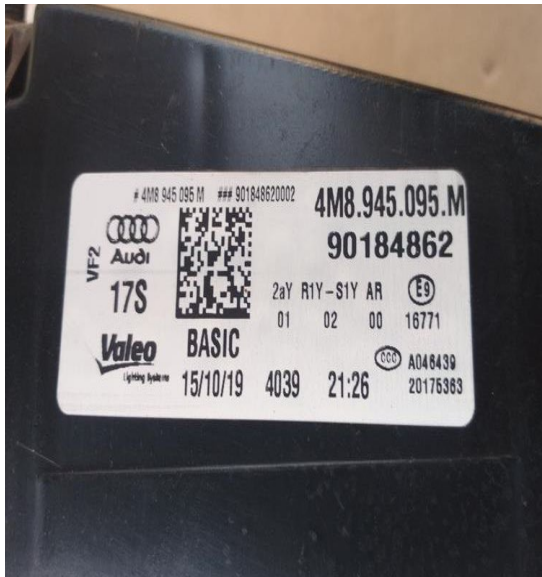
Figure 5. Example of tail light assembly label.

- Component removed.
- Entire label is visible (figures 5 – 6).
- Photo is in focus and properly lit.
- Any additional supporting photos that were taken at this time.

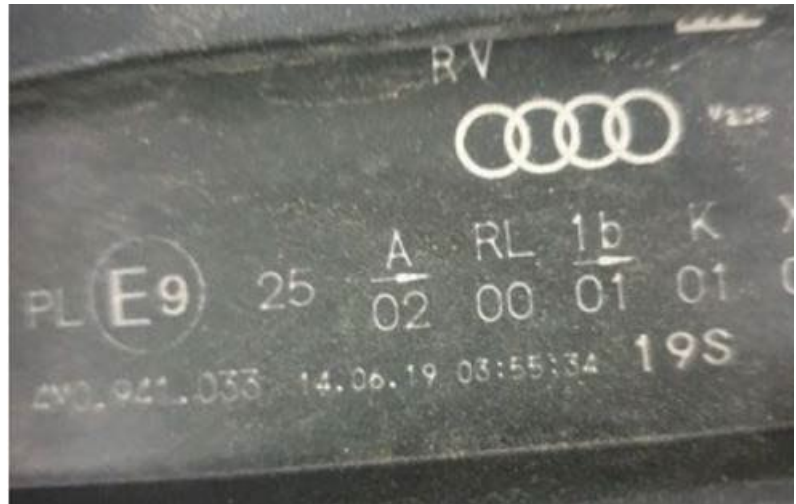
Figure 6. Example of headlight label.
