Technical Service Bulletin

97 MIL on, chafing found on transmission harness, DTC's: P157600, P157200, P218100, P260200, P260000
97 23 95 2070557/1 June 2, 2023.

Model(s)	Year	VIN Range	Vehicle-Specific Equipment
A6 allroad, A6, and S6	2023	043477 – 046976	Not Applicable

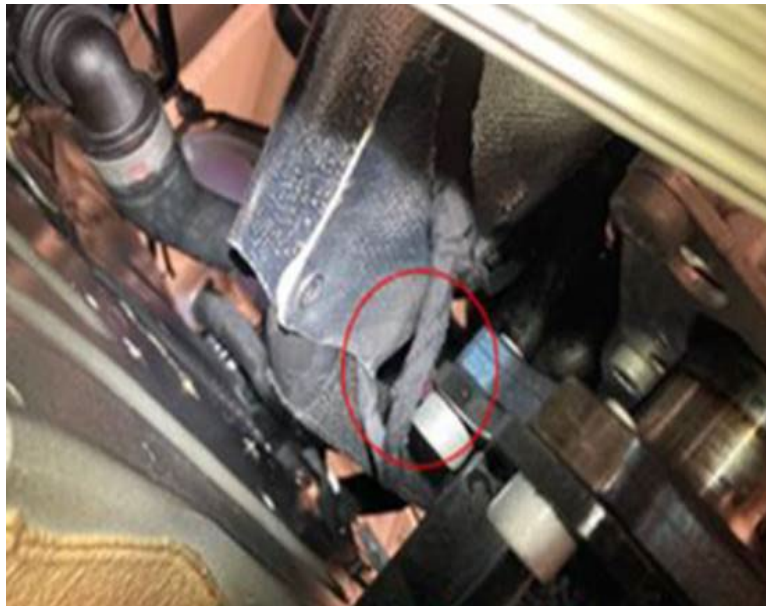
The wiring harness for the automatic gearbox is chafing on the front left drive shaft.

Figure 1: Transmission harness contact point.

Check the wiring on the left side of the gearbox (Figure 1).

If wiring harness damage is found, repair using wiring harness repair set **VAS 1978 B**.

Replace the harness if it is damaged beyond repair. In this case, attach a photo of the damage to DOC-IT for review.

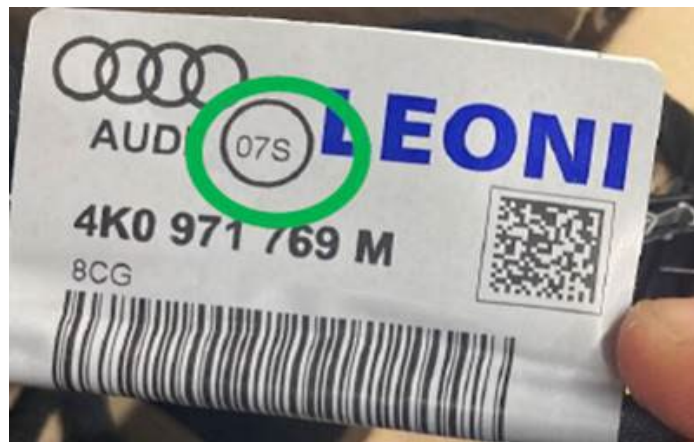
Figure 2: Example of 07S harness.

Regardless if harness is repaired or replaced, check the gearbox wiring harness generation (Figure 2).

Route the harness as described below depending on harness generation **06S** or **07S**.

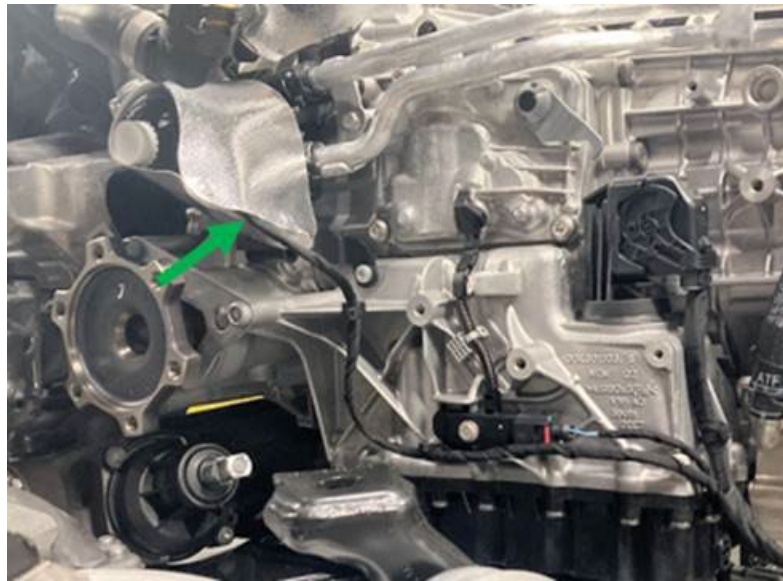
Warning: If this is not performed, the wiring harness will make contact with the drive shaft again.

Figure 3: Optimized routing for generation 06S.

The generation 06S wiring harness **must be** routed through the circulation pump heat shield (the two buttons determine the position, green arrow, Figure 3).

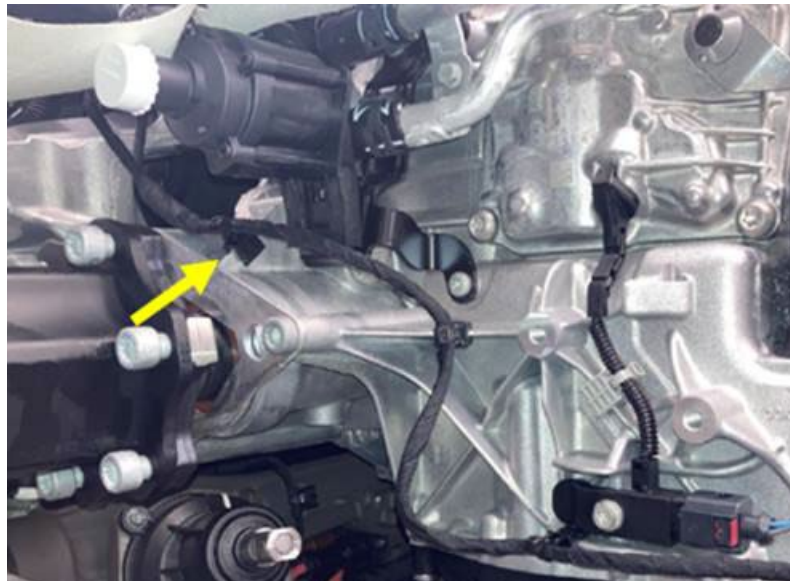
Figure 4: Optimized routing for generation 07S.

Generation 07S has a different shape and an additional retaining element (see yellow arrow in Figure 4). Generation 07S **must not be** routed through the circulation pump heat shield.
