## 97 Rear parking aid, lane change assist or rear lid power opening does not work

97 23 96 2070488/1 June 5, 2023.

Model(s)	Year	VIN Range	Vehicle-Specific Equipment
A6	2019 – 2023	All	Reinforced Bumper
A6 allroad, and S6	2020 – 2023		
RS 6 Avant	2021 - 2023

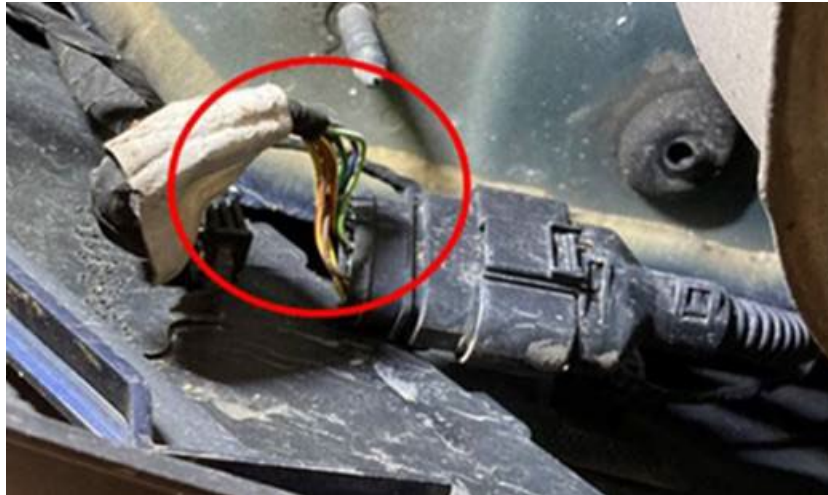
Environmental influences can cause damage to wiring at the coupling point on the rear left bumper TSFHL.

Inspect connection point TSFHL at the rear bumper for damage (Figure 1).

**Figure 1:** Inspection point of TSFHL

If damage is found, repair the harness using the following steps.

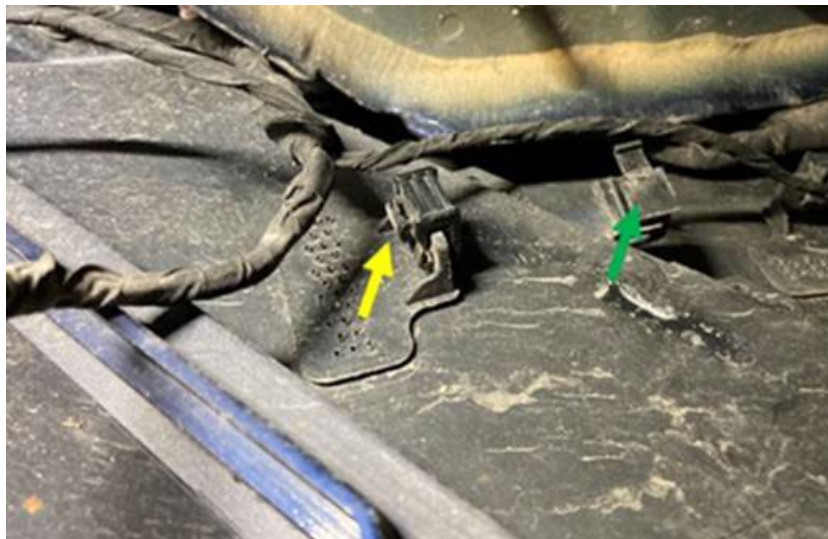
**Figure 2:** Cable ties to be removed

Remove the cable tie (yellow arrow in Figure 2).

Release T14mx connector from its mounting (green arrow in Figure 2).

Repair damaged wires using wiring harness repair set **VAS 1978 B/C**.

Re-wrap the repaired wiring harness with adhesive tape **N 10729002**.

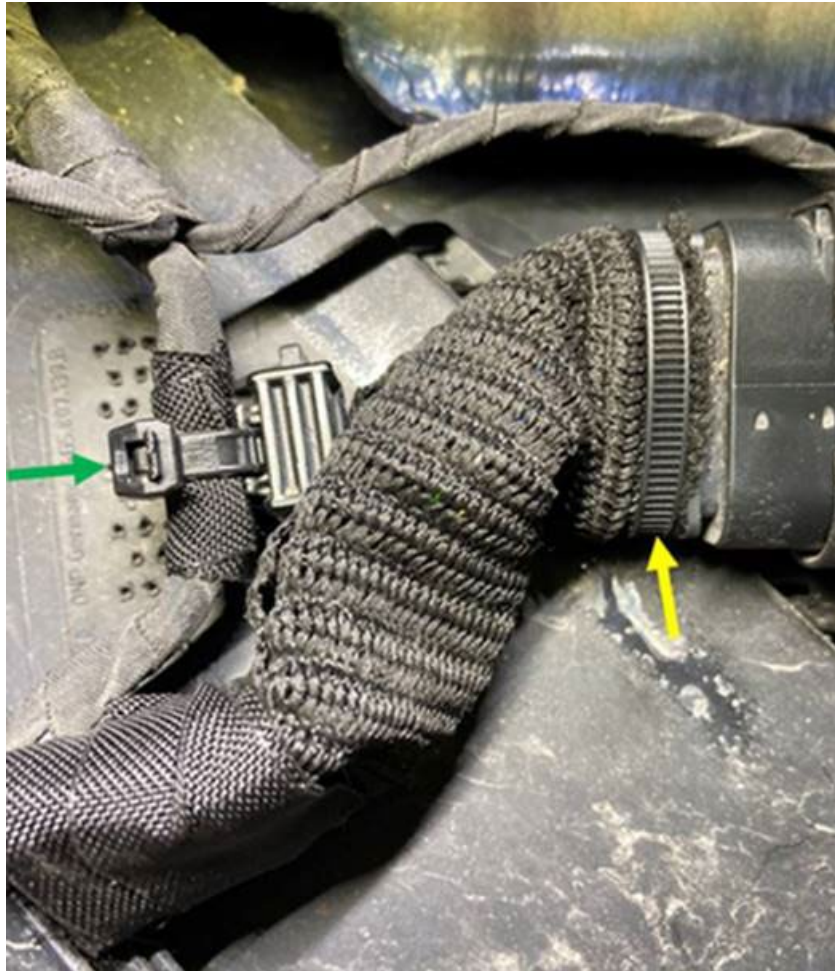
**Figure 3:** Completed repair of harness connection T14mx

Secure protective sleeve **N 10892001** to T14mx connector using cable tie **N 10623101** (yellow arrow in Figure 3).

Wrap adhesive tape **N 10729002** around other end of protective sleeve several times. Protective sleeve must not be attached to wiring harness with adhesive tape.

Wrap three layers of adhesive tape **N 10729002** underneath cable tie **N 90937701** (green arrow in Figure 3).
