**97 Reduced power "Electrical system: fault" or "Drive system: fault" appears: P068500, P068A00, P1BEF00, B158131 P0C4700**  
97 23 97 2070566/1 June 6, 2023.

Model(s)	Year	VIN Range	Vehicle-Specific Equipment
Q4 e-tron, and Q4 e-tron Sportback	2024	All	Not Applicable

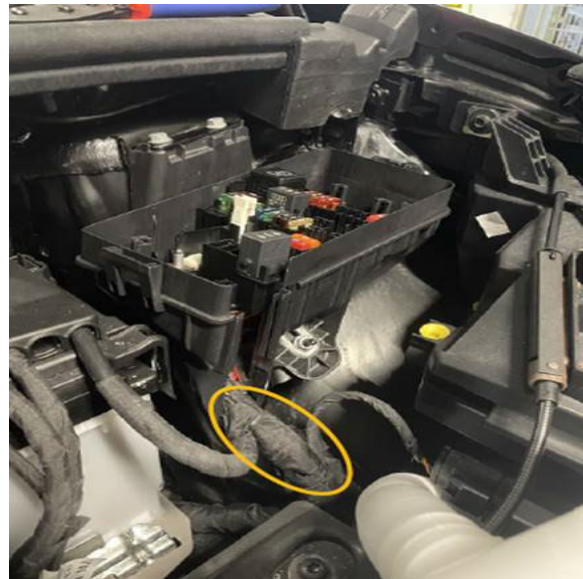
Insufficient sealing to splice point J1 "positive connection (30) in main wiring harness".

If the above DTC's are present, inspect splice point J1 within the main wiring harness indicated by the yellow circle (Figure 1).

**Figure 1:** J1 splice point location.

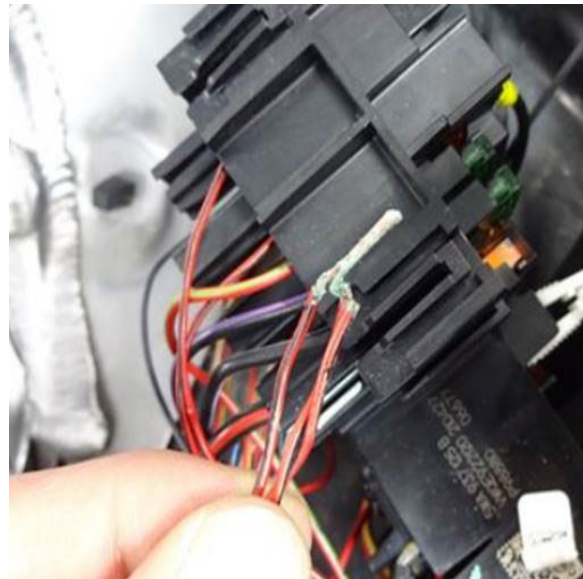
If splice point J1 is corroded as seen in Figure 2, repair the splice point using the following steps.

**Figure 2:** Corrosion found at splice point J1.

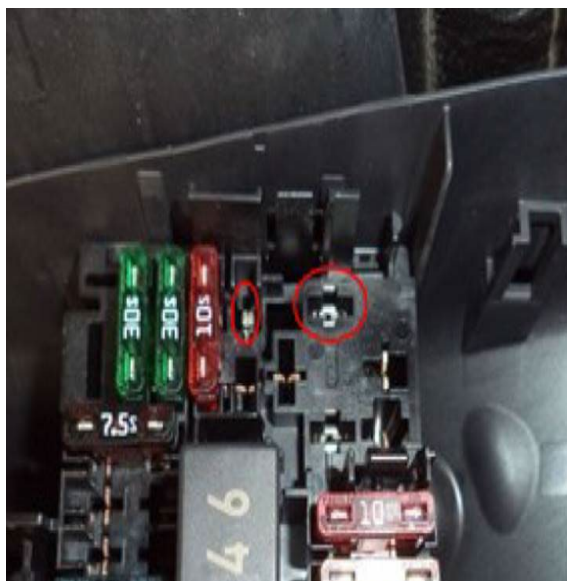
**Figure 3:** Fuse block SB pins to remove.

Unpin the affected contacts (red circles, Figure 3) in fuse holder SB using **VAS 1978/18**.

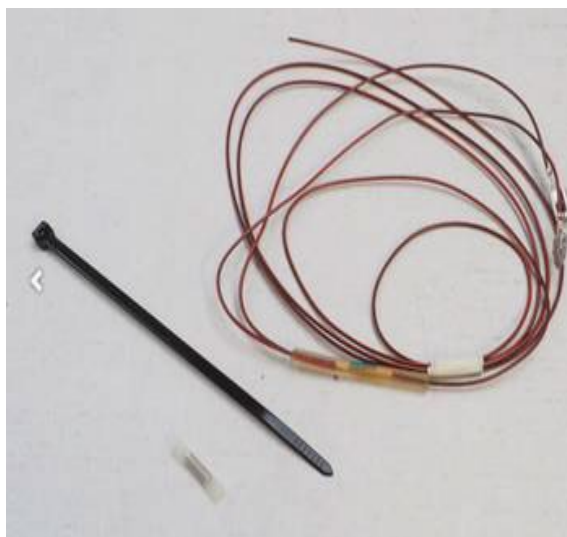
**Figure 4:** Repair kit 10A998110

Fit the repair wiring harness **10A998110** (Figure 4) to the fuse block.

Repair junction point J1 using wiring harness repair set **VAS 1978 B/C**.

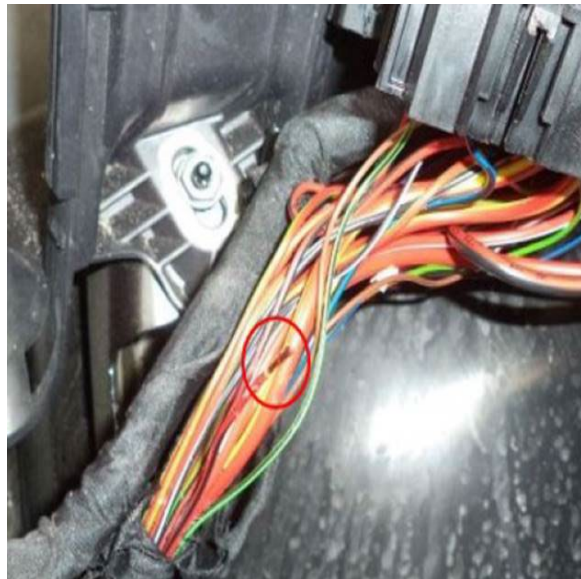
*Figure 5: Clean wire stripped back at J1 splice point.*

The corroded wire **MUST** be cut back until the wires are clean and shiny (Figure 5).

It may be necessary to lengthen or replace the corroded wire(s).

Connect the repair wiring kit **10A998110** to the harness. Use the crimp connector included in the repair kit. Shrink the crimp connector so that the connection is sealed.

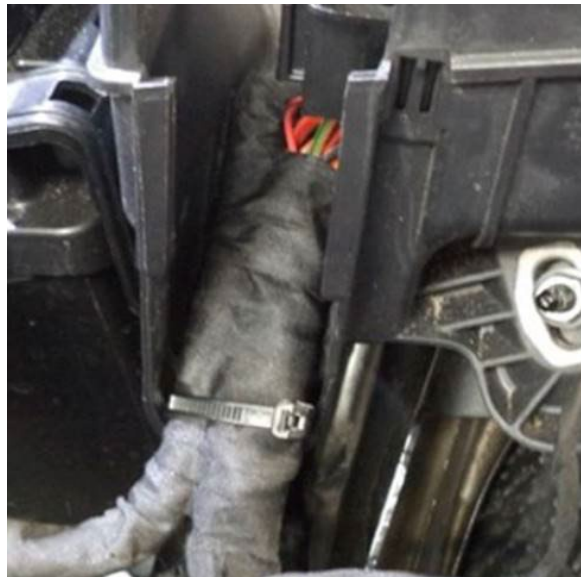
*Figure 6: Completed repair.*

Wrap fabric adhesive tape **N 10729001** around the wiring harness and secure the cable tie supplied (Figure 6).
