Service Action

Code: 40S9

Subject Suspension Strut Mountings

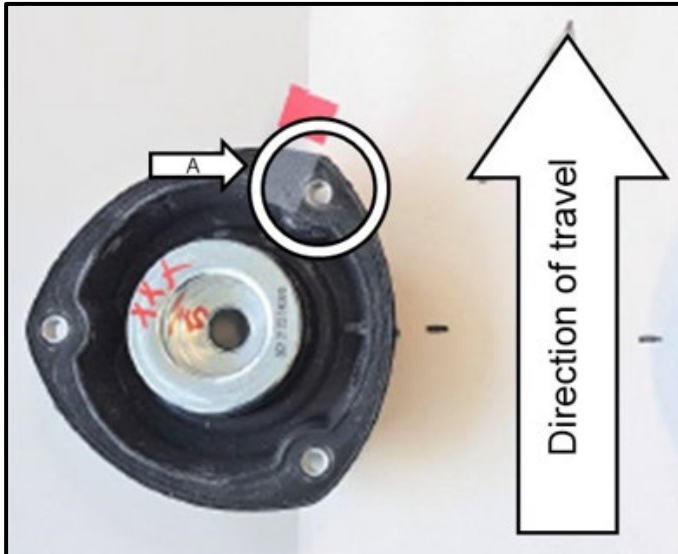
Criteria 01 and 01 + 02 vehicles, left front strut mount inspection:

- Remove the bolt <arrow A> at the front of the left strut mount in the direction of travel.

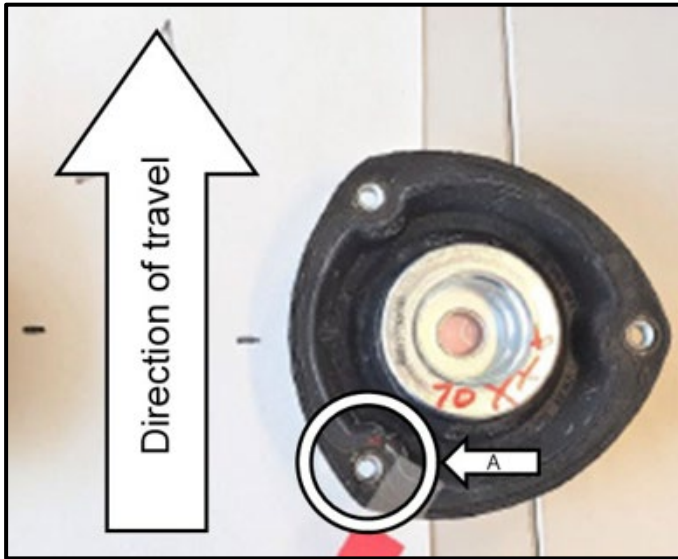
Criteria 02 and 01 + 02 vehicles, right front strut mount inspection:

- Remove the bolt <arrow A> at the rear of the right strut mount in the direction of travel.

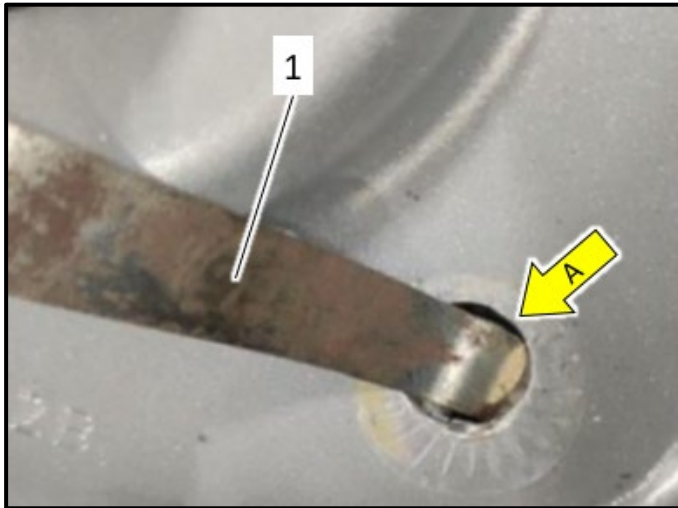
- Using a 0.05mm (0.002") feeler gauge <1>, check if there is a gap between the strut mount(s) and the body <arrow A>.
- If a gap is detected:
 - The strut mount requires replacement
 - **Proceed to Section C.**
- If there is not a gap detected, install a new bolt and torque to 20 Nm + 90°.

- If the strut mount(s) are OK:
 - Reinstall the plenum chamber cover in the reverse order of removal.
 - **Proceed to Section D.**

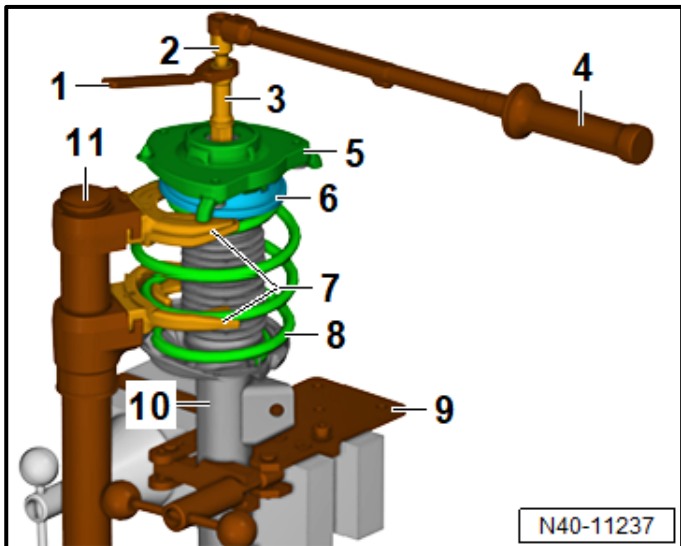
Replace the deformed strut mount(s):

- Make sure the spring is positioned correctly in the spring compressor.
 - Pretension the spring, until the strut mount is released.
- Replace the affected strut mount(s) according to the ELSA repair manual:
 - See ELSA Repair Manual: *Repair Manual > Chassis > Suspension, Wheels, and Steering, 40 Front Suspension > Suspension Strut and Upper Control Arm > Spring, Removing and installing.*
