#### 70 Noises from top of front door trim panel

70 23 83 2066883/2 June 26, 2023. Supersedes Technical Service Bulletin Group 70 number 22-74 dated April 26, 2022, for reasons listed below.

Model(s)	Year	VIN Range	Vehicle-Specific Equipment	
A5, A5 Cabriolet, A5 Sportback, S5, S5 Cabriolet, S5 Sportback	2018 – 2024		Not Applicable	
RS 5	2018 – 2019 2021 – 2024	All		
RS 5 Sportback	2019 2021 - 2024

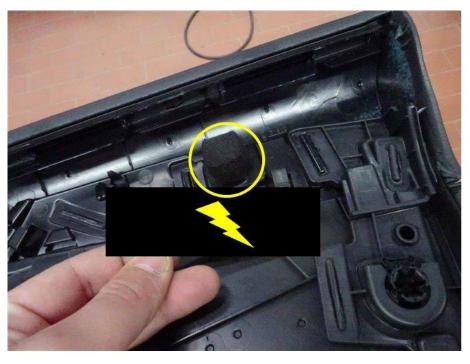
Warning: Do not apply anything to the crash element on the door trim panel or its retaining clamp on the door (Figure 2). This is strictly prohibited!

**Figure 2.** Incorrect application of fleece tape on crash element. Do not attach anything to the crash element or its retaining clamp!
