GROUP	MODEL
BOD	2022-2023MY Telluride (ON)
NUMBER	DATE
318	June 2023

TECHNICAL SERVICE BULLETIN

SUBJECT: **REAR HVAC CONTROL CLIP REPLACEMENT (SA534)**

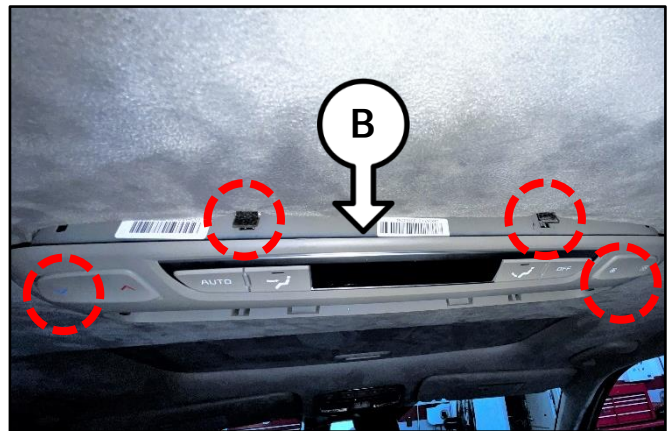
Note: The location of the four (4) mounting clips are outlined in red.

3. Using a plastic trim tool remover, lightly pry down to remove the rear HVAC control assembly (B).

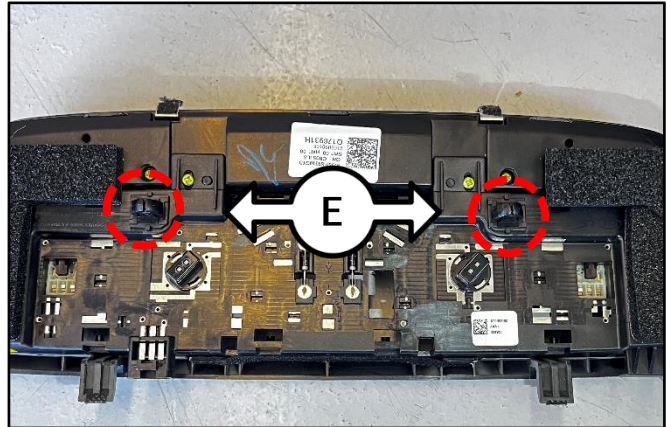
Note: When removing the HVAC control assembly, one (1) or both retaining clips may still be attached to the cross member.

- Remove the two (2) retaining clips (E).

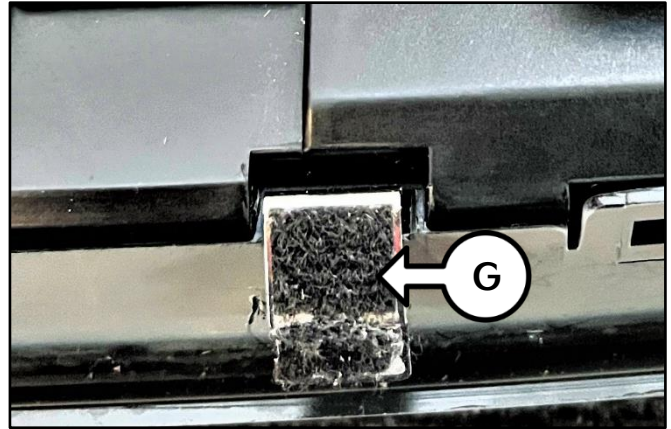
10. Verify the metal retaining clips (G) are not deformed.
