GROUP	MODEL
BOD	2023MY Telluride (ON)
NUMBER	DATE
320	June 2023

## TECHNICAL SERVICE BULLETIN

SUBJECT: **FRONT DRIVER DOOR BELT OUTSIDE  
WEATHERSTRIP INSPECTION/REPLACEMENT (SA535)**

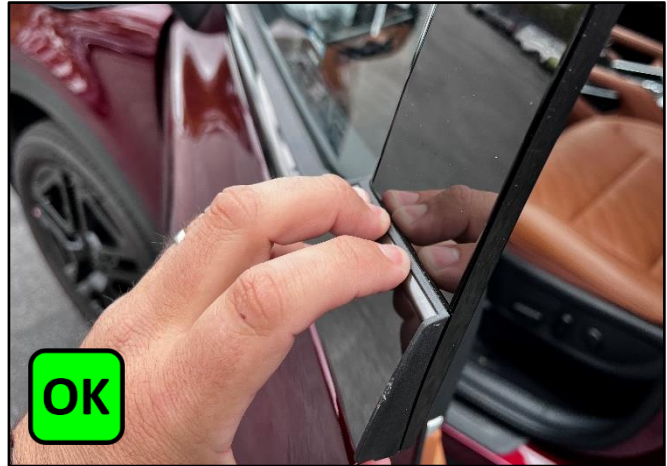
- If the outer faceplate is not detached or separating from the molding (OK), no further action required.

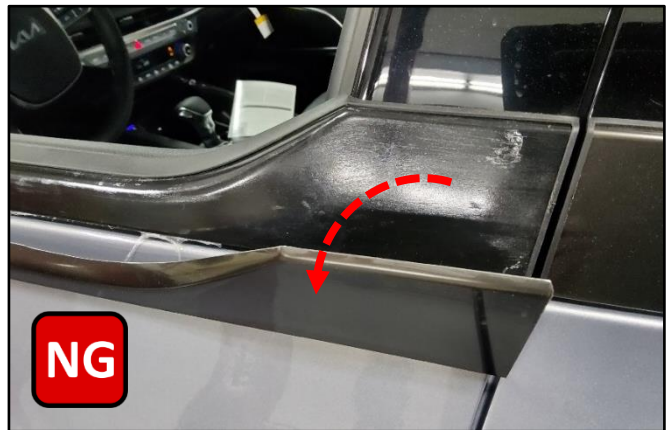
- If the outer faceplate is detached or separating from the molding (NG), proceed to the 'Replacement Procedure' below.
