Release Date	06/22/2023	<b>Technical Service Bulletin</b>	
<b>51H9 UPDATE</b> <b>Sealing Underbody – (NVLW)</b>

<b>Audi</b>

## Condition/Technical Background

<b>This Update has been proactively released to prevent the following condition(s) from occurring in the vehicle:</b>	
Criteria	Technical Background
ALL	The paint drain hole on the front left of the underbody was not sealed due to a change in components. As a result, water may enter the vehicle interior at the front left through this paint drain hole.

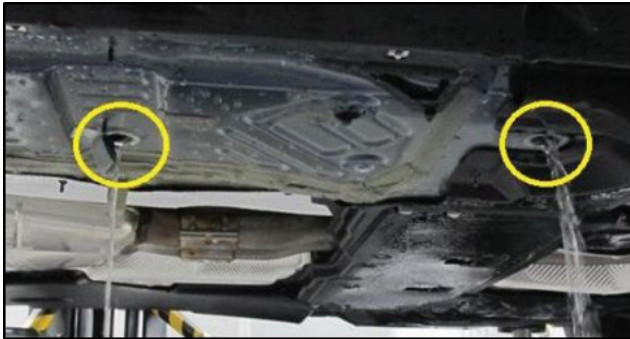
- Remove left underbody trim panel:
  - See ELSA Repair Manual: Repair manual > Body > Body Exterior > 66 Exterior Equipment > Underbody Trim Panel > Underbody Trim Panel, Removing and Installing, Front
- Remove plugs on underbody (left-side) using a suitable tool, such as a scraper.
- If no water escapes, visually inspect and feel the holes to determine whether there is water or moisture inside them.
- If you do not identify moisture in the underbody/side member, only step 1 must be performed.
- If you identify moisture in the underbody, continue with step 2.
