TECHNICAL SERVICE BULLETIN

Lack Of Audio And/Or Water Leak In Rear Of Vehicle And/Or Spare Tire Area

23-2181

Ford 2020-2023 Explorer
Lincoln 2020-2023 Aviator

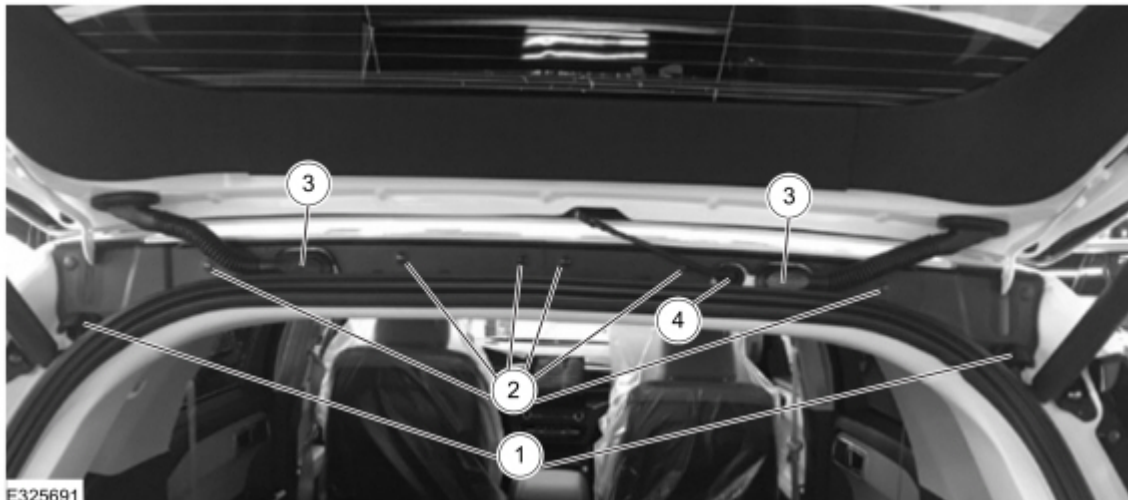
Figure 1

- (1). Power liftgate grommet (if equipped). If not properly seated, replace the affected power liftgate strut. (Figure 1 Callout 1, Figure 2)
- (2). Margin seal and margin seal pushpins. (Figure 1 Callout 2, Figure 3 Callout 2)
- (3). Electrical wiring grommet. (Figure 1 Callout 3, Figure 3 Callout 3)
- (4). Rear washer hose. (Figure 1 Callout 4, Figure 3 Callout 4)

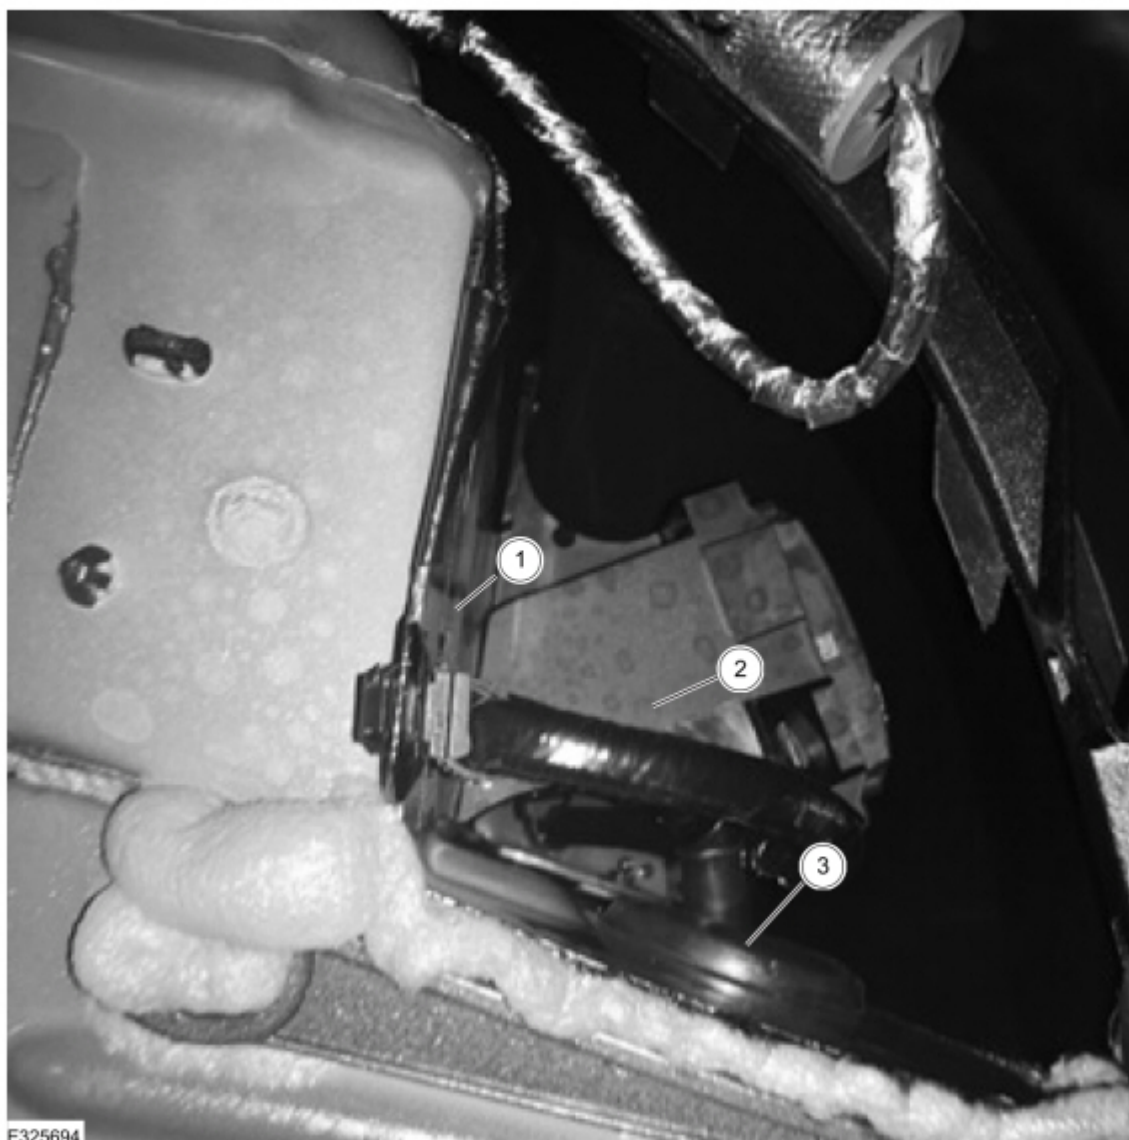
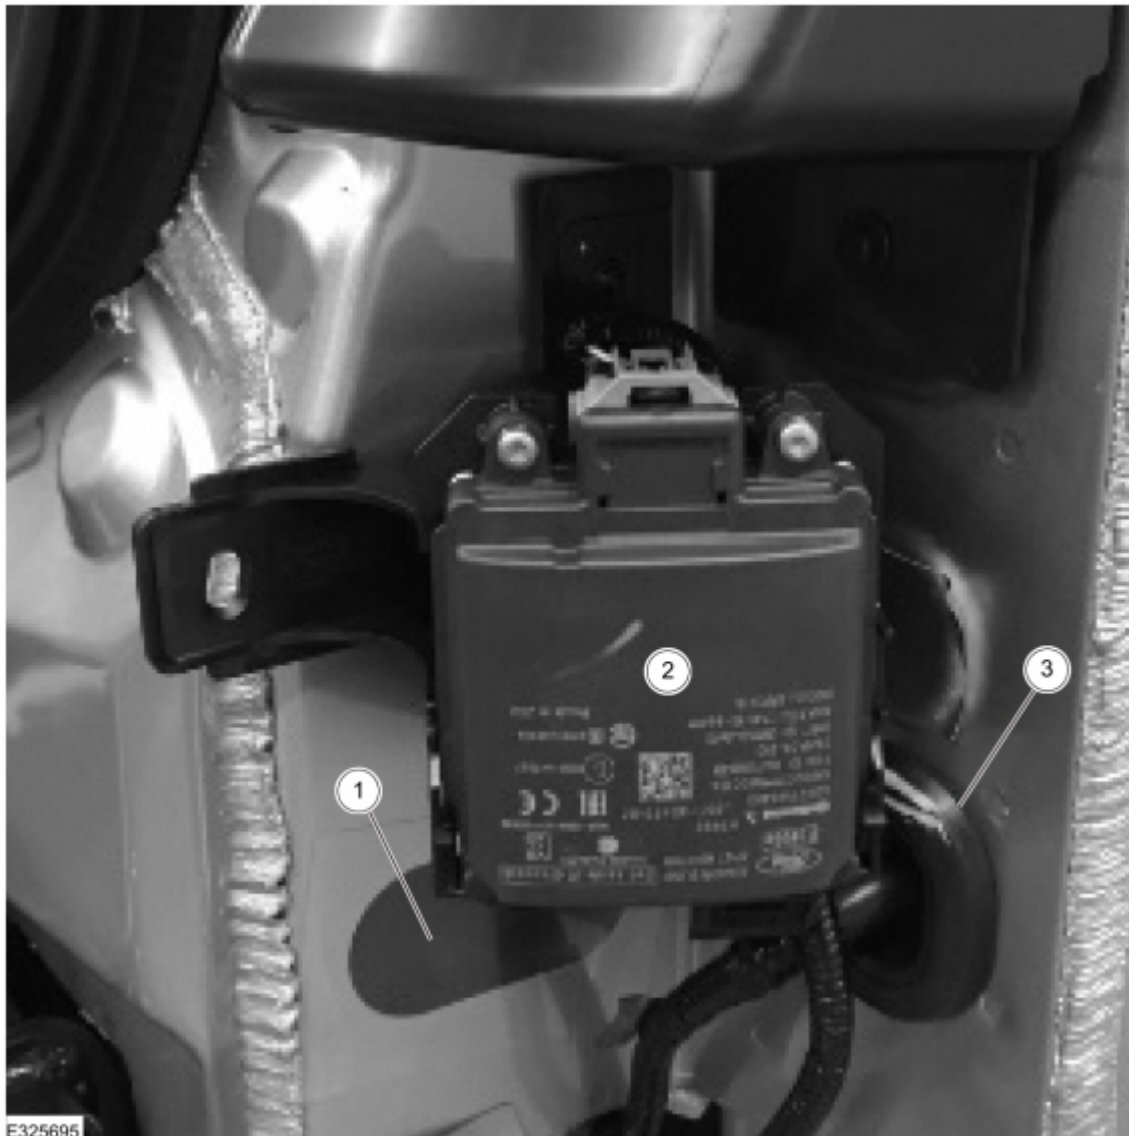
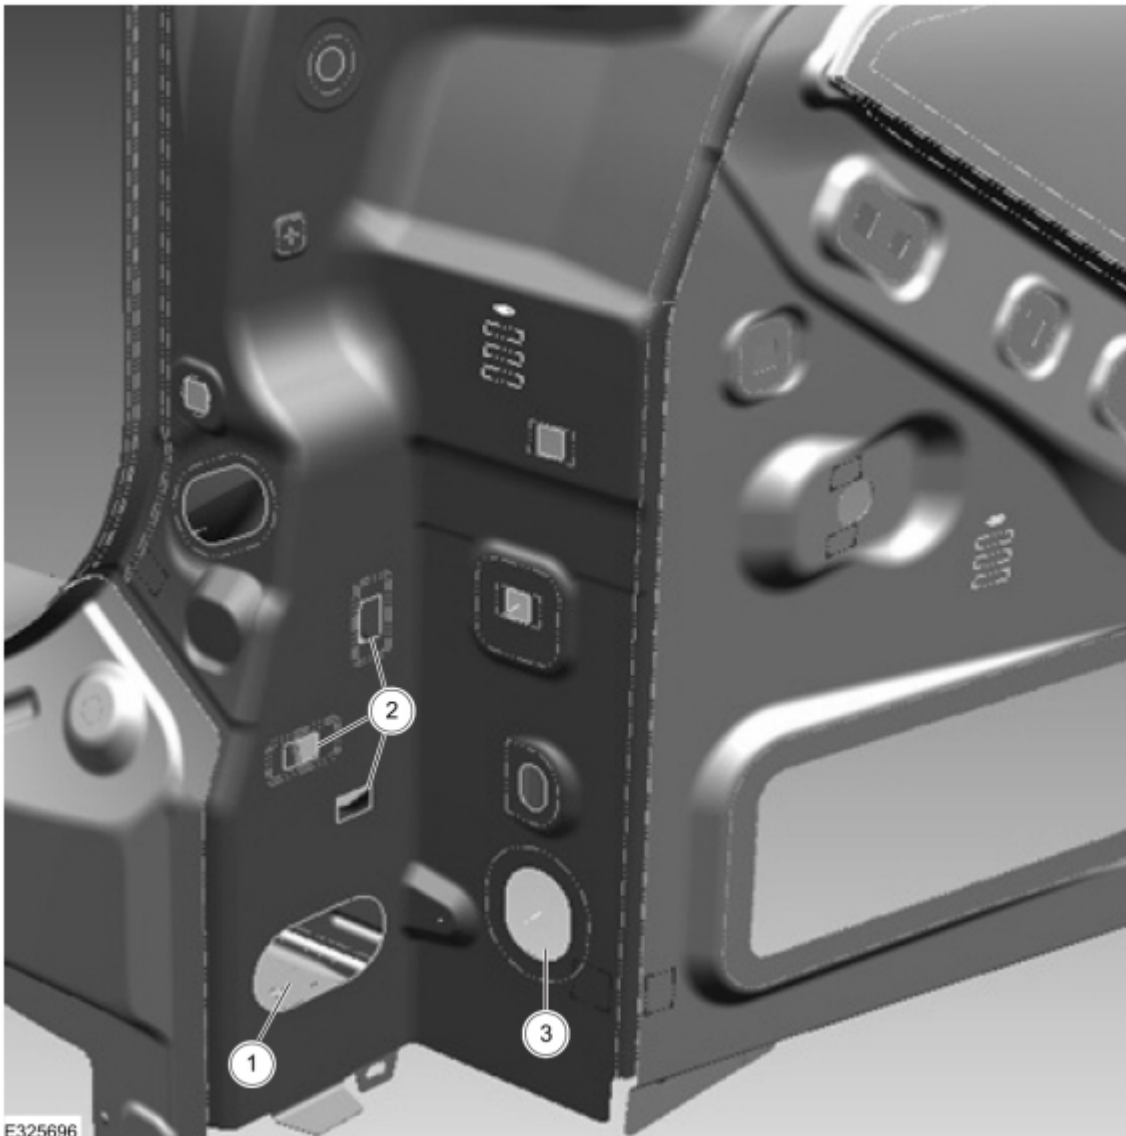
3. If a water leak is present on the right side of the vehicle, replace the audio control module (ACM).
 - (1). Reinstall the rain shield (if equipped) on the new ACM. The rain shield, if present, is attached to the ACM chassis using a pushpin which can be reused.
4. Raise the vehicle on a hoist.
5. Inspect the right side rear corner area under the rear bumper cover for the following loose, disconnected, or missing items:
 - (1). Visually inspect for delete tape completely covering the body hole. (Figures 4-6 Callout 1) If the tape is damaged or leaking, replace with a rubber plug.
 - (2). Press down on the blind spot information system (BLIS) module to make sure it is fully seated into the body. (Figures 4-6 Callout 2)
 - (3). Visually inspect the BLIS module wire harness grommet is seated. (Figures 4-6 Callout 3)

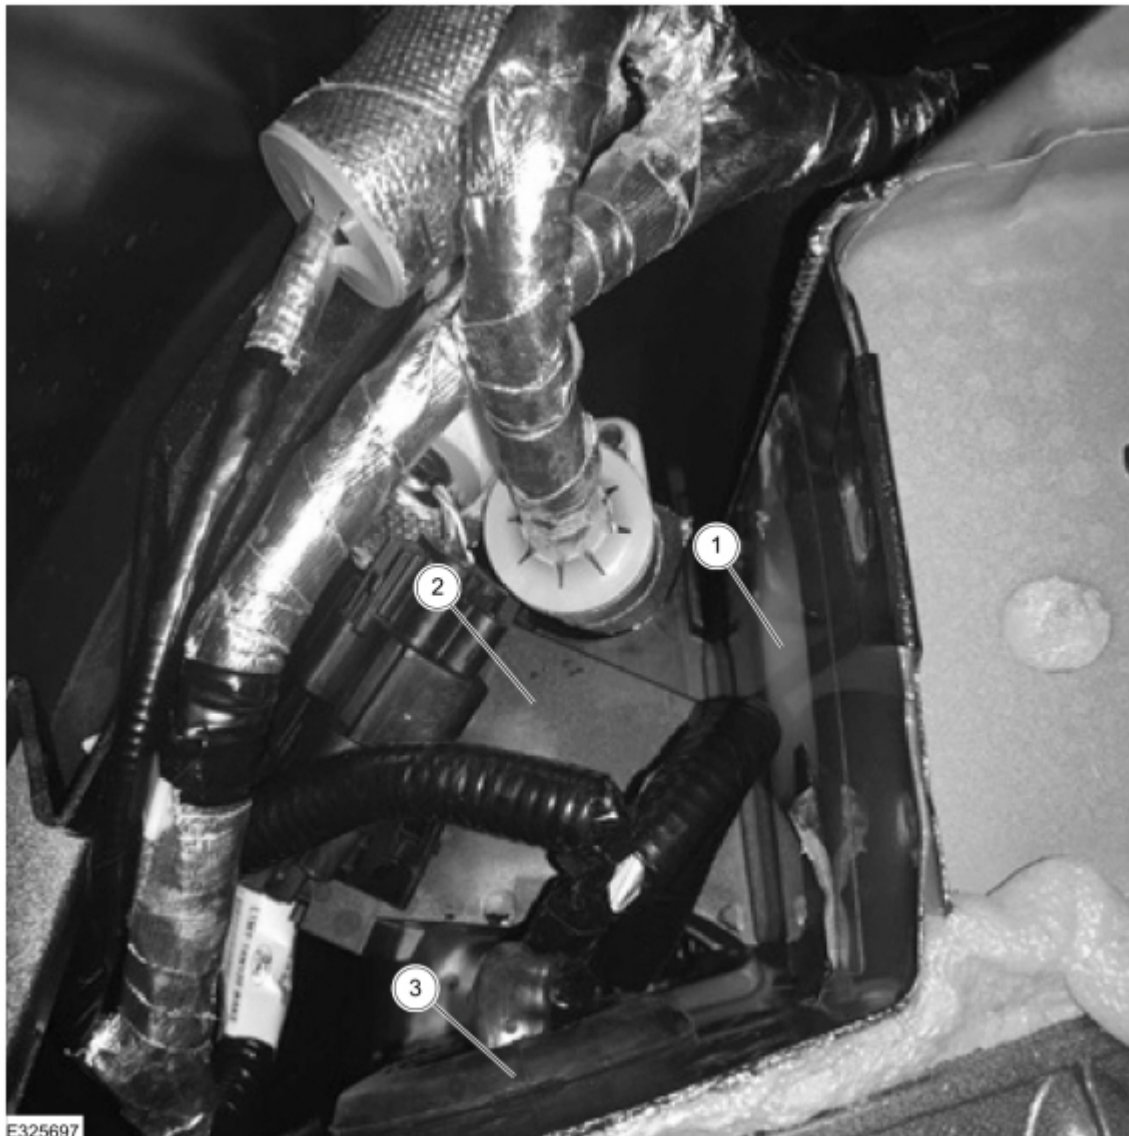
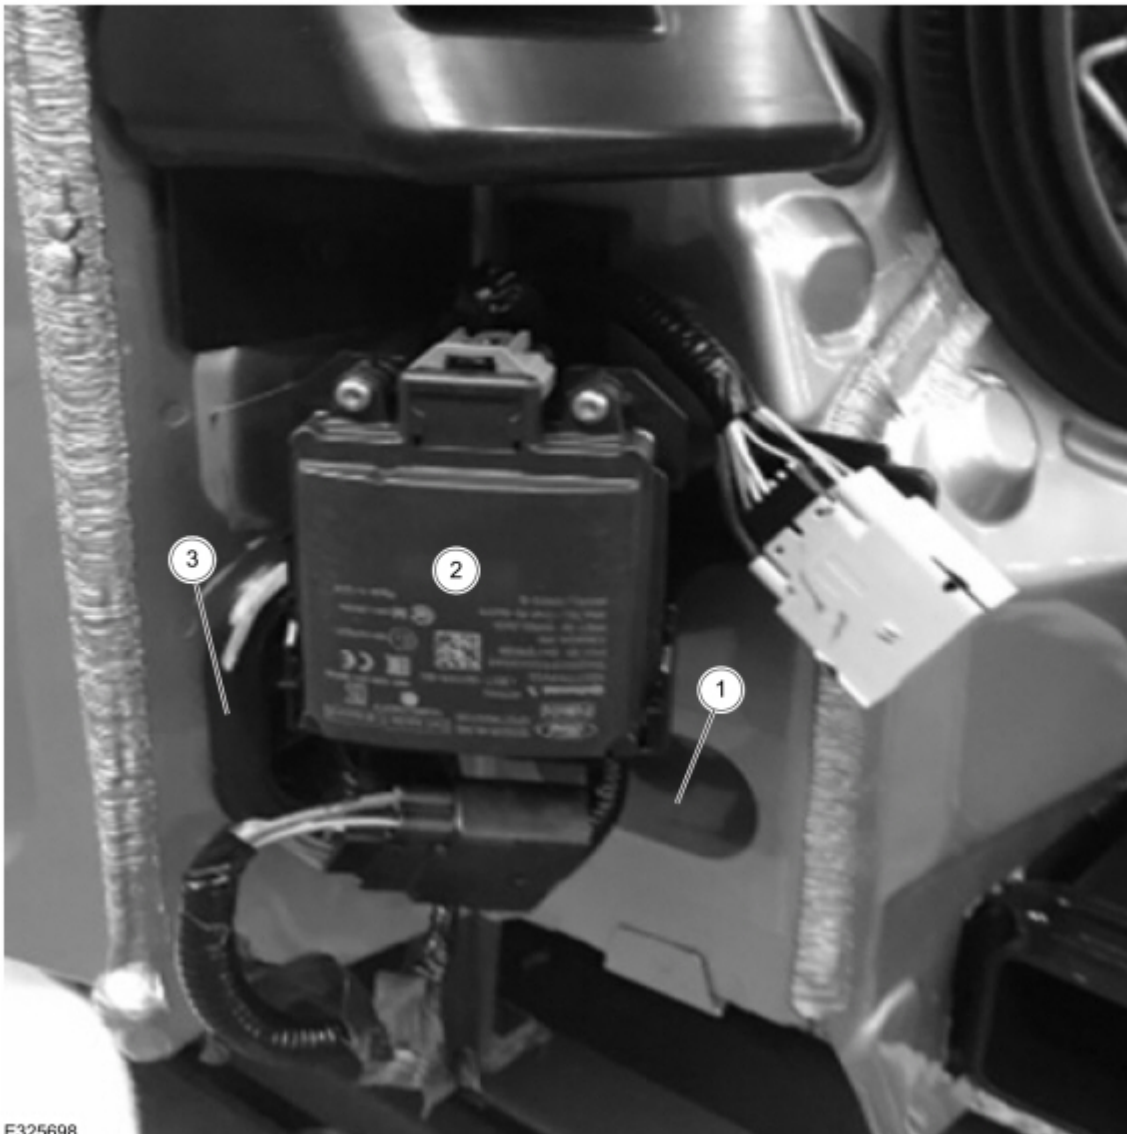
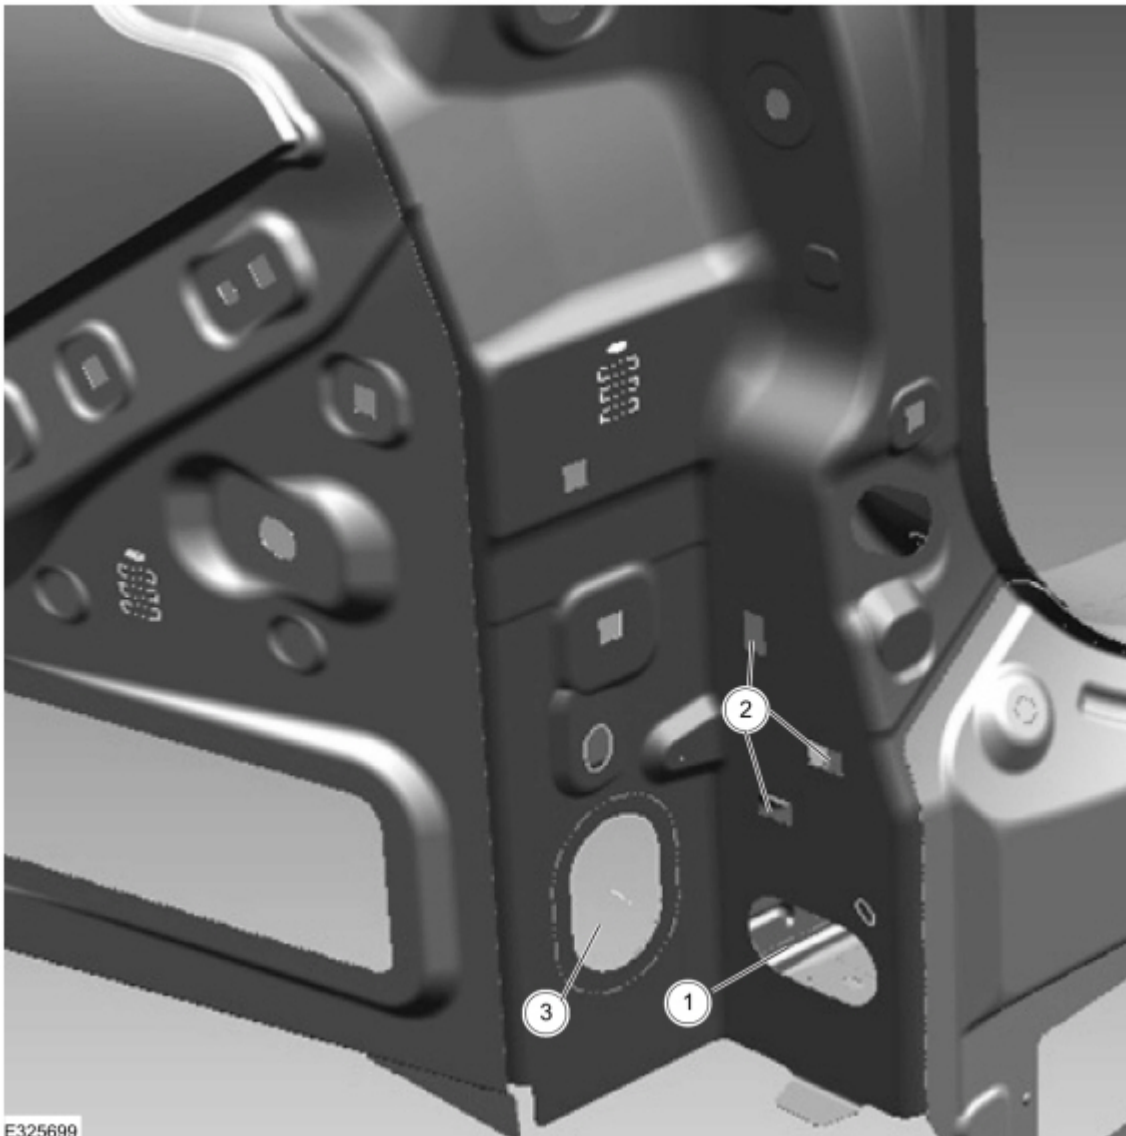
- (1). Visually inspect for delete tape completely covering the body hole. (Figures 7-9 Callout 1) If the tape is damaged or leaking, replace with a rubber plug.
- (2). Press down on the BLIS module to make sure it is fully seated into the body. (Figures 7-9 Callout 2)
- (3). Visually inspect the BLIS module wire harness grommet is seated. (Figures 7-9 Callout 3)

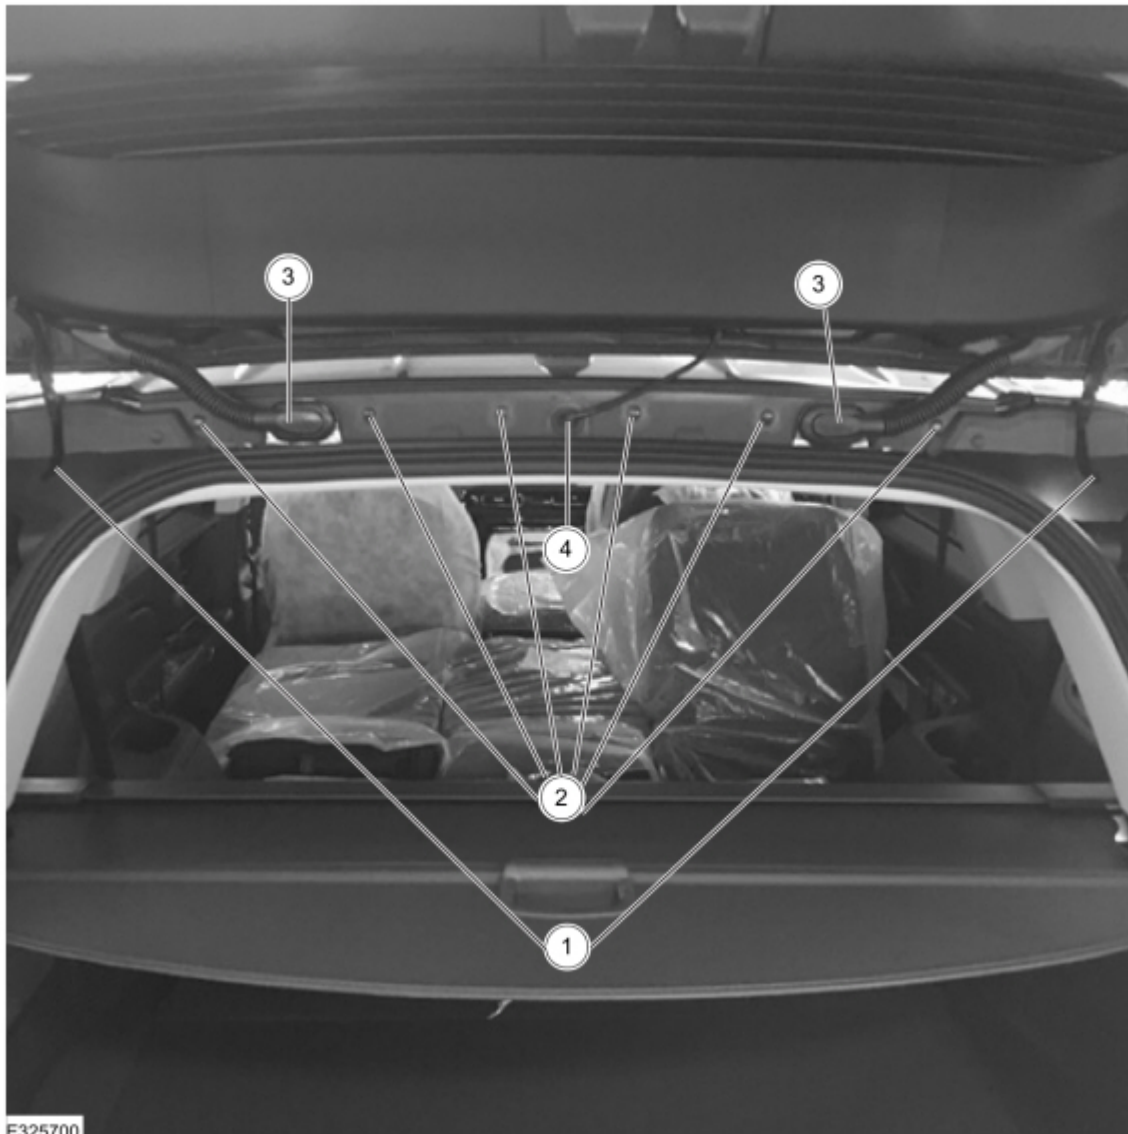
Figure 10

1. Open the rear liftgate.
2. Inspect and make sure the following components are correctly seated by pushing:
 - (1). Power liftgate grommet. If not properly seated, replace the affected power liftgate strut. (Figure 10 Callout 1, Figure 11)
 - (2). Margin seal and margin seal pushpins. (Figure 10 Callout 2)
 - (3). Electrical wiring grommet. (Figure 10 Callout 3)
 - (4). Rear washer hose. (Figure 10 Callout 4)

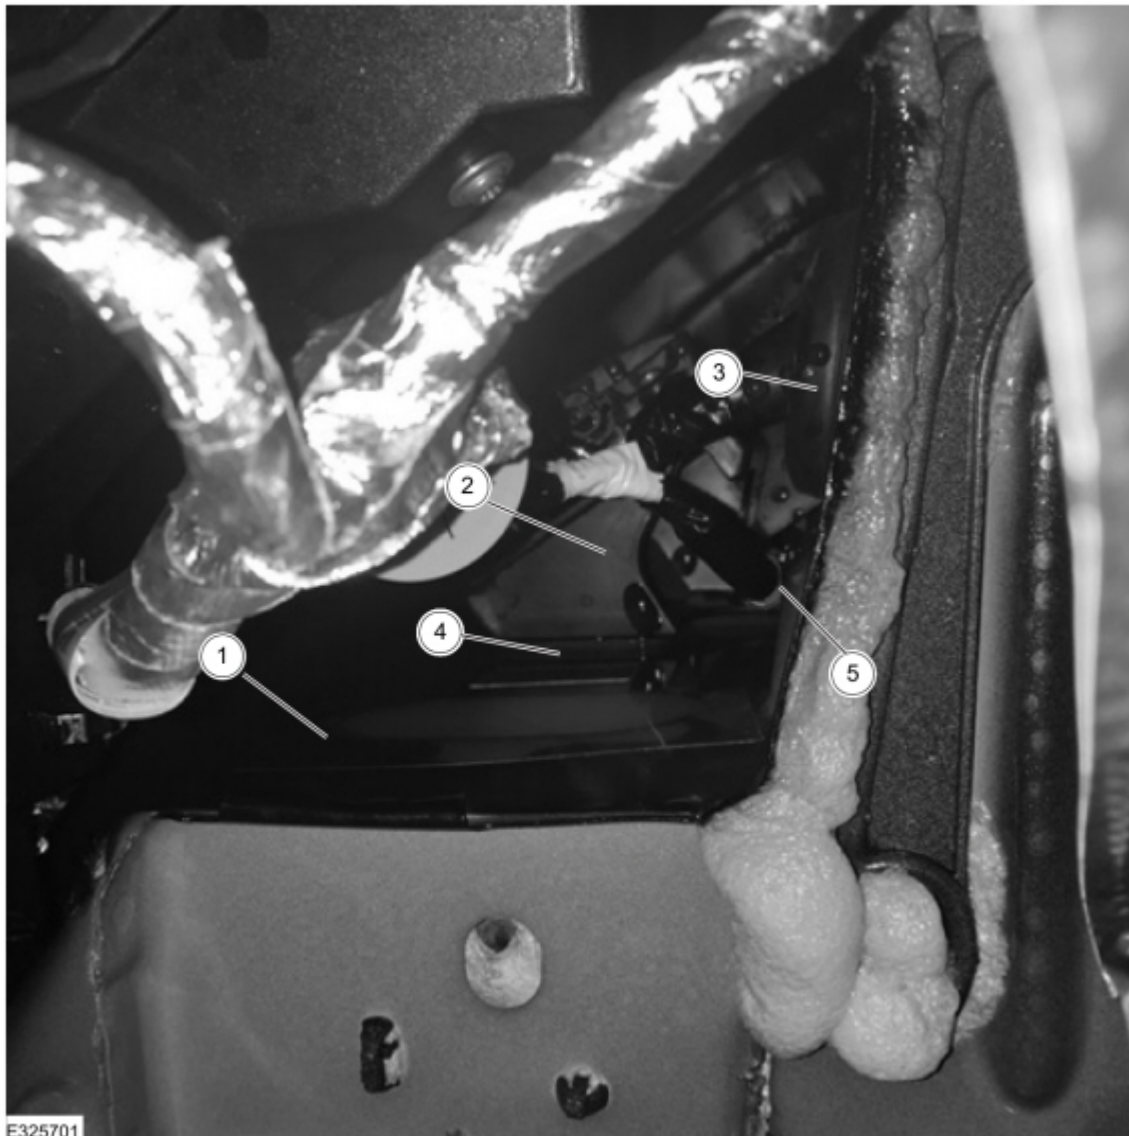
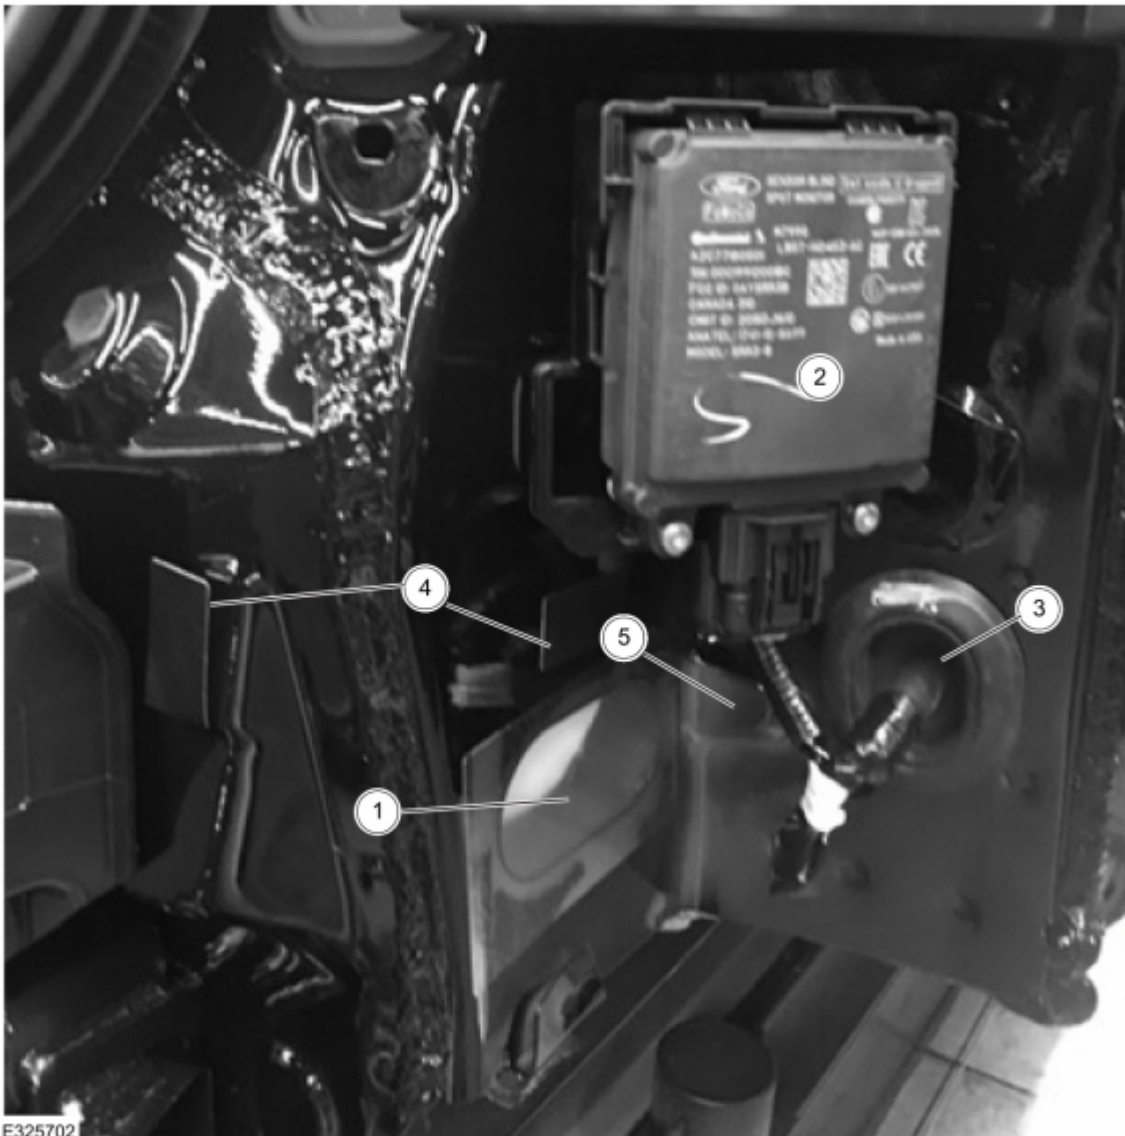
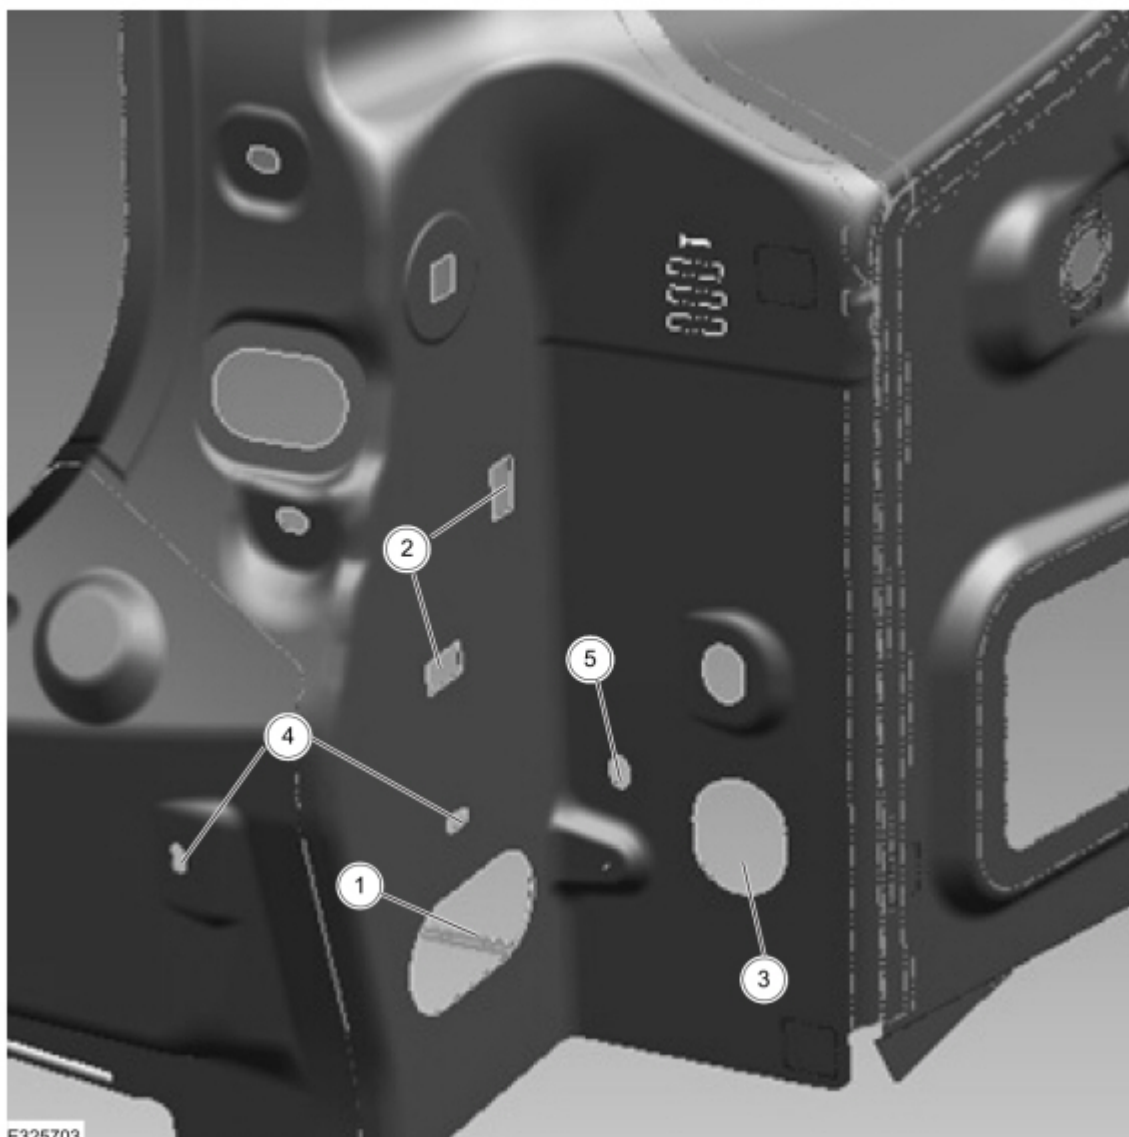
5. Inspect the right side rear corner area under the rear bumper cover for the following loose, disconnected or missing items:

(1). Visually inspect for delete tape completely covering the body hole. (Figures 12-14 Callout 1) If the tape is damaged or leaking, replace with a rubber plug.

(2). Press down on the BLIS module to make sure it is fully seated into the body. (Figures 12-14 Callout 2)

(3). Visually inspect the BLIS module wire harness grommet is seated. (Figures 12-14 Callout 3)

(4). Make sure the wire harness grommet for the phone as a key feature is seated or the delete tape is completely covering the body hole. (Figures 12-14 Callout 4) If the tape is damaged or leaking, replace with a rubber plug.

(5). BLIS grommet to module wire. (Figures 12-14 Callout 5)

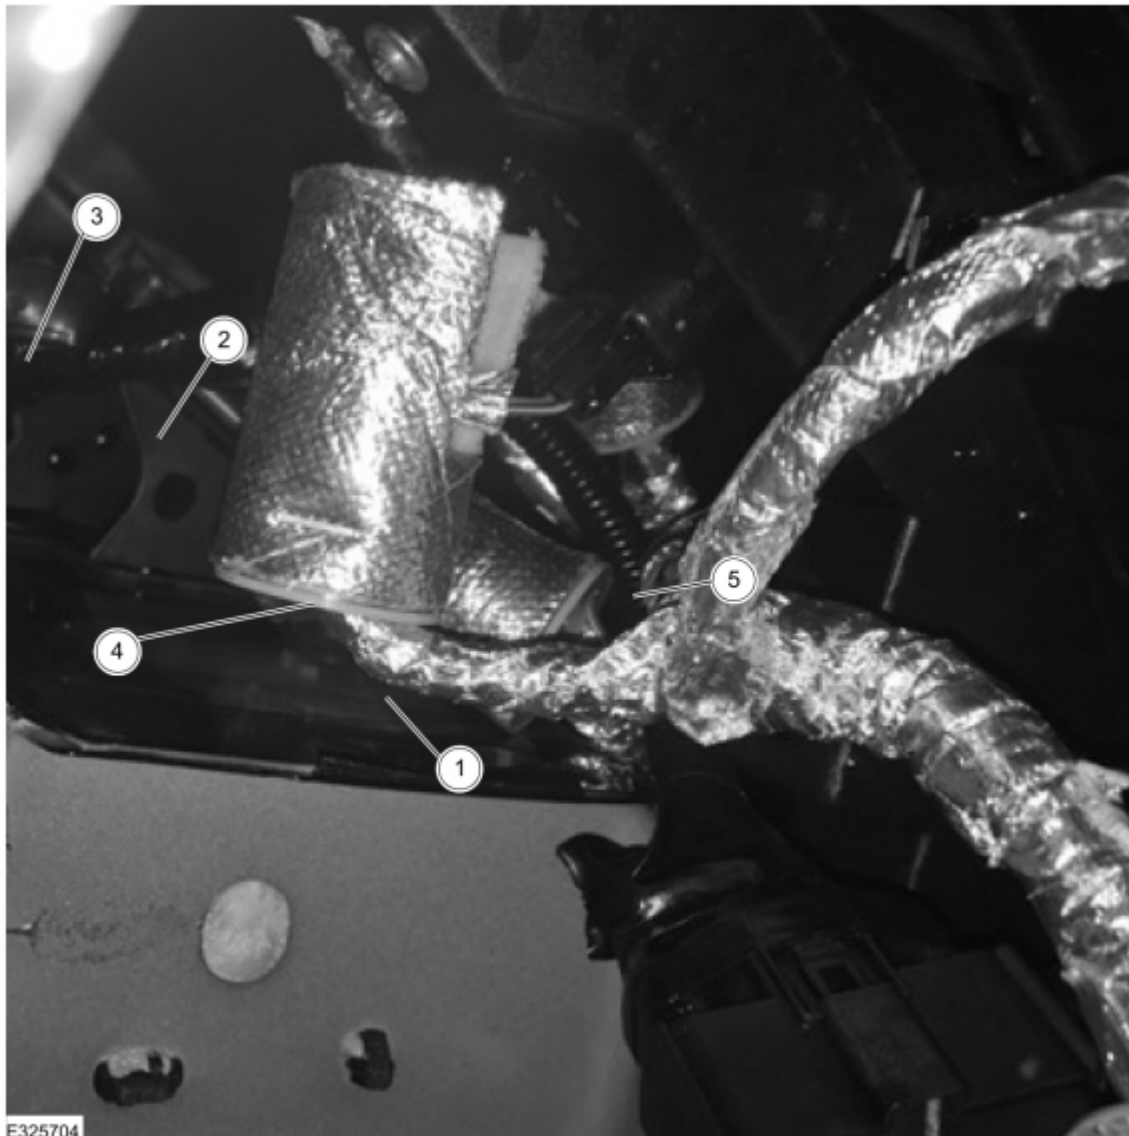
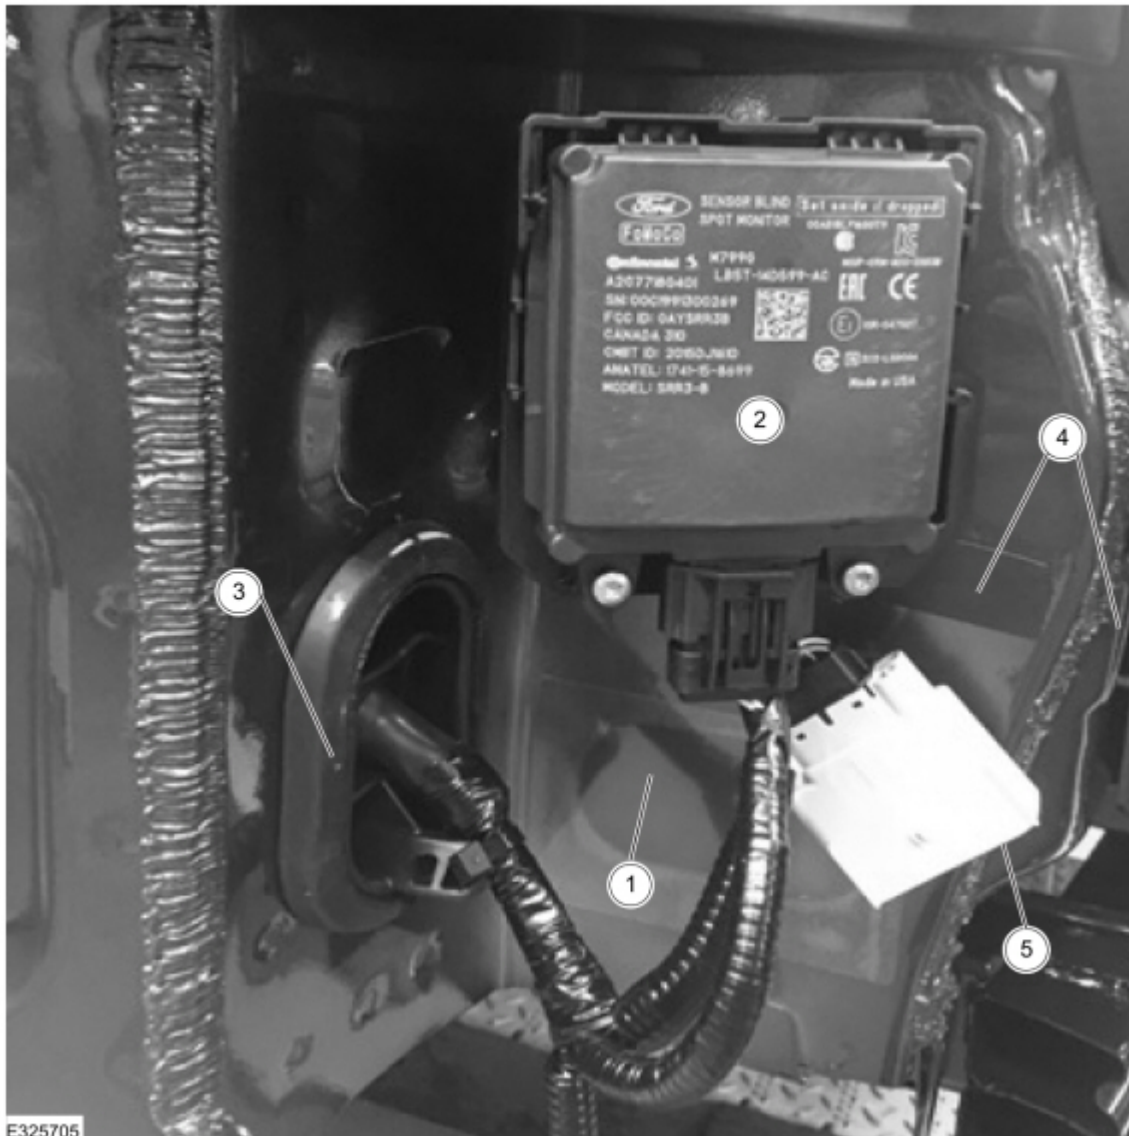
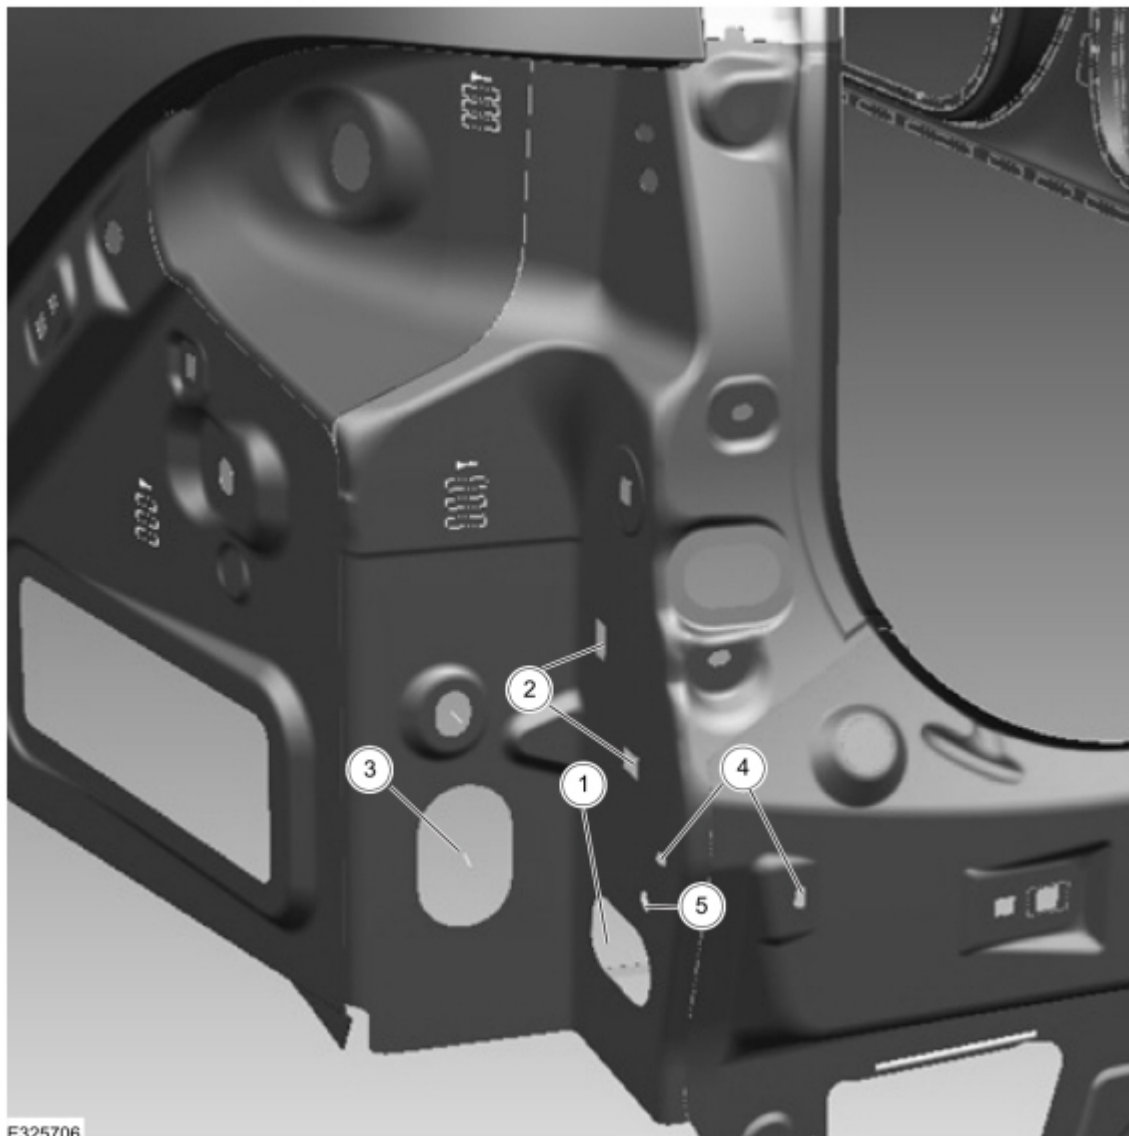
6. Inspect the left side rear corner area under the rear bumper cover for the following loose, disconnected or missing items:

- (1). Visually inspect for delete tape completely covering the body hole. (Figures 15-17 Callout 1) If the tape is damaged or leaking, replace with a rubber plug.
- (2). Press down on the BLIS module to make it is fully seated into the body. (Figures 15-17 Callout 2)
- (3). Visually inspect the BLIS module wire harness grommet is seated. (Figures 15-17 Callout 3)
- (4). Make sure the wire harness grommet for the phone as a key feature is seated or the delete tape is completely covering the body hole. (Figures 15-17 Callout 4) If the tape is damaged or leaking, replace with a rubber plug.
- (5). Rear fascia wire. (Figures 15-17 Callout 5)
