**TECHNICAL SERVICE BULLETIN****23-2200****Soft Top Roof – Rear Quarter Window(s) Not Staying Attached To The Rear Window**

21 June 2023

Ford 2021-2023 Bronco

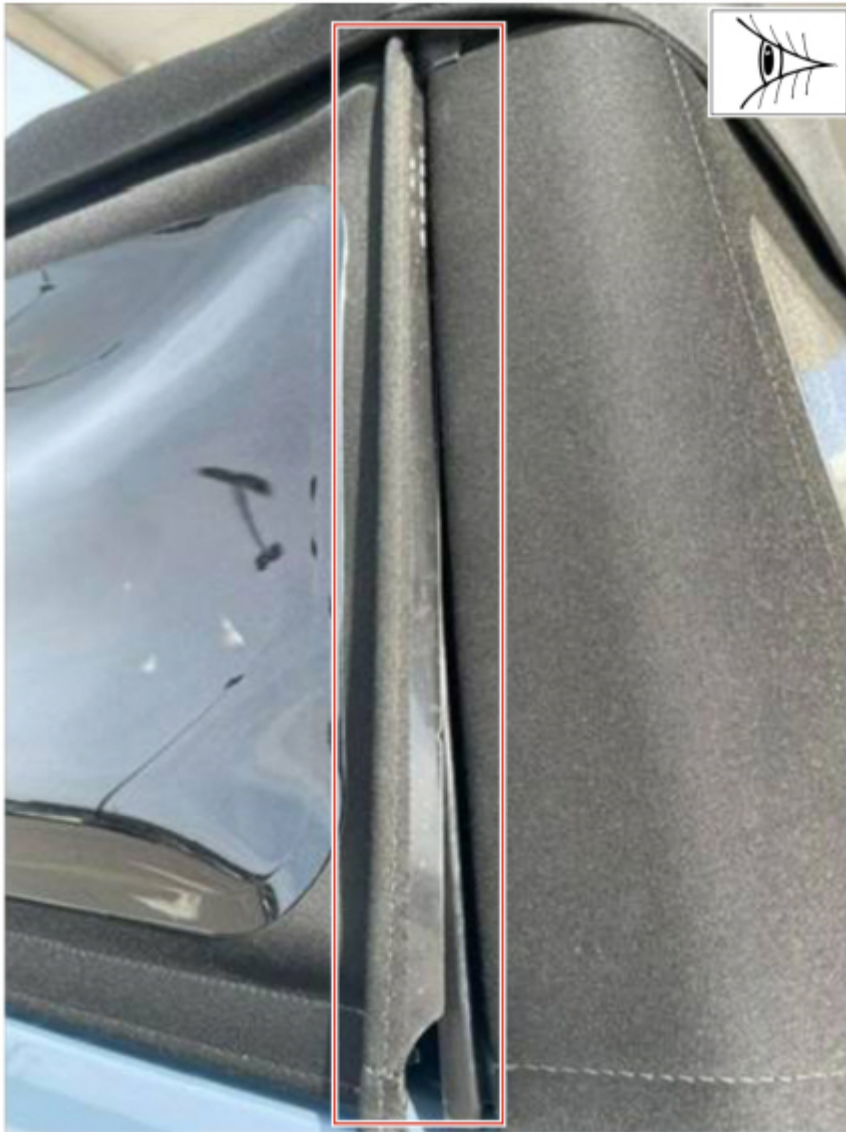
1. Are the rear quarter window(s) not staying attached to the rear window channels as shown in Figure 1?
 - (1). Yes – proceed to Step 2.
 - (2). No – this article does not apply.

Figure 1 – Left rear shown, right rear similar.

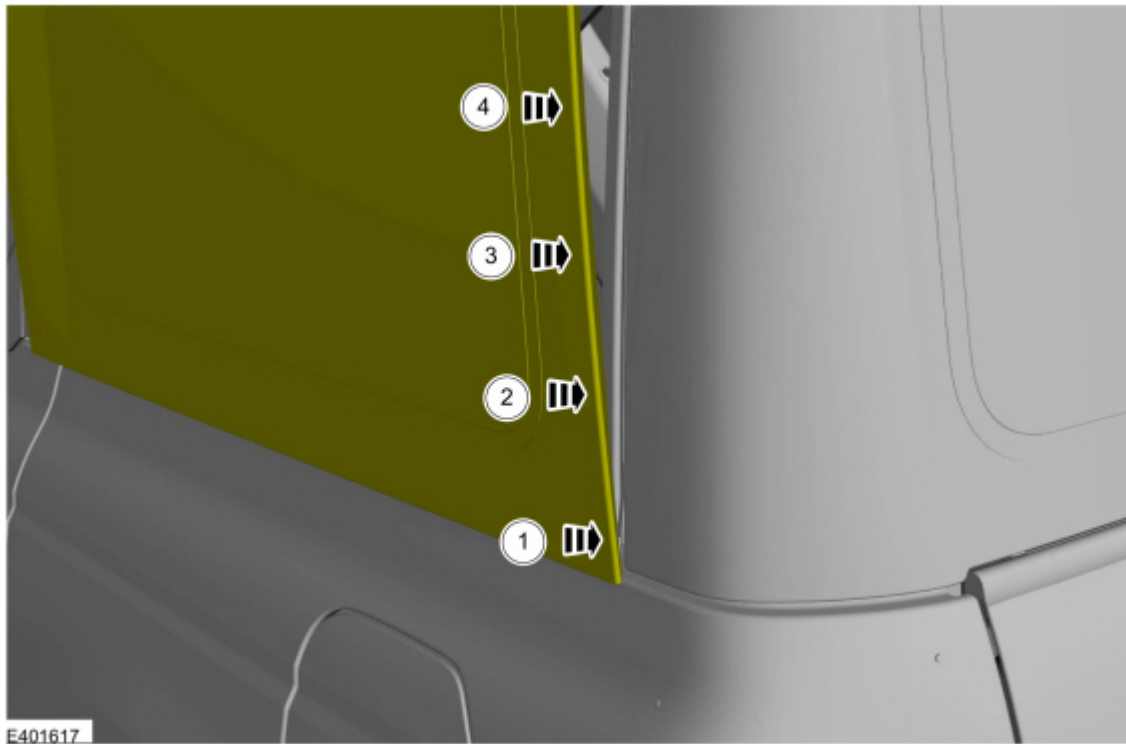
Figure 2 – Left side shown, right side similar.

2. Manually install the quarter window(s) into the rear window retention channels. To be sure proper window alignment is achieved, perform the installation starting at the bottom and finishing at the top. (Figure 2)

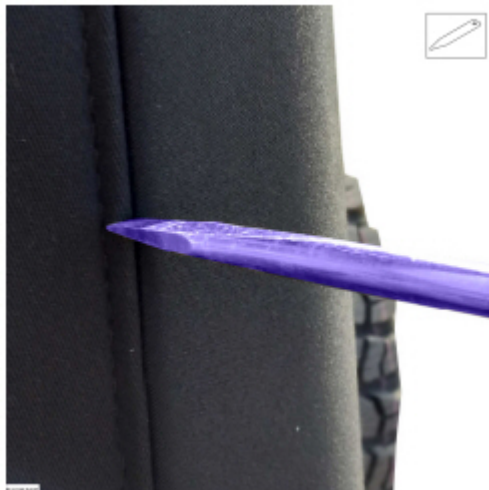
Figure 3 – Left side shown, right side similar.

3. Use a non-marring trim tool to push the rear quarter window(s) completely into the rear window retention channel(s). Do not drag the tool on the window while applying pressure. Do not damage the fabric during this step. Perform this step on the entire length of the rear quarter window(s) until they are fully seated in the rear window retention channel(s). When fully installed, the rear quarter window ridge (fabric) should sit sub-flush to the rear window just behind it. (Figure 3)
