# Technical Service Bulletin

## 01 Engine Crankcase breather Whistling Noise and DTC P227900 warning light ON

01 23 59 2069351/3 June 28, 2023. Supersedes Technical Service Bulletin Group 01 number 23-44 dated February 13, 2023, for reasons listed below.

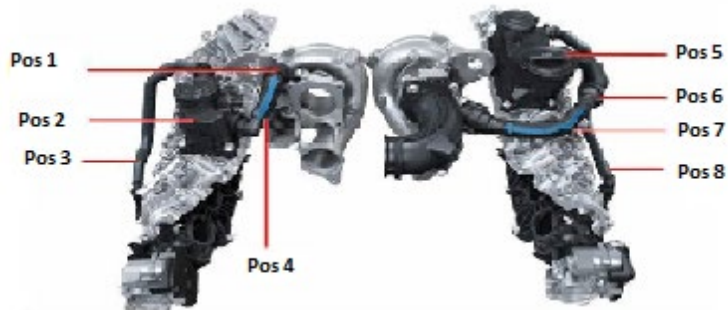
Item 1: Non-return valve

Item 2: Oil separator for bank 1

Item 3: Part load breather line

**Item 4: Full load breather line for bank 1 (Replacement required)**

Item 5: Oil separator for bank 2

Item 6: Non-return valve

Item 7: Full load breather line

Item 8: Part load breather line

In this case, replace the full load breather line for cylinder bank 1.

1. Do not replace the oil separator for bank 1 or bank 2 or the part load breather lines.
2. Please refer to image of the crankcase breather from the Self Study Program 920493 as a guide.
