Technical Service Bulletin

48 Squeaking noises from rubber boot of the intermediate steering shaft

48 23 43 2055733/4 June 29, 2023. Supersedes Technical Service Bulletin Group 48 number 22-31 dated April 28, 2022, for reasons listed below.

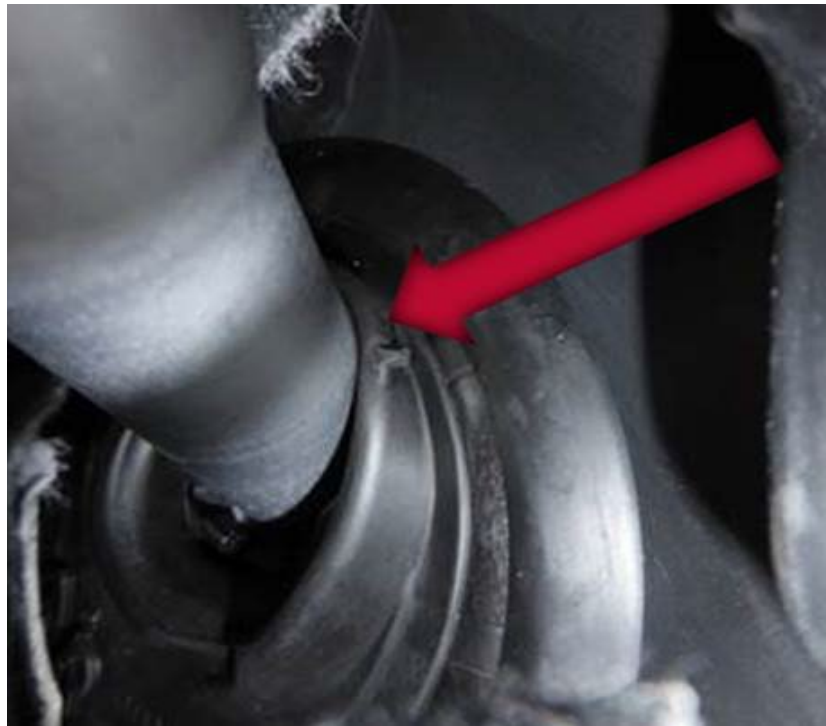
- The noise comes from the sealing sleeve/steering column opening on the bulkhead.
- The steering column adjustment is set in the lower range.
- The steering shaft rests on the cone of the sealing sleeve (Figure 1).

Figure 1. Steering shaft rests on the sealing sleeve (also known as sealing lip).

Incorrect positioning of the sealing sleeve (lip) in the bulkhead in connection with unfavorable tolerances of the components.

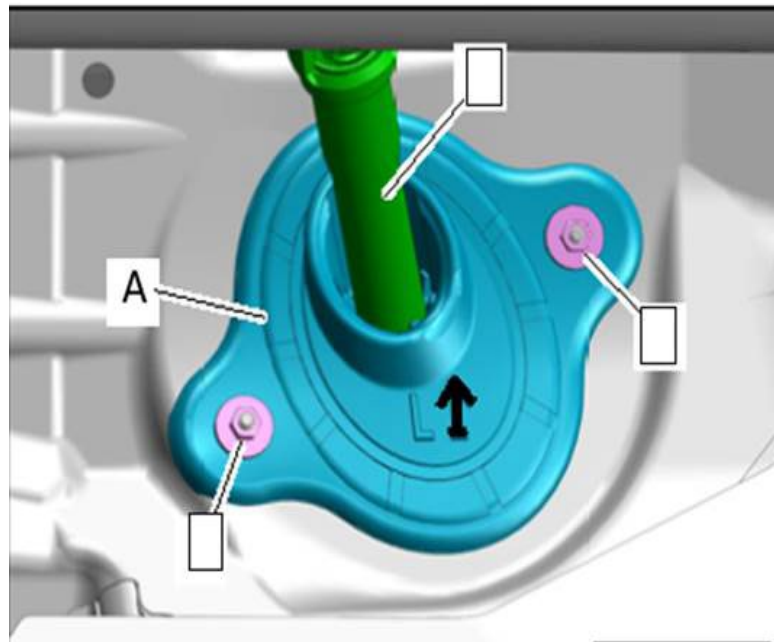
Figure 2. Sealing sleeve (also known as sealing lip).

1. Disconnect the intermediate steering shaft from the steering column.
2. Loosen the rubber sealing sleeve (A) and push it upwards as far as possible and retighten (Figure 2).

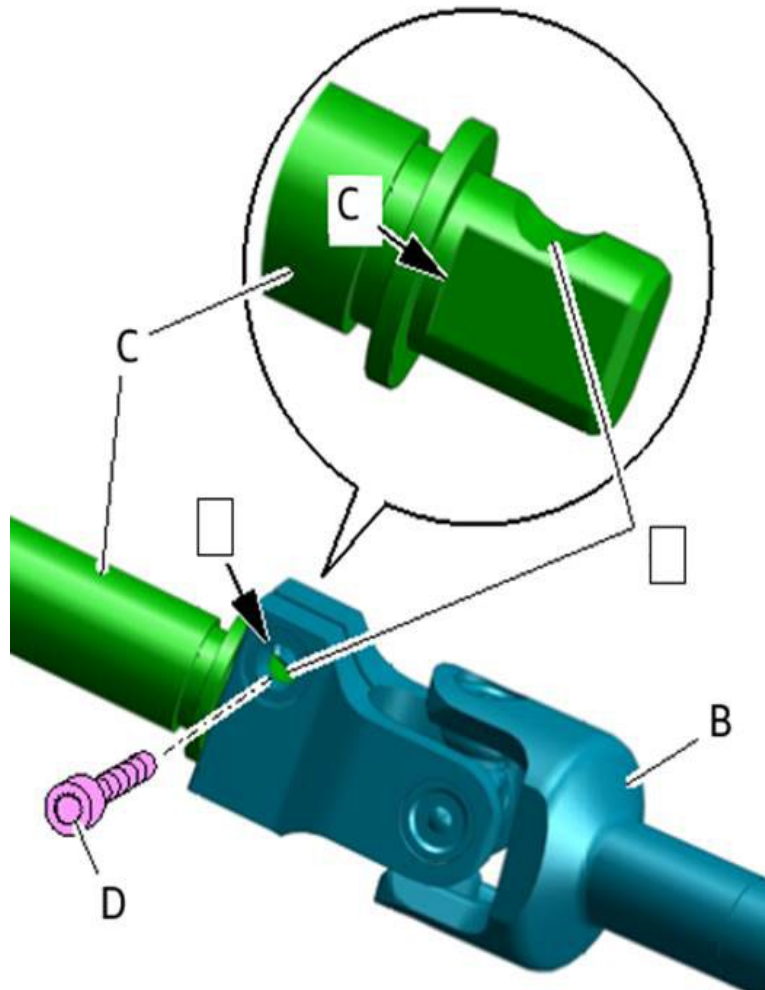
Figure 3. Steering column shaft and intermediate shaft connection.

3. Reinstall the steering intermediate shaft (B) to the steering column (C) and tighten with new bolts (D) (Figure 3).
