Technical Service Bulletin

91 No diagnostics communication to the telematics control module; DTC U142100

91 23 08 2056076/18 June 29, 2023. Supersedes Technical Service Bulletin Group 91 number 23-04 dated June 12, 2023, for reasons listed below.

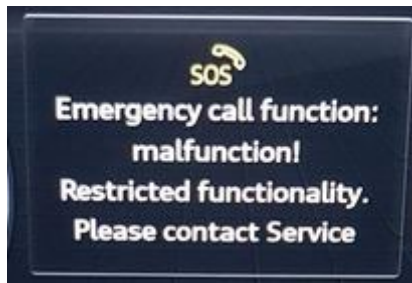
- An SOS Warning might be displayed in the instrument cluster (Figure 1).

Figure 1. Emergency call malfunction warning.

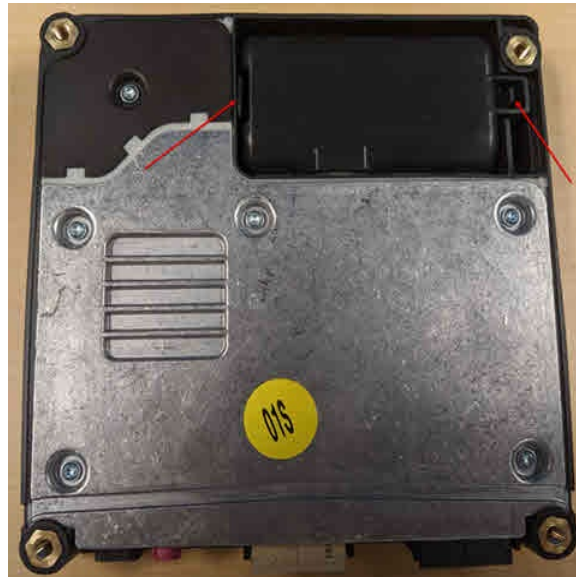
Figure 2. Backup battery compartment location.

1. Remove and unplug the telematics control module, J949 (address word 0075) according to the Elsa Repair Manual.
2. Open the battery compartment of the telematics control module, J949 (address word 0075), and disconnect the backup battery (Figures 2 - 3).

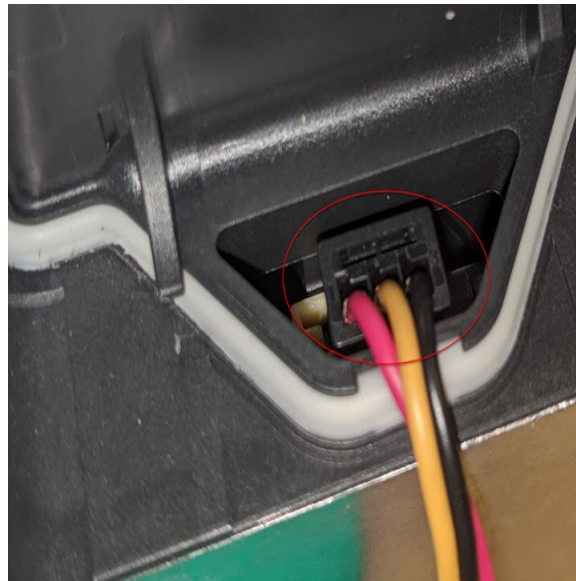
Figure 3. Backup battery connector (no release mechanism).
