Technical Service Bulletin

GROUF)	NUMBER
CAI	MPAIGN	23-01-052H
DATE		MODEL(S)
JUN	NE, 2023	TUCSON HYBRID (NX4 HEV) & SANTA FE HYBRID (TM HEV)

COOLING SYSTEM CIRCUIT DEBRIS DISCHARGE AND COOLANT CHANGE (SERVICE CAMPAIGN T9L)

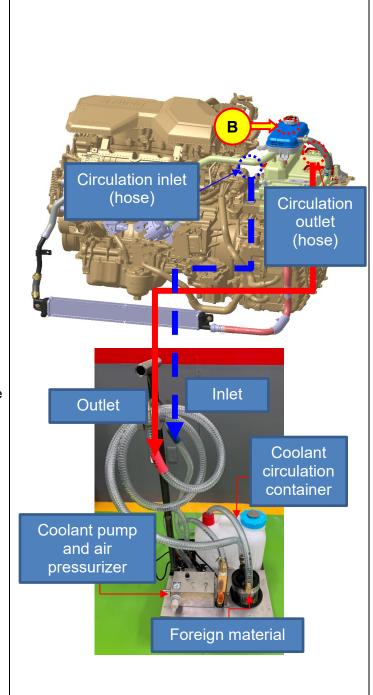
- Coolant concentration (coolant: diluted water): 6:4
- Coolant injection: 1.9 liters (coolant + diluted water)
- If there is a large amount of low-conductivity coolant (blue) remaining inside the vehicle, the color of the newly injected pink coolant may change to murky. In this case, drain all coolant inside the vehicle and re-inject normal (pink) coolant.

- 12. Confirm that all coolant hoses are properly installed and inject coolant (LLC-10) into vehicle.
 - Reconnect the Service Interlock Connector (A) -Use the GDS under Actuation Test to manually turn on EWP to aid in air bleeding during coolant injection.
