Technical Service Bulletin

91 SOS Emergency call function deactivated message in the cluster, DTC U153E00 is stored in the telematics module

91 23 09 2055945/13 June 29, 2023. Supersedes Technical Service Bulletin Group 91 number 22-31 dated September 23, 2022, for reasons listed below.

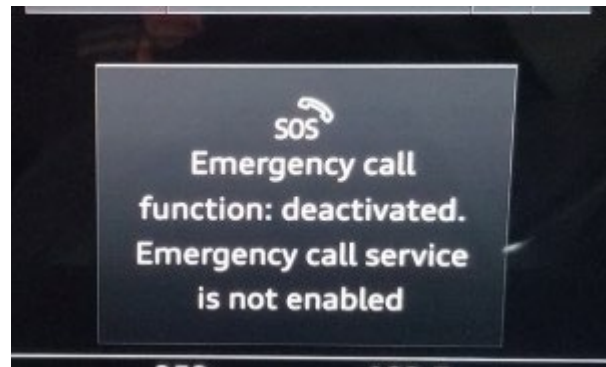
- The warning message “SOS Emergency call function deactivated” is seen in the instrument cluster (Figure 1 or 2).

Figure 1. SOS warning in the instrument cluster.

- **DTC U153E00:** Emergency call module and communication unit Recognition in mobile communications network not possible.

This DTC will trigger the warning message in the cluster immediately when the signal to the MNO (AT&T) is lost. However, depending on how long of a period the signal loss occurs, the vehicle may require a full sleep cycle in order for the DTC to change to sporadic. The warning message in the cluster will only turn off when the DTC changes to sporadic.

1. Follow all instructions in TSB 2011732: *00 Software Version Management (SVM), operating instructions*.
2. Update the telematics control module, J949 (address word 0075) using the SVM action code as listed in the table below, if necessary:

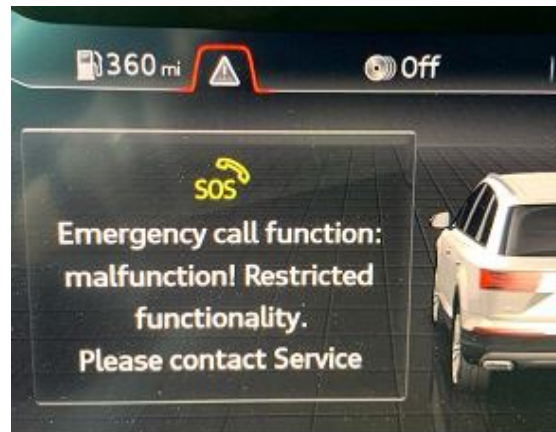
Figure 2. SOS warning in the instrument cluster.
