# E279 - Paccar MX13/MX11 Engine MY17 Software Update

E279

6/1/2023

Peterbilt - Certain chassis equipped with a model year 2017 Paccar MX-11 or MX-13 engine.

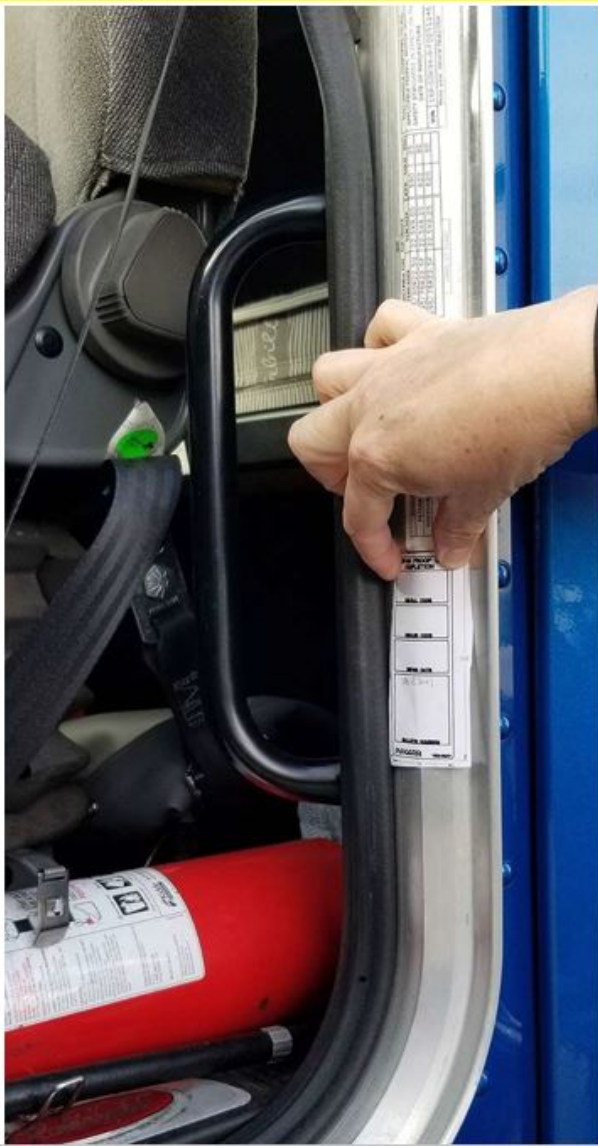
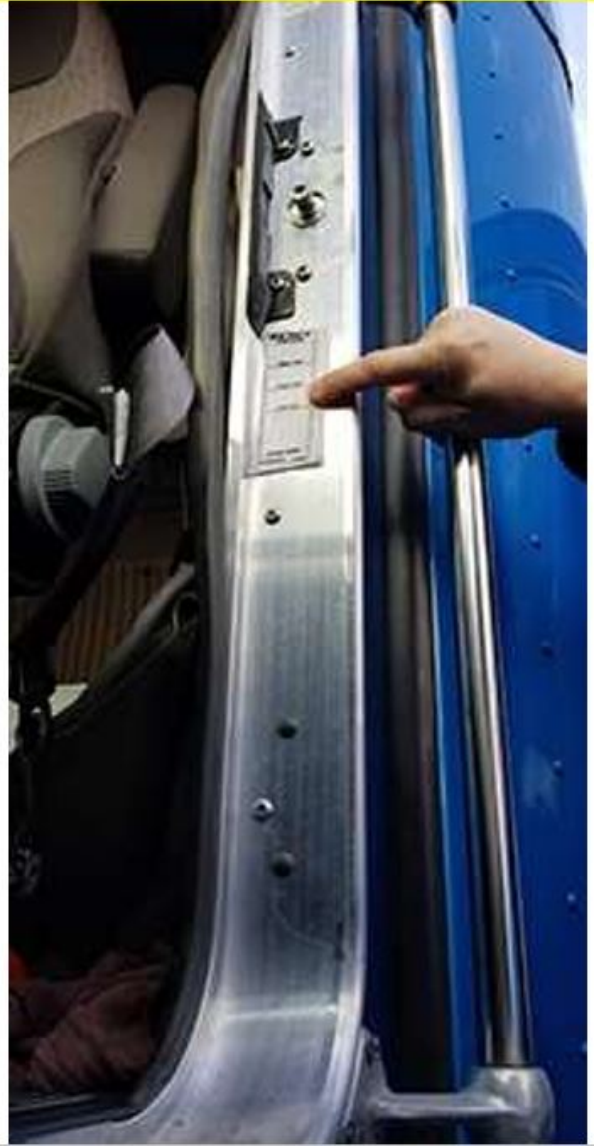
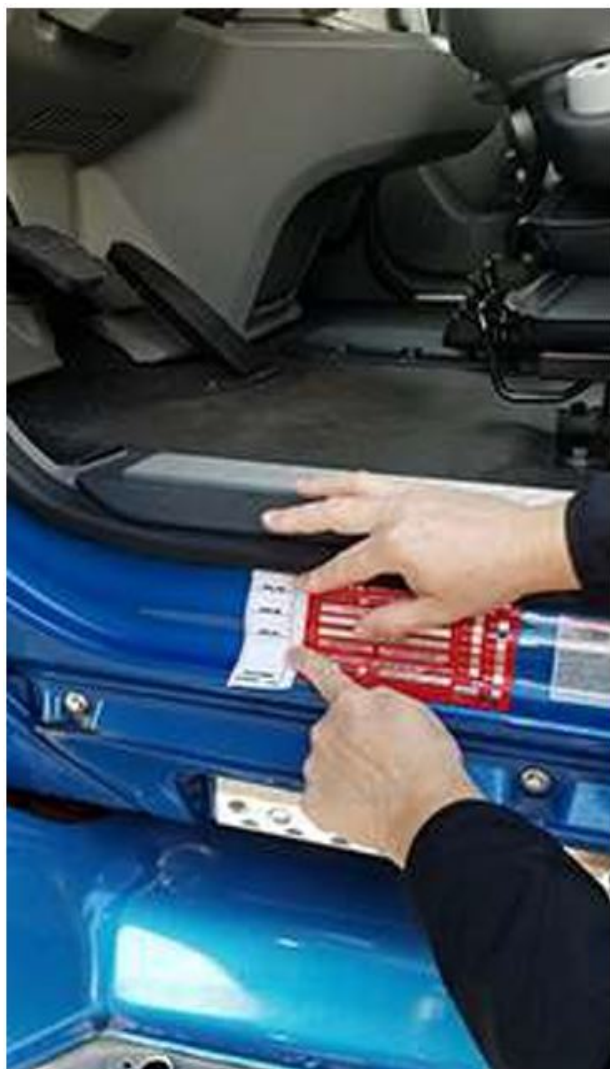
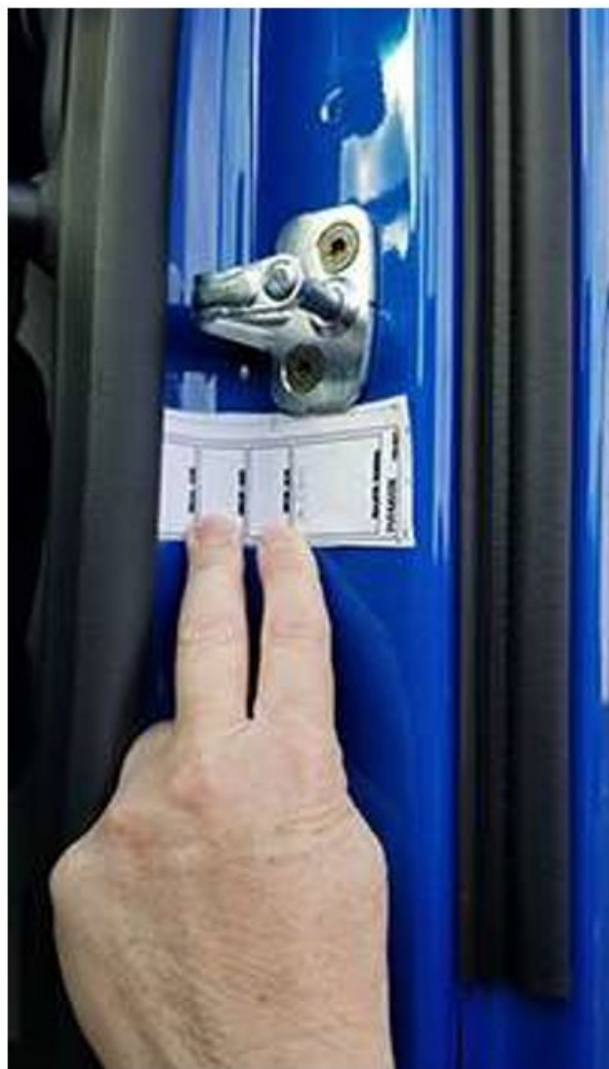
1. Update the engine software. Refer to Bulletin E134 for information about programming a PACCAR MX engine.
2. For California registered chassis, complete the California POC Certificate per bulletin E192 (check link for POC certificate) and install the repair label, p/n Y53-6107, in the driver's door jamb.
  - a. Use Recall code 0075.
  - b. Fill out the Y53-6107 label fields with the Recall Code and Bulletin Number shown below. Add the appropriate Dealer Code and Repair Date.
3. Take photos of the new labels after installation and attach them to the warranty claim.
  - a. Place the Y53-6107 label in the door jamb. If there is no room in the driver's door jamb, the label can be installed in the passenger door jamb. The images below show how the labels can be installed in various door

jamb.

b. Install the clear overlay (part number Y53-6108) over the label.

**Please remember to take photos of the new labels after installation and attach them to the warranty claim.**
