# 01-079 - AC Stops Blowing Cold Intermittently

01-079

HVAC Intermittently Stops Blowing Cold Air

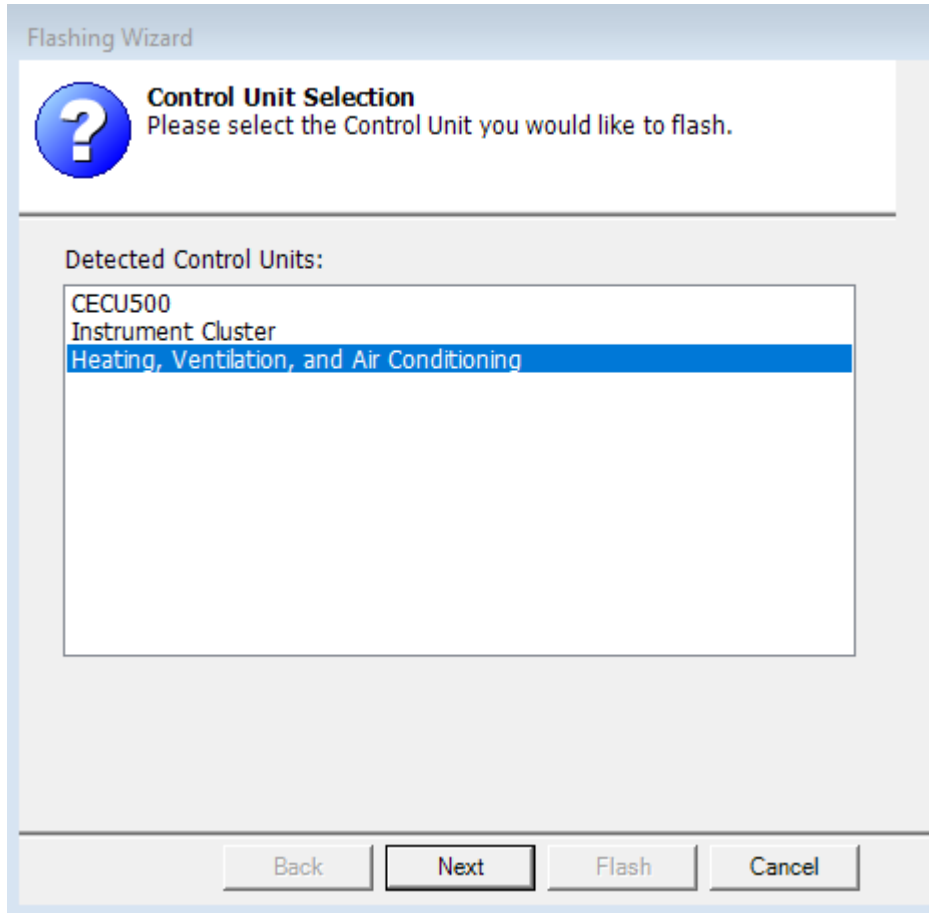
3. Update the HVAC Controller software to the latest available version. In ESA, click Tools | Flashing, then select Heating, Ventilation, and Air Conditioning from the Flashing Wizard window.

4. Select the most current software version from the Version Selection window.

5. Click Flash to update the software.
