E283: PACCAR MX EMY2021B Engine Fuel Injector Connectors Not Seated

PACCAR MX Engine Model Year 2021B Engine Fuel Injector Connectors Not Seated

6/24/2022

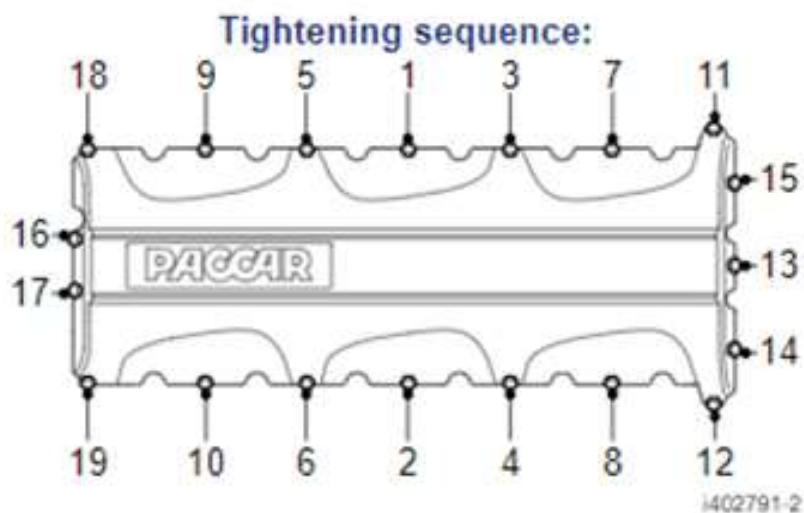
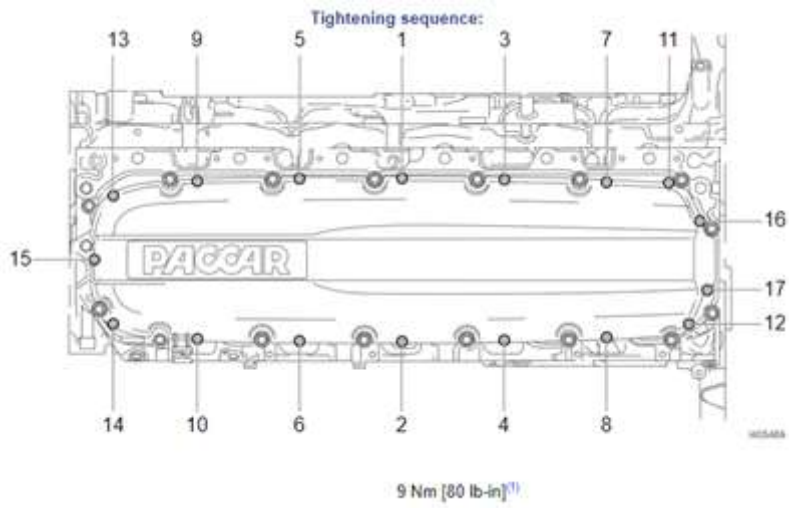
Partially seated fuel injector electrical connections may result in an intermittent connection with the PCI, limiting fuel delivery. Injector or misfire fault codes (see Links section) may also be set.

1. Remove the four bolts that secure the air cleaner assembly to the two brackets atop the valve cover.
2. Remove the two brackets from atop the valve cover.
3. Remove the valve cover bolts and valve cover.
4. Inspect the fuel injector electrical connectors and ensure that they are properly seated.
5. If the chassis has reached 100,000 miles (160,000km), replace the valve cover gasket.
6. Reinstall the valve cover and tighten the in the proper sequence shown below.
 - Torque for both MX-13 and MX-11 valve cover bolts is 9 Nm / 80 in-lb / 6.67 ft-lb
7. Reinstall the two air cleaner brackets to the valve cover.
8. Reinstall the air cleaner assembly.
9. Connect DAVIE4
10. Clear codes stored as a result of injector connectors.
