Technical Service Bulletin

GROUP CAMPAIGN	NUMBER 23-01-039H
DATE JUNE 2023	MODEL(S) Ioniq 5 Electric (NE1)

SUBJECT: VCU UPDATE AND OWNER'S MANUAL SUPPLEMENT (CAMPAIGN TAF)

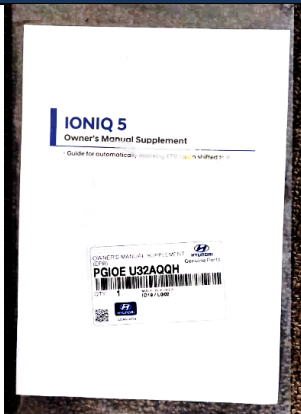
Part Name	Part Number	Remarks.
OWNER'S MANUAL SUPPLEMENT (EPB)	PGIOE-U32A QQH	Use only for 2022MY vehicles

- For 22MY Vehicles only:** Attach the Owner's Manual Supplement (EPB) leaflet listed in the Parts Information section on top of the Repair Order. Inform the Service Advisor to explain and provide it to the customer.
- Perform the VCU Update in Auto Mode.
 - Use the Auto Mode ID Check to verify the VCU ROM ID before updating the software.

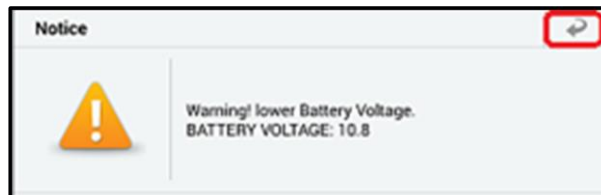
GDS Vehicle Battery Voltage:

- This VCU Update is long, so the 12V battery must be at good charge level (>60% SOC).
- If the voltage is below 12 volts as per the GDS warning, then select **Back** and run the vehicle at least 30 minutes to reach an adequate battery state of charge to prevent an ECU Update failure. Cycle the ignition **OFF/ON** before retrying ECU update again.
