## TECHNICAL SERVICE BULLETIN # 2023-6

### Cleervision Windshield

It has been determined some travel trailers manufactured with Cleervision windshields have the potential for the glass to delaminate from the adhesive bonding the trim ring. This Technical Service Bulletin explains how to correct the situation.

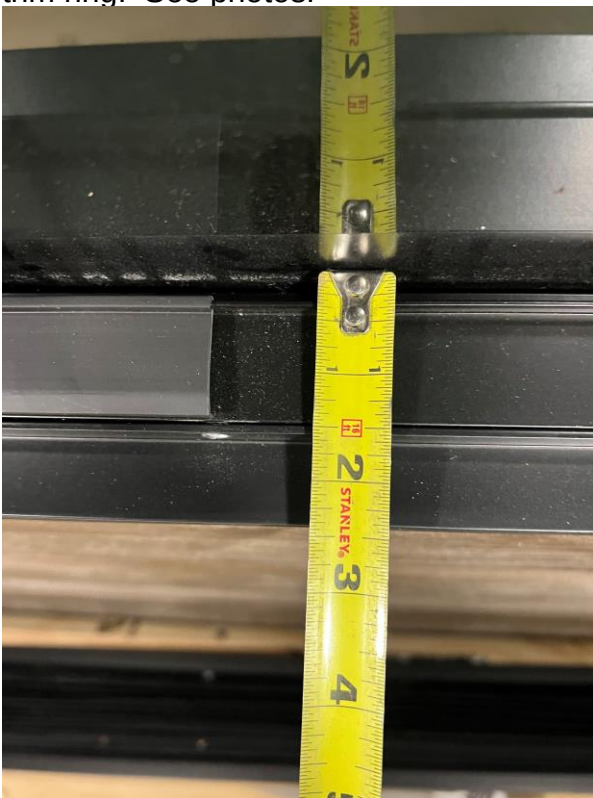
Cleervision measures 2 1/2" from glass to ring.

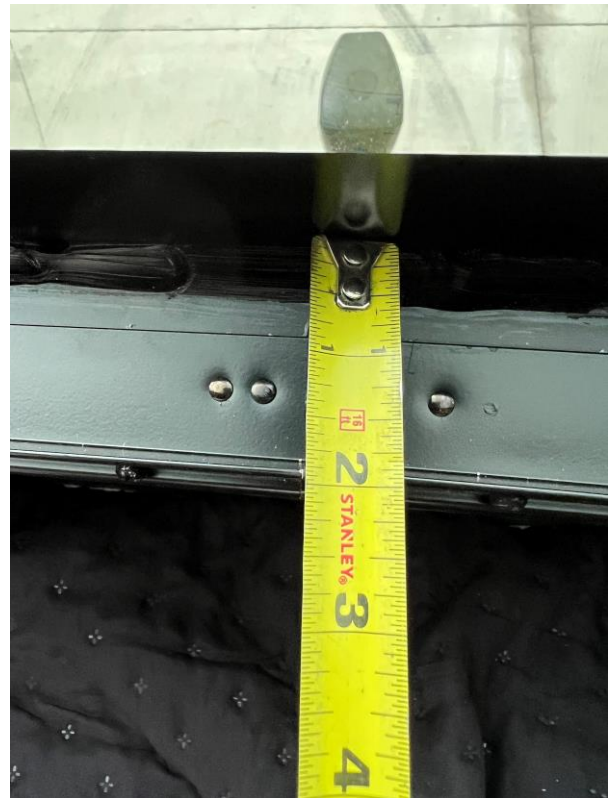
Statewide measures 2" from glass to ring.
