Campaign No. 2023060008, June 2023

SUBJECT: **Model C-Class (206 platform)**
Model Year 2023

Install Rivets on Cross-member above Rear Axle

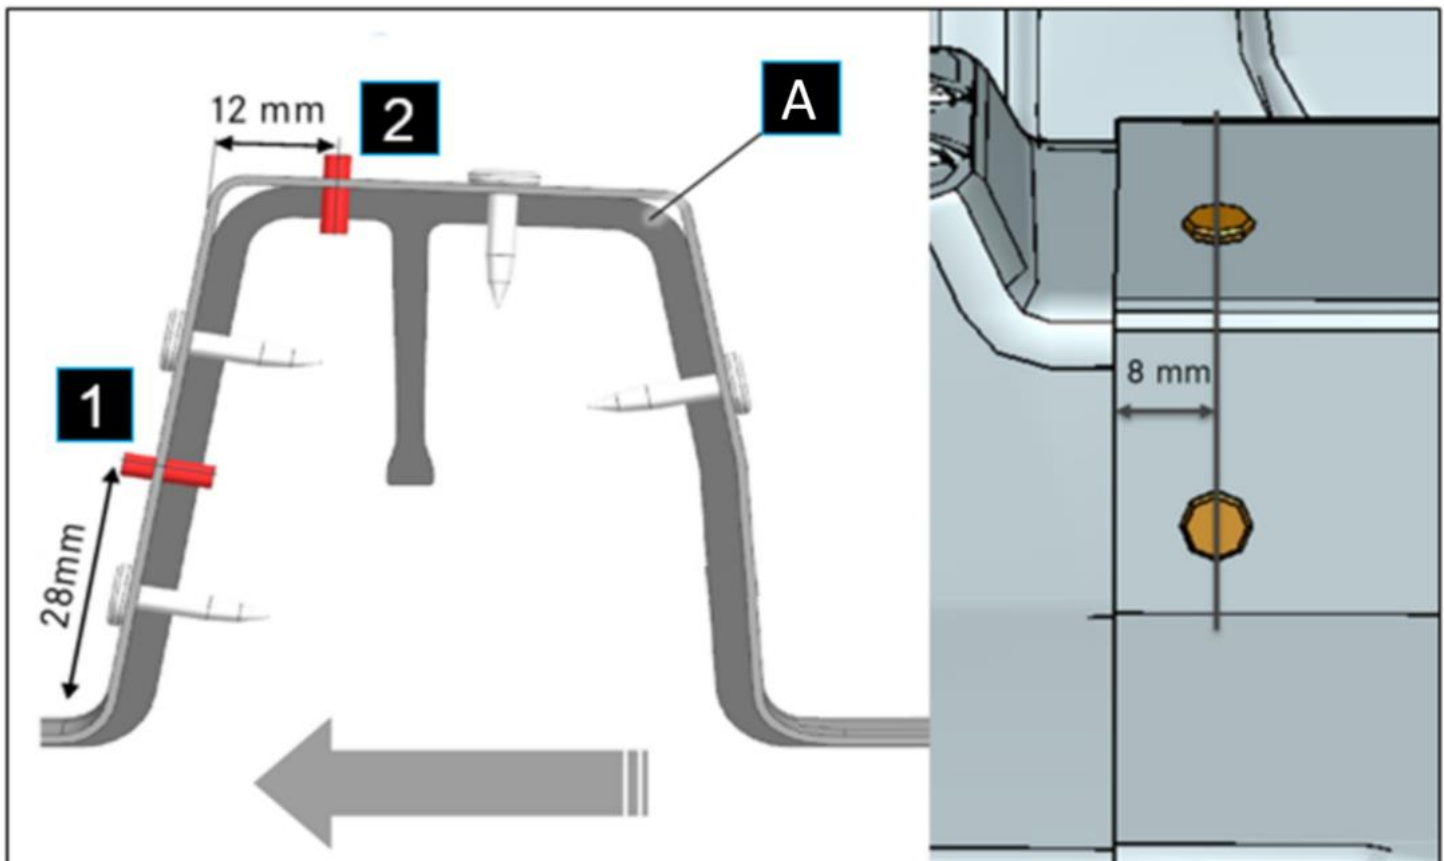
Figure 1

Mercedes-Benz AG (“MBAG”), the manufacturer of Mercedes-Benz vehicles, has determined that on certain Model Year (“MY”) 2023 C-Class (206 platform) vehicles, the adhesive seam on the cross-member in the rear area does not correspond to current specifications. As a result, noise may occur in the rear area of the vehicle while driving and the body may be subjected to greater stress in this area. An authorized Mercedes-Benz dealer will install rivets on the cross-member above the rear axle on the affected vehicles.

1. Remove rear seat cushion padding.
 - i For basic information, see: AR91.12-P-1022WT.
2. Remove seat backrest in rear passenger compartment completely.
 - i For basic information, see: AR91.12-P-1713WT (**except** code 287 (Through-loading feature)).
 - i For basic information, see: AR91.12-P-1723WT (**with** code 287 (Through-loading feature)).
3. Remove trunk lining.
 - i For basic information, see: AR68.30-P-4602WT (**except** code ME10 (Hybrid vehicle (plug-in, PHEV))).
 - i For basic information, see: AR68.80-P-6000WT (**with** code ME10 (Hybrid vehicle (plug-in, PHEV))).
4. Perform power disconnect for high-voltage on-board electrical system.
 - i For basic information, see: AR47.70-P-1010AMC (**with** code ME10 (Hybrid vehicle (plug-in, PHEV))).
5. Mark rivet holes on cross-member (**A**, Figure 1).
 - i Mark positions 1 and 2.

6. Drill 6.7 mm rivet holes and deburr.
7. Clean rivet holes and surrounding area.
