**SERVICE BULLETIN**

**NUMBER:** 15-236-18R

**SUBJECT:** Reprogramming File Availability for Optimization of Harman Gen 3.1 and Gen 3.1α Audio and Navigation Head Units

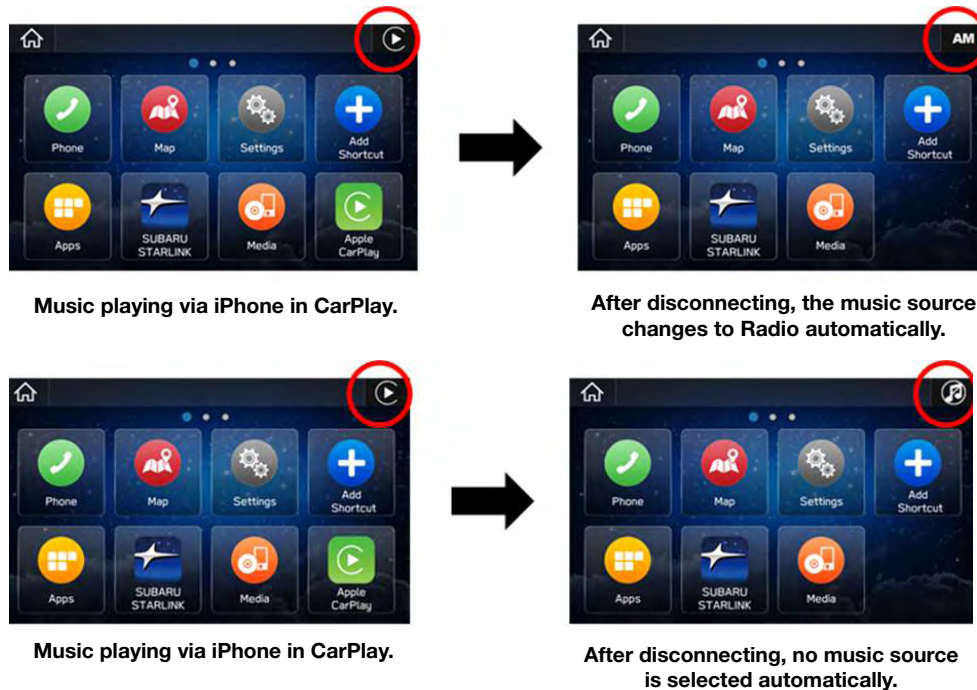
**On Ver. 6.0 and before:**

If a source of music other than CarPlay has been playing when the iPhone is disconnected, the music source remains same (it is not turned off.)

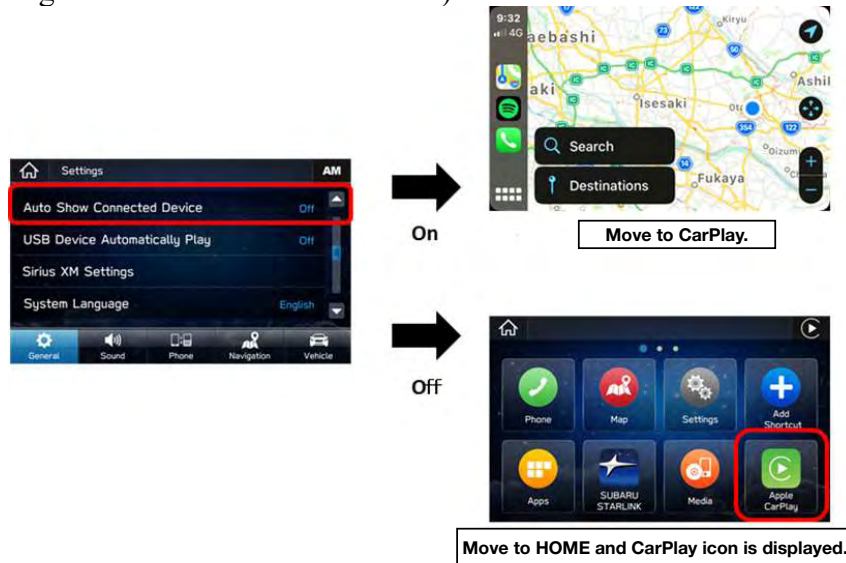
In a case where the iPhone was disconnected while playing music then reconnected while it is playing music, the system moves to CarPlay screen no matter what is set in <Auto Show Connected Device> in Setting (depending on iOS version of the iPhone.)

The <Auto Show Connected Device> is no longer available for CarPlay. The Setting menu shows only <Android Auto> to access the <Auto Show Connected Device> selection menu. If an iPhone with active CarPlay is connected, the Head Unit always moves to the CarPlay screen.

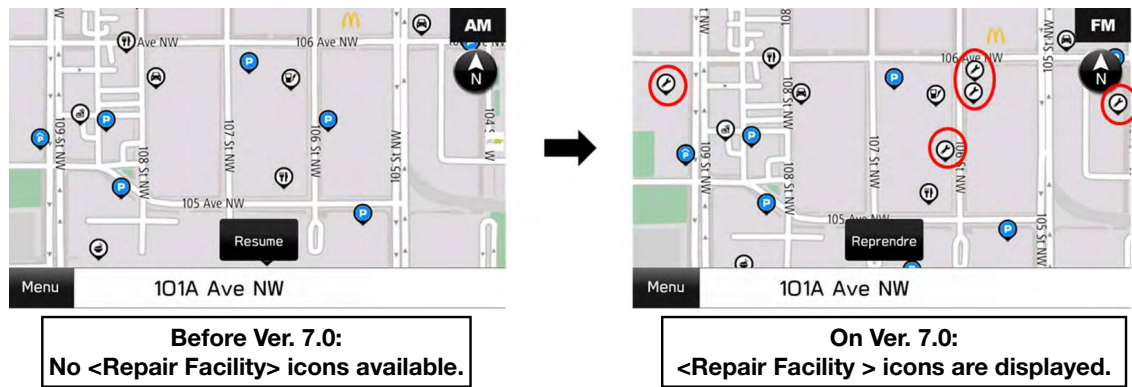
<Repair Facility> Icons can be displayed in the NAVI Map.

<Repair Facility> Icons can be turned On or OFF by going to: Settings > Navigation > POI Icons.

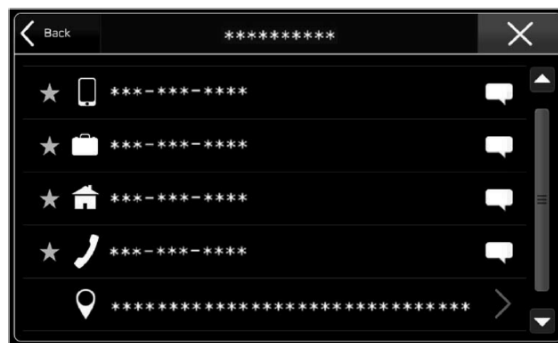
- 1) AM/FM radio station presets are lost.
- 2) Favorite Phone Contacts list is lost.

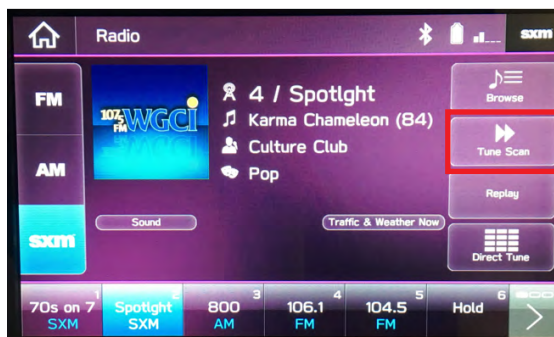
<Scan> previously displayed on SXM screen was changed to <Tune Scan> (a.k.a. SEEK).

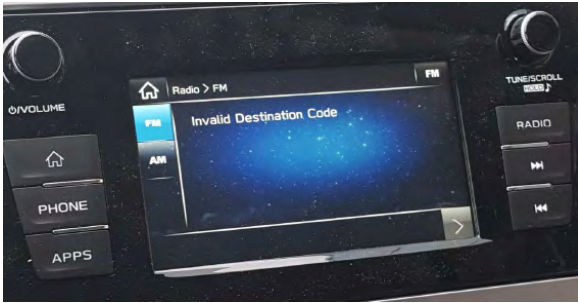
- 6) Music skips/cuts out while using Apple CarPlay.
- 7) Hands-free feature freezes intermittently while loading.
- 8) Navigation system freezes after entering a particular address using Voice Recognition.  
**NOTE:** All other functions are not affected.
- 9) The voice guidance volume no longer changes After Ignition Off/On. Once the Voice Guidance has been muted, the system retains that setting even after switching the ignition Off/On.
- 10) Invalid Destination Code message appears on the display while listening to the radio.

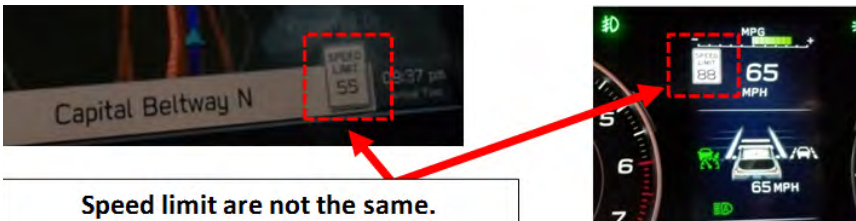
- 11) Spanish version FOTA (Firmware Over The Air) translation corrected.
- 12) Mismatch of Speed Limit between Navigation display and the Speed Limit displayed in the Combination Meter Multi-Function Display (MFD).

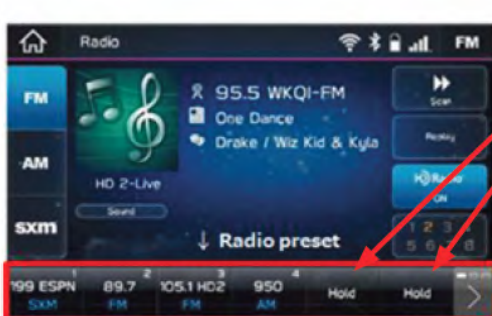
- 1) Station presets are lost. Touch buttons read “Hold”. (Applicable for software versions Rel\_4.18.25.50 (or before)). Included in software version Rel\_U1.18.38.50.
