PRODUCT CAMPAIGN BULLETIN

APPLICABILITY: 2017-19MY Impreza / Halogen Head Lamps

NUMBER: WRG-22

SUBJECT: Halogen Headlamp Low Beam & Side Reflector

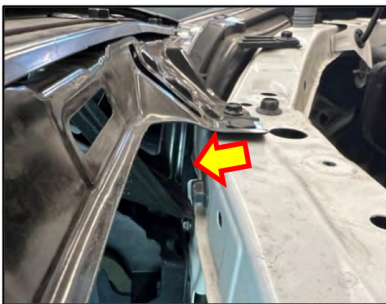
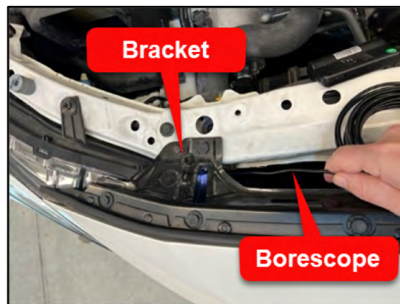
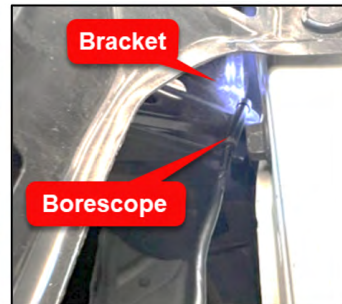
STEP 3: Insert a borescope in between the upper bumper bracket and the inner front portion of both left and right headlamps.

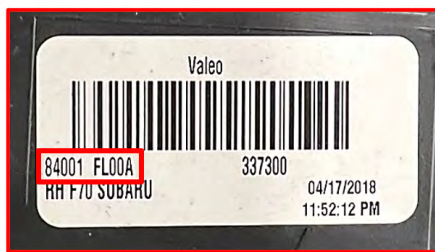
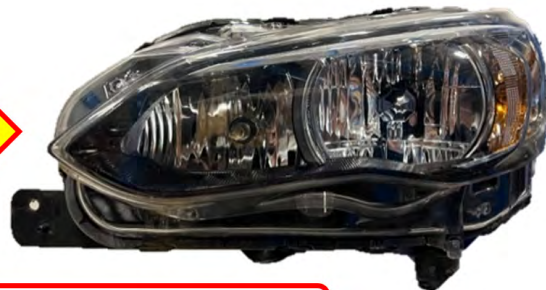
Locate the part numbers labeled on the both the left and right headlamp assemblies. The part identification label is located on the inner front portion of the headlamp. See the images below.

The example part identification label pictured above shows part number **84001FL00A**

Headlamps with part number **84001FL00B** or **84001FL01B** will not require replacement. If **84001FL00B** or **84001FL01B** are found, no replacement is required. Reinstall all removed parts in the reverse order of disassembly.

ALL other part numbers will require replacement and adjustment (see below).
