## SERVICE BULLETIN

**APPLICABILITY:** 2022MY WRX

**NUMBER:** 09-102-23

**SUBJECT:** Diagnosis Procedures for DTCs  
P2404 & P2109

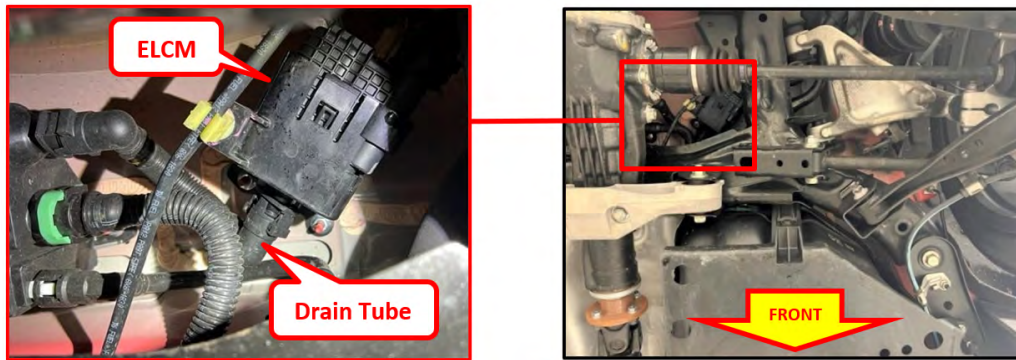
**STEP 3:** CAREFULLY disconnect the ELCM drain tube. Inspect for signs of water or oil.

Have signs of water or oil been detected within the ELCM drain tube?

**YES** – Clean and dry the drain tube using a non-alcohol base cleaner. Proceed to STEP 4.

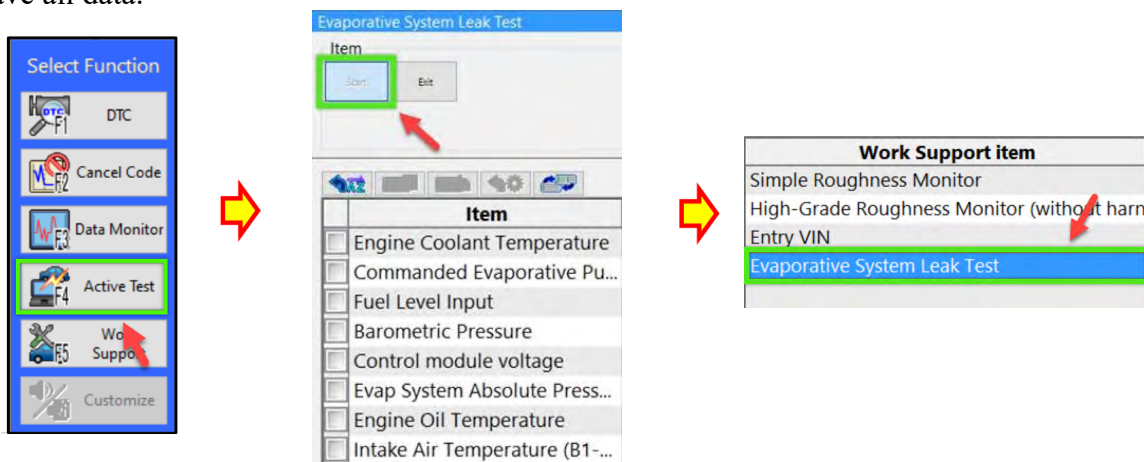
**STEP 4:** Connect the vehicle to a recommended power supply. See APPENDIX A for addition information regarding power supply. Using SSM, perform the Evaporative System Leak Test. Collect and save all data.

Once the evaporative system leak test is complete, check the DTCs and examine the vacuum value results. Record the value shown in the row labeled MID: \$3C, TID: \$C4, and Scaling ID: \$FE. This value should be lower than -0.26 PSI.

Value Must Be Lower Than -0.26 PSI

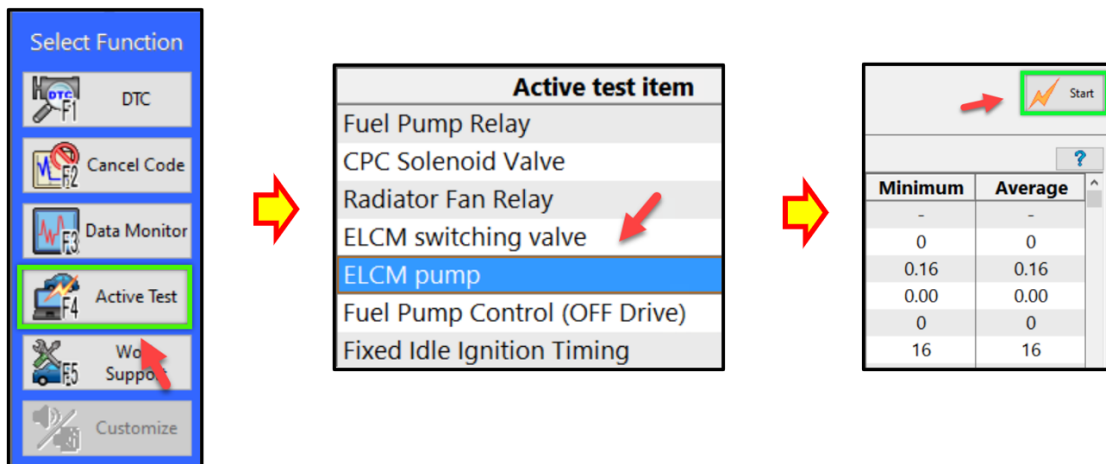
**STEP 6:** Using SSM, perform the ELCM Pump Active Test for a period of 35 minutes or more. See APPENDIX A for addition information regarding power supply.

Once the ELCM Pump Active Test has been performed for a period of 35 minutes or more, repeat the Evaporative System Leak Test outlined in STEP 4. Check the DTCs and the vacuum value results.

**STEP 8:** Replace the Evaporate Leak Check Module and repeat the Evaporative System Leak Test outlined in STEP 4. Check the DTCs and the vacuum value results.
