INTRODUCTION

The purpose of this Bulletin is to provide procedures for the diagnosis and repair of oil seepage which may be coming from the areas listed below:

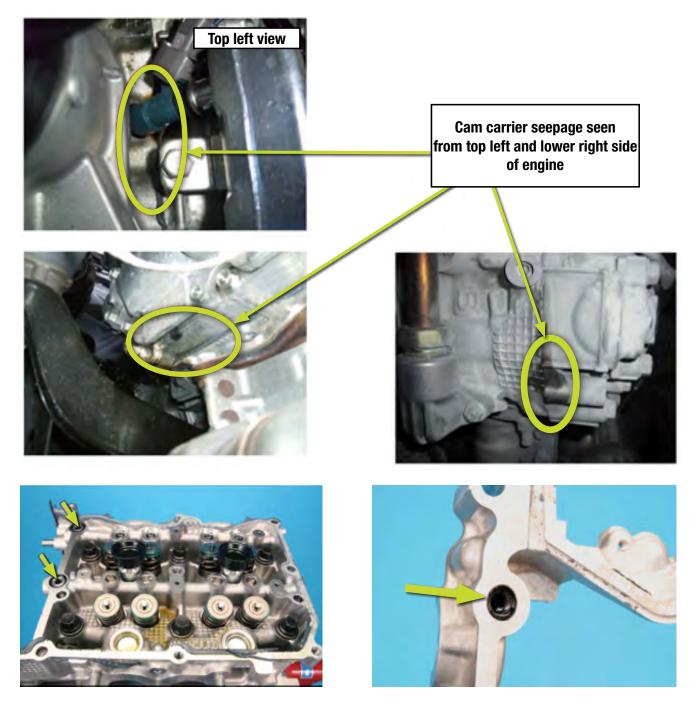
One-time use cam carrier o-rings which must be replaced.

AVCS filter screens must be replaced if removed.

ISO 14001 is the international standard for excellence in Environmental Management Systems. Please recycle or dispose of automotive products in a manner that is friendly to our environment and in accordance with all local, state and federal laws and regulations. If oil seepage is verified coming from between the cam carrier and the cylinder head as shown in the photos below, remove the cam carrier. Clean the machined sealing surfaces thoroughly and then reseal using Liquid Gasket ThreeBond 1217H (SOA868V9610) or equivalent*. As shown in the photos below, the o-rings between the cam carrier and the cylinder head will need to be replaced as they are not re-usable. This would also be a good time to clean the Active Valve Control System (AVCS) filter screens which are contained in the cam carriers and shown in the photos below. **NOTE:** The filter screens are one-time use and must be replaced if they need to be removed. The replacement filter part # is 14451 AA 050.

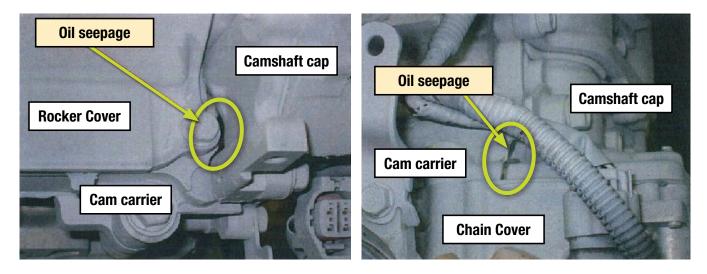
If oil seepage is verified coming from the front camshaft cap and/or camshaft carrier as shown in the photos below, remove the cam cap and clean both surfaces thoroughly before applying sealer. **Note:** The 2 o-rings between the camshaft cap and the cam carrier will need to be replaced as they are not re-usable.

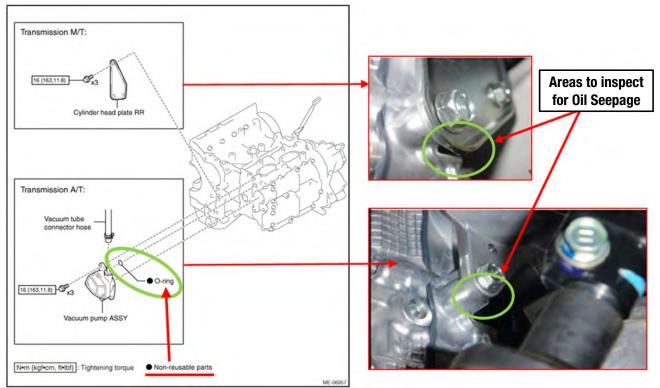
If oil seepage is verified at the bottom of the cylinder head block-off plate (on M/T models) or bottom of the vacuum pump assembly (on A/T models), the source may be the area between the cam carrier and the intake cam cap. The seeped oil then collects at the bottom of the block-off plate or vacuum pump as shown in the photo and illustration below.

IMPORTANT: ALWAYS replace the small vacuum pump o-ring as it is a **one-time use item**.
