SERVICE BULLETIN

APPLICABILITY: 2022-23MY BRZ Models **NUMBER:** 15-297-22R
SUBJECT: Reprogramming File Availability for Optimization of Gen 4 Denso CP1 Infotainment Systems **DATE:** 07/01/22
REVISED: 06/30/23

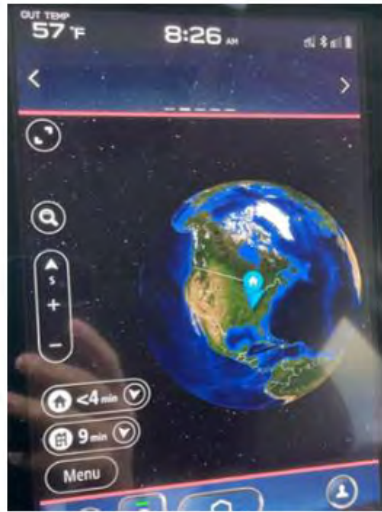
12	Navigation map scale is changed to the lowest setting (globe is displayed). <div style="text-align: center;">

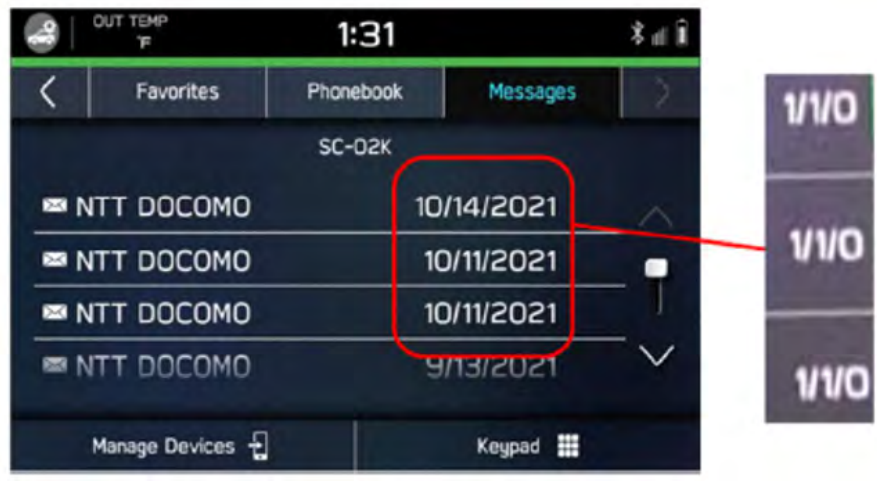
Number	Symptoms to be Improved:
<p>14</p>	<p>When selecting “Phone->”Message,” message received time is displayed incorrectly as “1/1/0.”</p> <p>It can occur with an Android phone with a specific Android OS (Pixel 6, Pixel4a, Pixel4XL, Xperia etc.) in which time zone data is attached to the message receiving time.</p>

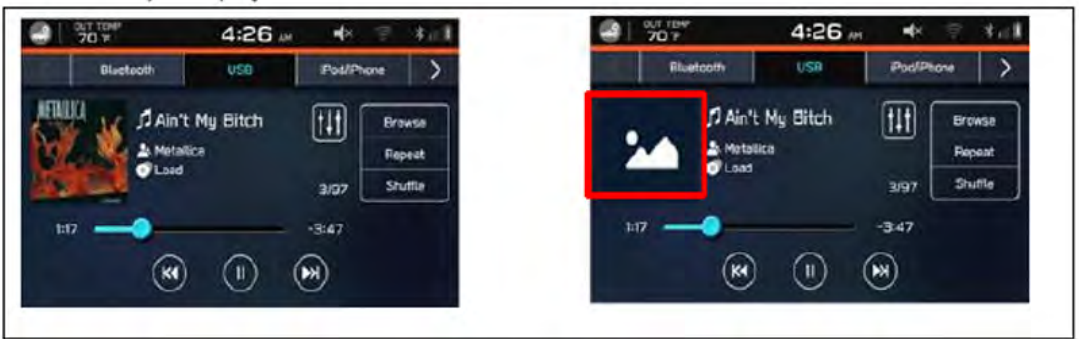
<p>15</p>	<p>Even when using the same mobile device that was paired previously, a message of “Are you sure you want to activate this profile?” is prompted and confirmation is needed to activate the device.</p>
<p>16</p>	<p>Cover art of previous music is displayed when playing music without cover art in USB audio. It can occur when music with and without cover art is mixed and stored together a single USB.</p>

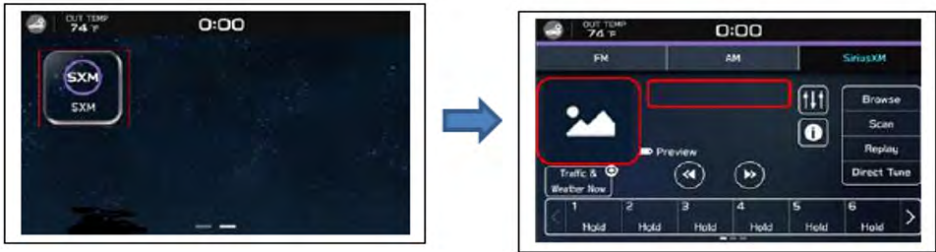
21	<p>When selecting shortcut for SXM channel on “Home” screen, the screen is changed to SXM but no sound is coming or no channel name is displayed.</p>

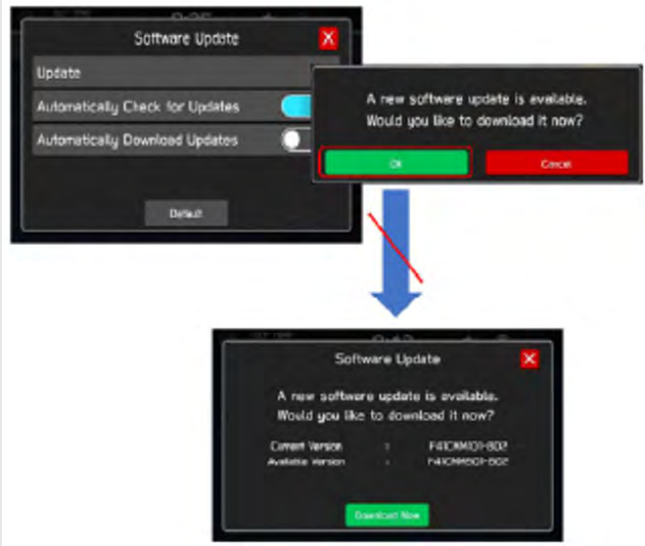
22	<p>When using FOTA service to update the software by selecting “Setting” > “Software Update,” a message of “A new software update is available. Would you like to download it now?” is displayed but the downloading does not start after pressing “OK.” When this symptom occurs, it comes back to the “Software Update” screen. The downloading can be started by pressing the “Update” on the “Software Update” screen. (Temporary solution.)</p>

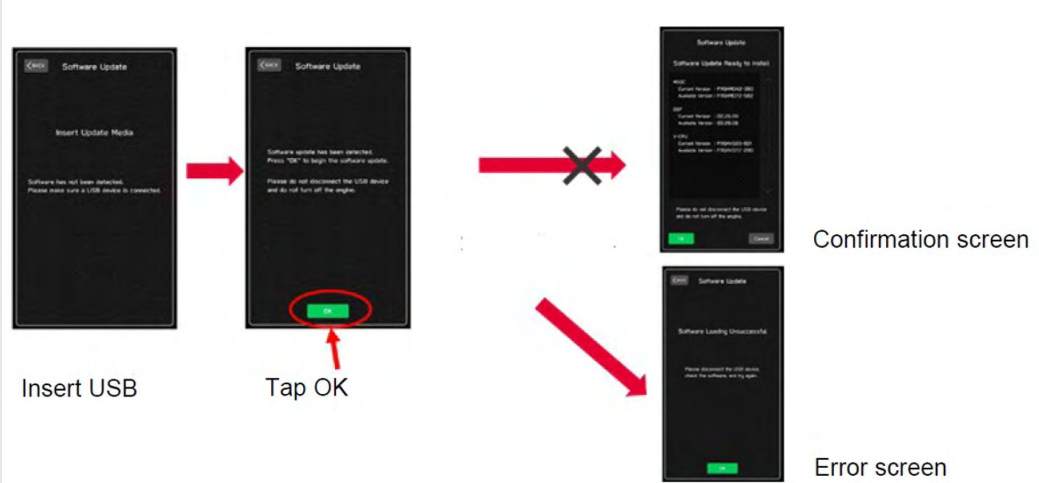
11	<p>Reprogramming process takes extensive time (40 minutes or more.)</p> <p>After the ignition switch is turned off and on again, the combination meter display mode changes itself and shows the ECO gauge (Current fuel consumption/Driving range on remaining fuel.) Both attribute to processing errors in CCU.</p>
12	<p>When conducting USB reprogramming, the screen transition to error screen instead of confirmation screen.</p>

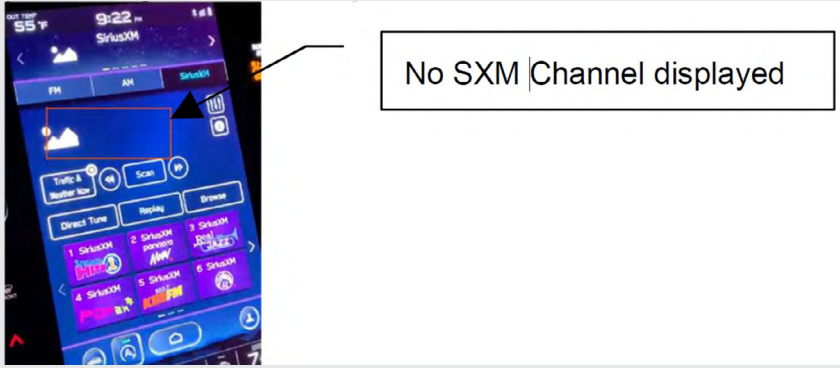
Number	Symptoms to be Improved:
26	<p>SXM has blank screen and no sound when the SXM screen had been selected as audio source at the previous ignition off timing.</p> <div data-bbox="483 239 1318 604">

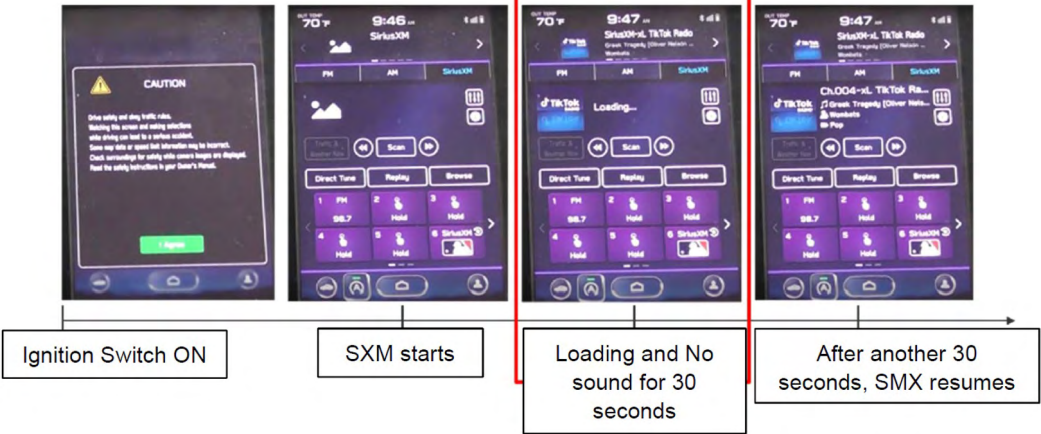
</div>
27	<p>About 30 seconds after starting the SXM the operation is paused with loading screen and resume after another 30 seconds. This symptom occurs when the SXM screen had been selected as audio source at the previous ignition off timing.</p> <div data-bbox="386 751 1421 1182">

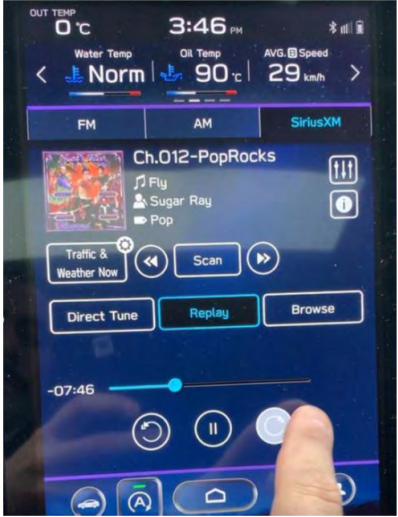
</div>
28	SXM has blank screen and no sound when the audio source is change to SXM.
29	<p>“Fast forward” does not work in SXM replay function. (Fast Rewind works.)</p> <div data-bbox="706 1339 1101 1852">

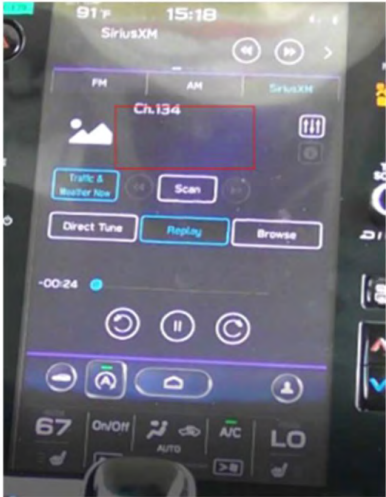
Number	Symptoms to be Improved:
30	<p>The channel information becomes blank when the seek button (<< / >>) of the steering satellite switches is pressed continuously to control the Traffic & Weather Now (TWN) in SXM.</p>

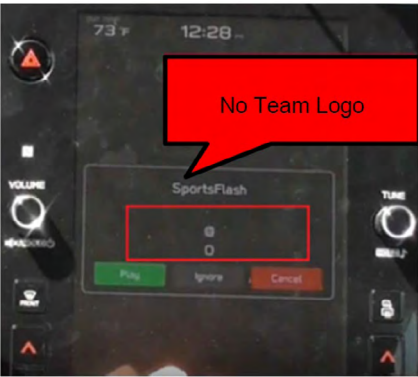
31	<p>The team logo is not displayed on Sports Flash screen when the SXM screen had been selected as audio source at the previous ignition off timing.</p>

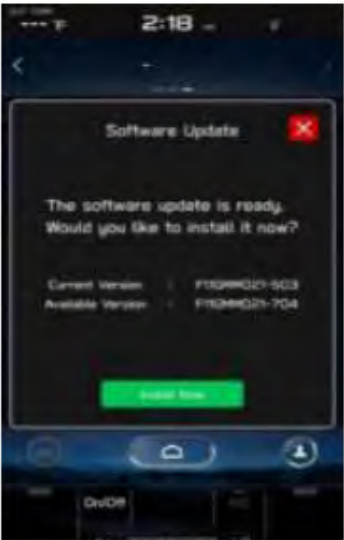
Number	Symptoms to be Improved:
1	<p>System restarts itself during FOTA (Firmware Over The Air) update. FOTA operation is conducted in two processes: downloading (from the server to the Cockpit Control Unit via Wi-Fi) and installation (inside the Cockpit Control Unit). During the FOTA operation, after the new software has been downloaded to the Cockpit Control Unit (CCU) customer is to push “Install Now” on the Center Information Display (CID) to start installation of the software.</p>

<p>However, in rare case, the CCU restarts itself* during installation.</p>

<p>Note* Even if this symptom occurs, after approximately 2 minutes, the system resumes, and the CID comes back to the below screen. Customer can then push the “Install Now” to proceed with the installation.</p>
